19 April 2022

LICENCE/LEASE CONCESSION OLD TAUPŌ NURSERY – TE PAE O WAIMIHIA

On 15 May 2019 [REDACTED] from Cheal Consultants Ltd, accompanied by Anita Porima, conducted a site inspection of two (2) houses at 153 Centennial Drive, Taupo (formally known as The Native Plant Nursery) to assess their structural integrity and note any structural items requiring further assessment or remediation. It should be noted that **no major structural issues were noted for either structure**. The inspection and assessment also picked up obvious non-structural issues which require some attention. As such, a further assessment by an architect is not deemed to be required at this time. However, a general inspection by a qualified builder/electrician, if not completed already, would be recommended to determine any potential code of compliance issues which are beyond Cheal's scope (fire protection, power circuitry/RCDs, plumbing, wood fire compliance, etc.). In addition, Cheal has not attempted to determine the presence of asbestos within either structure as this will be assessed by others.

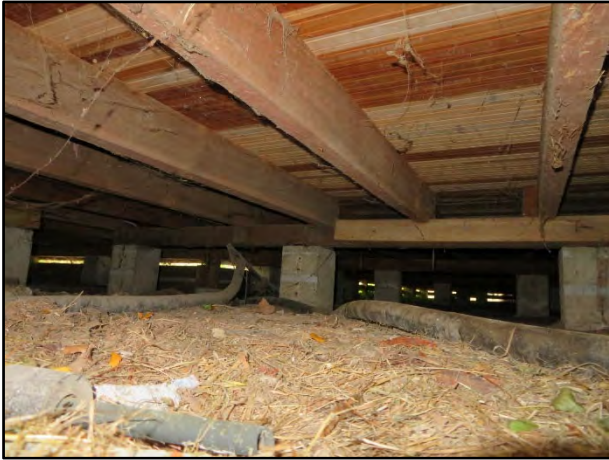
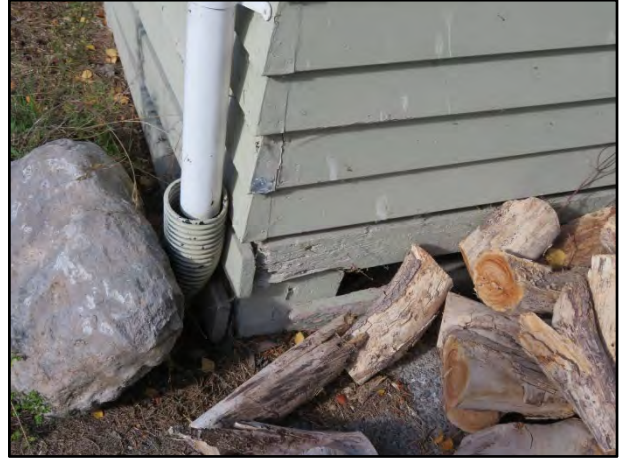
1. Sub-floor structure consists of timber bearers and joists supported on concrete piles. Some decay was note on the external base boards.

- Replace decayed external base boards
- Paint back of garage (external)
- Roof/Ceiling
 - Repair soffit lining where required
 - Re-fix roofing where required
 - Re-position ceiling insulation as required
 - Note – though not immediately imminent, roofing iron probably in need of replacement/maintenance in relatively near future (2-3 years)
- Repair/replace guttering and downpipes as required
- Repair minor damaged areas of internal wall lining
- Repair water damaged area of ceiling lining (porch and lounge)
- Replace timber decking and assess deck framing
- Wood fire to be assessed by specialist.

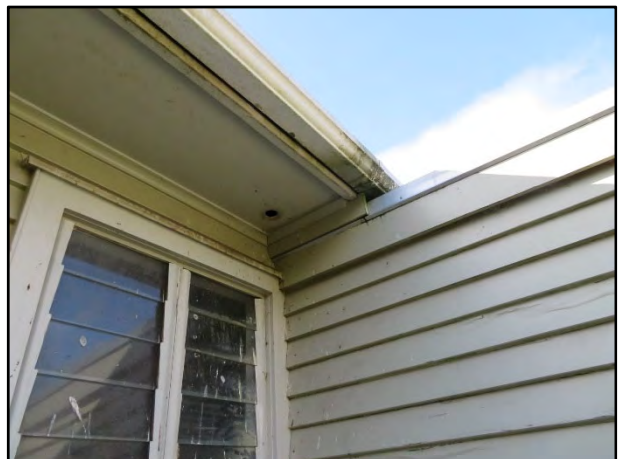
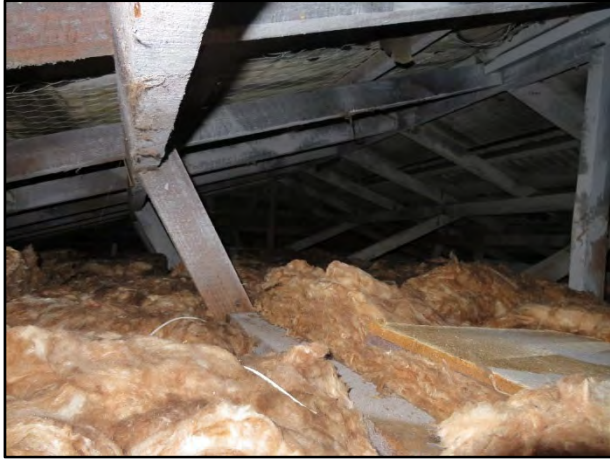
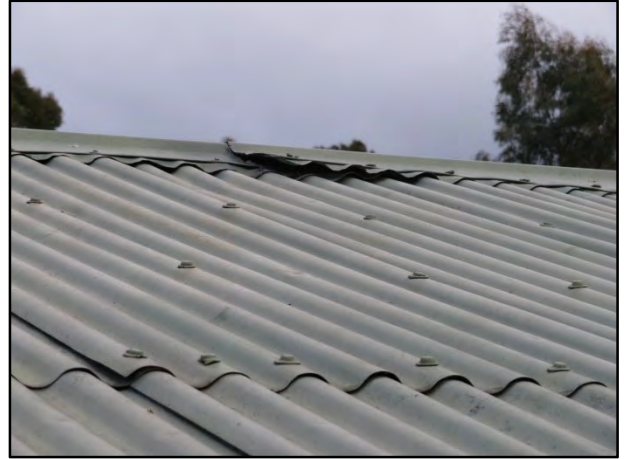
3. Windows are timber framed with timber sashes and all appear to be in sound condition.
4. Roof is corrugated iron on building paper supported by timber rafters with under purlins and struts to internal load bearing walls. Some roofing iron is rusting, and holes are visible from the manhole in ceiling. Roof fixing nails have 'popped' in places particularly along the front edges and ridge flashing needs re-fixing in places. The soffit lining also has a hole adjacent to back wall of house and garage. The roof/ceiling cavity is insulated with pink batts which need to be repositioned to cover exposed ceiling cladding.

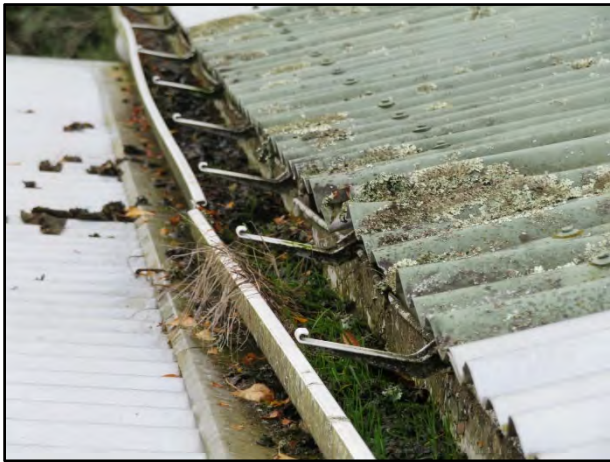
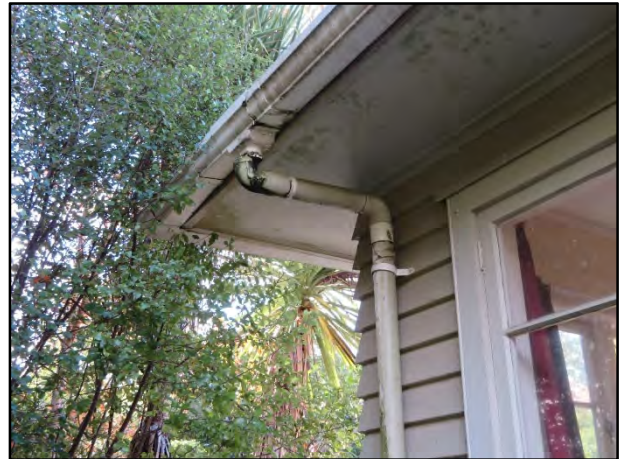
5. Roof guttering needs to be supported in places and broken downpipe connections fixed.

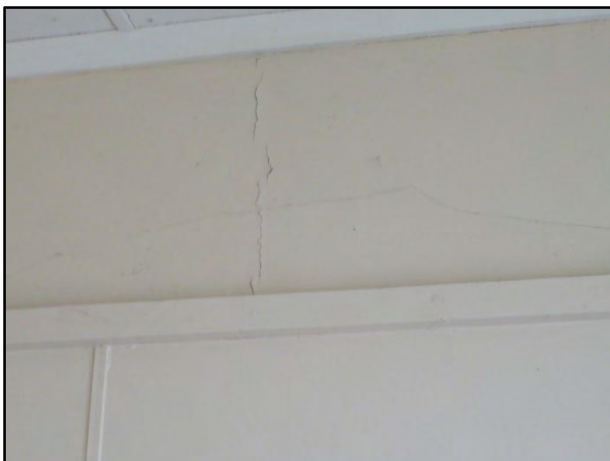
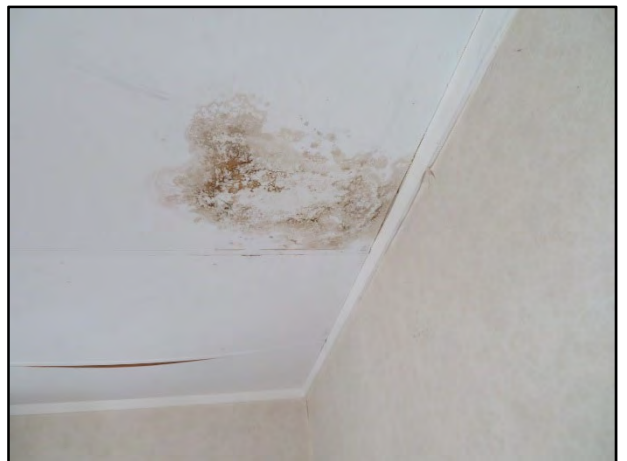
6. Internal walls are lined with Gib board. There is some minor cracking above the bath. Ceiling linings are Pinex soft board with water damage visible in the side entry porch and in the lounge.

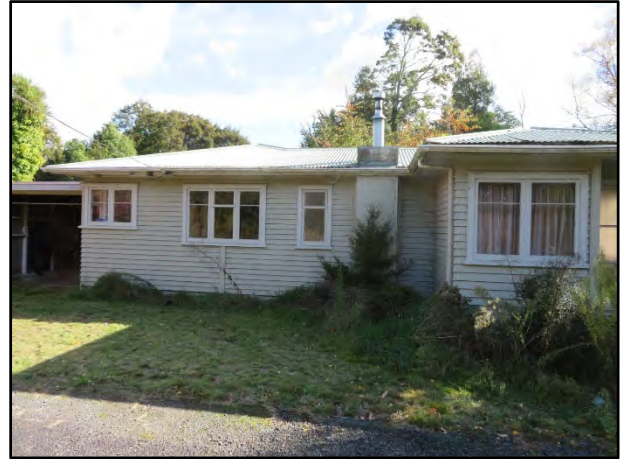
8. There is an enclosed wood burner fire in the lounge with flue through the ceiling and roof cavity. This has not been assessed by Cheal as this requires assessment by a specialist. Wood burner has been placed in front of an original open fire which has been blocked off and chimney removed, although the original concrete breast is still in place.

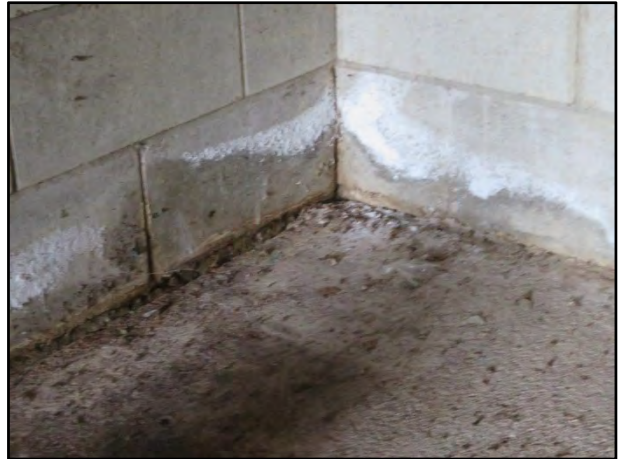
1. There is a line of effervescence along the bottom course of the block wall. A possible cause could be that the floor to wall joint is not sealed properly and rising damp has seeped through the joint. However, this is mainly cosmetic and is not considered to be a serious structural issue. It is also located in a non-living area and so does not pose a health and safety risk. If, however, you wish to pursue the problem further, we recommend seeking expert advice.

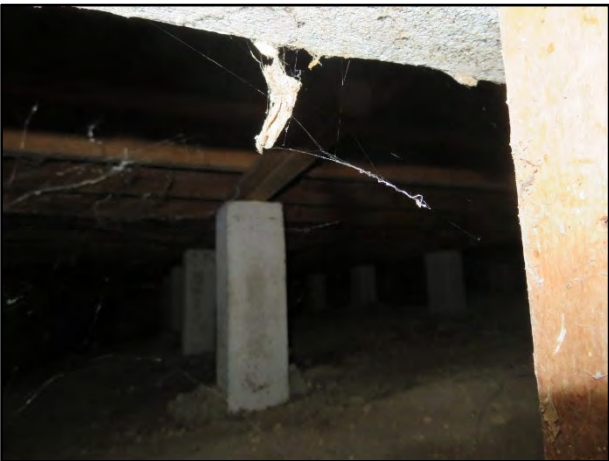
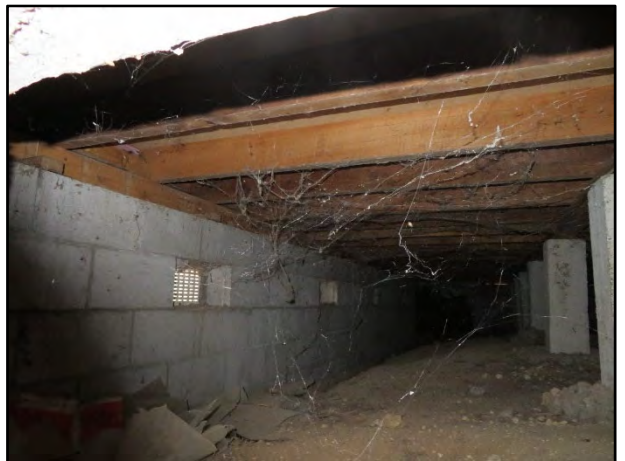
2. The remainder of the house sub-floor consists of concrete piles supporting timber bearers and timber floor joists. Under floor ventilation is provided by in built vents in exterior block wall foundation.

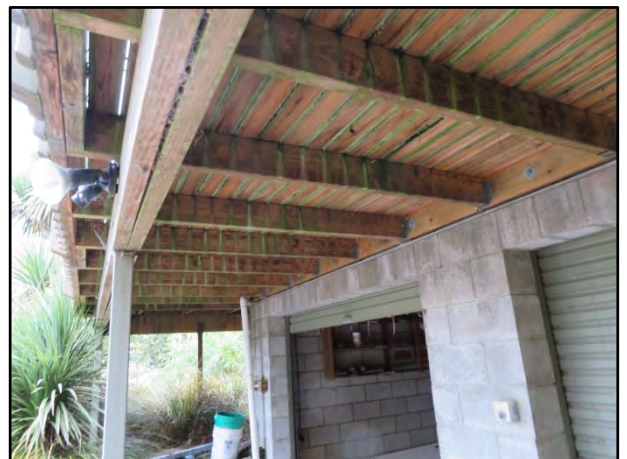
9. The timber deck joists are fixed to stringers on house wall and steel support posts along exterior edge, with galvanised joist hangers. These all appear sound and adequate. However, the handrail is inadequately fixed and has noticeable movement. This requires remediation and the fitting of propriety fixing brackets to the underside of the deck at handrail stanchions.
10. Entrance steps are supported on stringers and are shaded by shrubbery along the sides causing the treads to remain damp and hence slippery. Installing an anti-slip covering on the treads will alleviate this concern. Some trimming of vegetation would also assist in keeping treads dry.

- Replace lounge sliding door
- Reposition ceiling insulation as required
- Consult exterminator for rodent infestation within ceiling
- Re-fix front edge of roofing iron
- Replace flue and flashings for fireplace (consult with a specialist for fireplaces)
- Re-fix guttering where required
- Remediate deck handrail fixings with proprietary brackets
- Install anti-slip covering on stair treads and/or trim vegetation

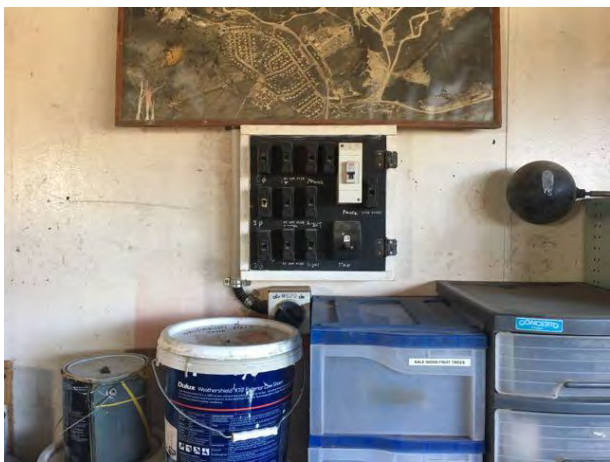
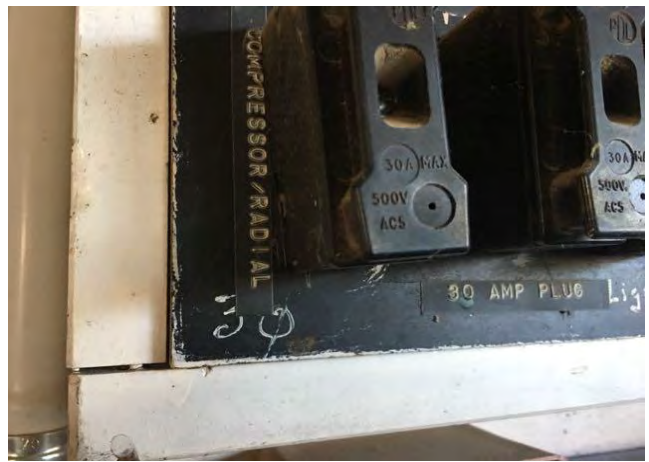
Product Type	Asbestos reinforced composites etc.	1	Condition	Low damage	1
Surface Treatment	Self-Sealed	0	Asbestos Type	Crocidolite	3
Material Score	5		Risk	Low

RISK ASSESSMENT	9 / 24	LOW
------------------------	---------------	------------

Recommendation:	Do not disturb
Comments:

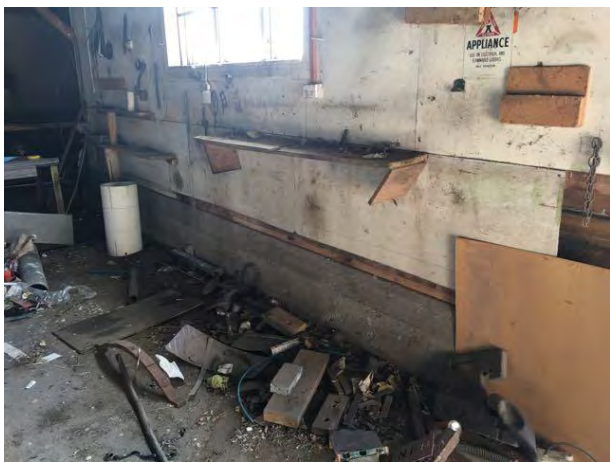
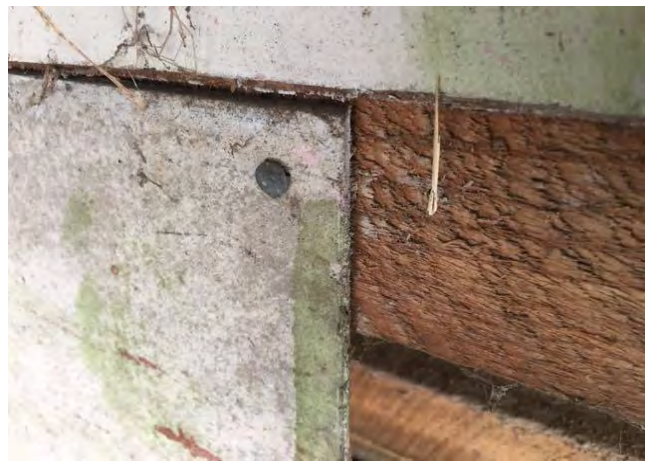
Product Type	Asbestos reinforced composites etc.	1	Condition	Low damage	1
Surface Treatment	Sealed	1	Asbestos Type	Amosite	2
Material Score	5		Risk	Low

RISK ASSESSMENT 11 / 24 **LOW**

Recommendation: Label and maintain

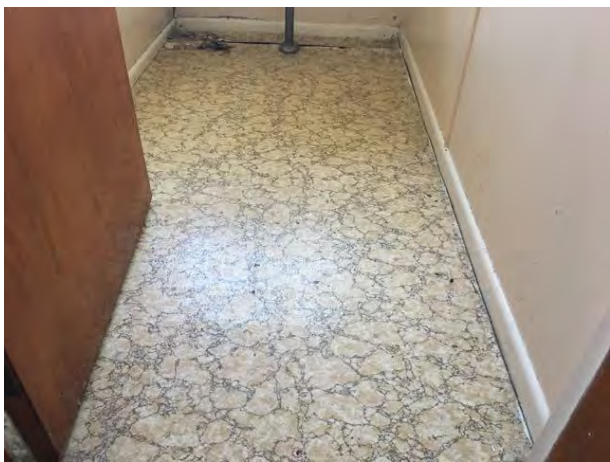
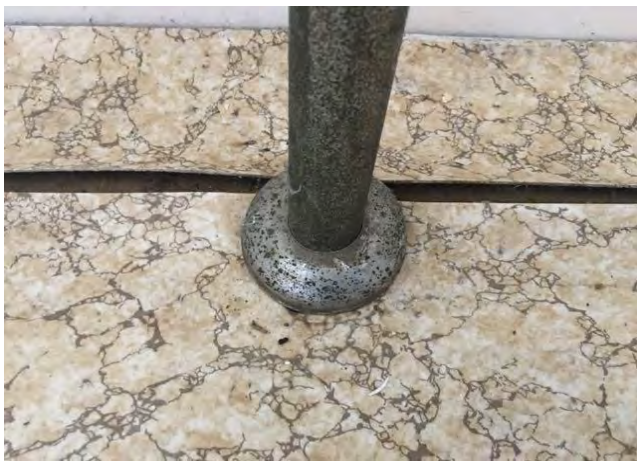
Product Type	Asbestos reinforced composites etc.	1	Condition	Low damage	1
Surface Treatment	Self-Sealed	0	Asbestos Type	Chrysotile	1
Material Score	3		Risk	Very Low

RISK ASSESSMENT	9 / 24	LOW
------------------------	--------	------------

Recommendation:	Label and monitor
Comments:

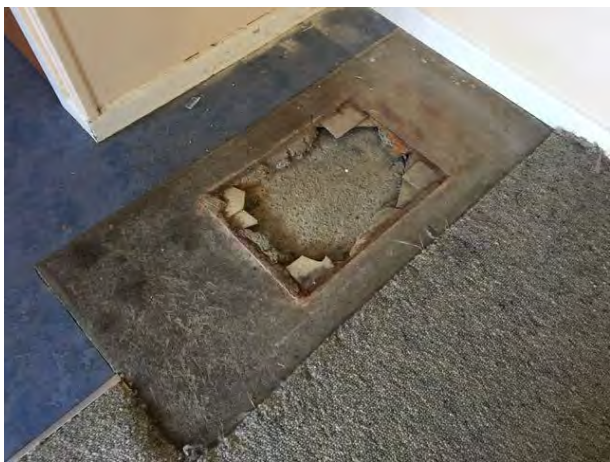
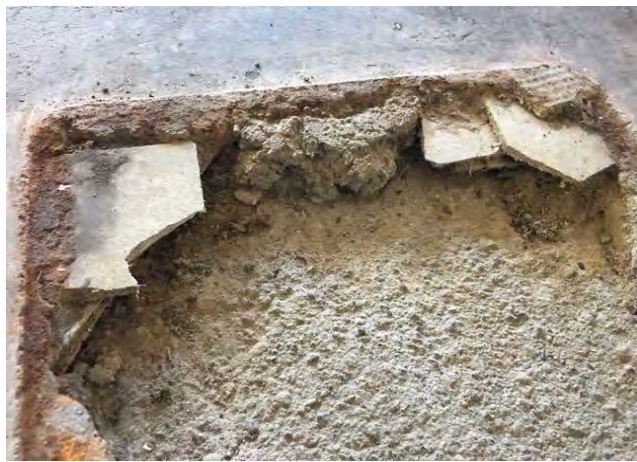
Product Type	Asbestos reinforced composites etc.	1	Condition	Medium damage	2
Surface Treatment	Sealed	1	Asbestos Type	Amosite	2
Material Score	6		Risk	Low

RISK ASSESSMENT	12 / 24	LOW
------------------------	---------	------------

Recommendation:	Repair and seal
Comments:

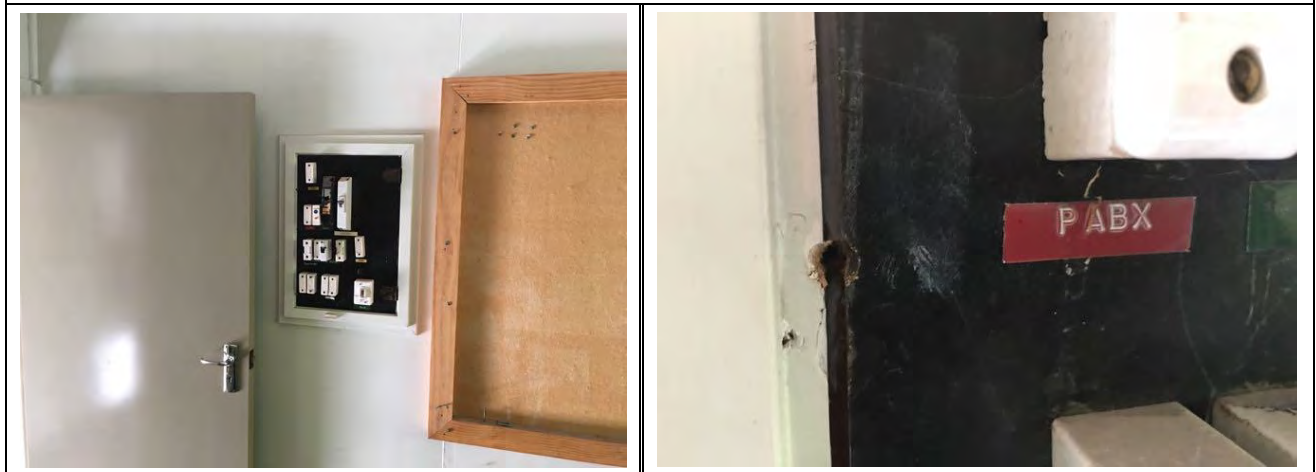
Product Type	Asbestos reinforced composites etc.	1	Condition	Low damage	1
Surface Treatment	Self-Sealed	0	Asbestos Type	Crocidolite	3
Material Score	5		Risk	Low

RISK ASSESSMENT 8 / 24 **VERY LOW**

Recommendation: Do not disturb

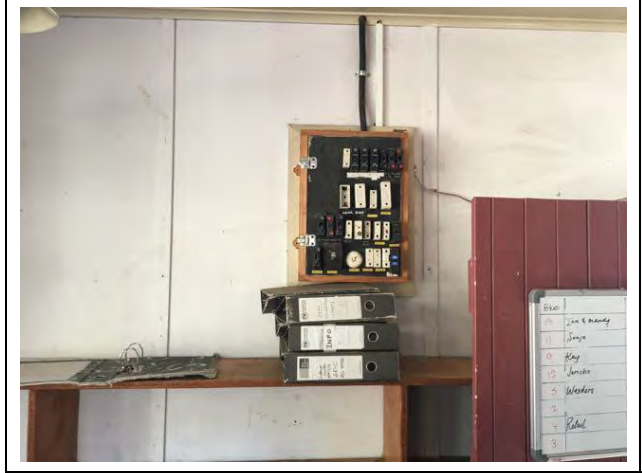
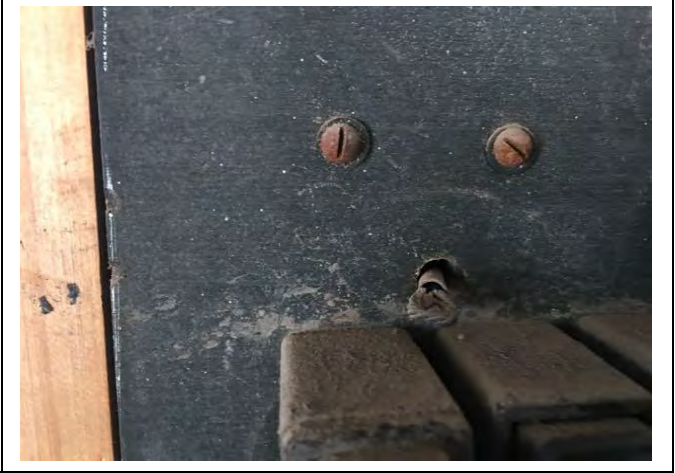
Product Type	Asbestos reinforced composites etc.	1	Condition	Low damage	1
Surface Treatment	Self-Sealed	0	Asbestos Type	Crocidolite	3
Material Score	5		Risk	Low

RISK ASSESSMENT 8 / 24 VERY LOW

Recommendation: Do not disturb

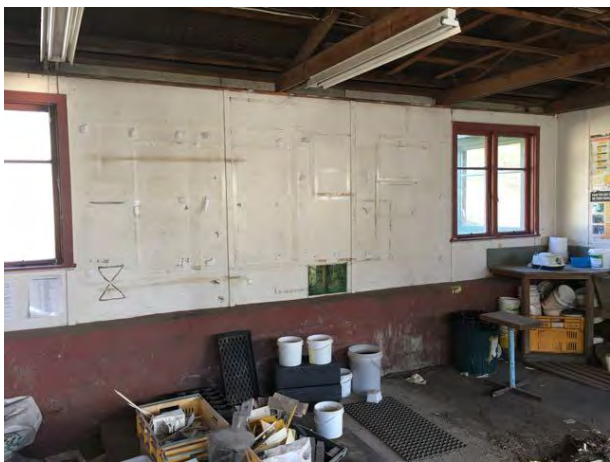
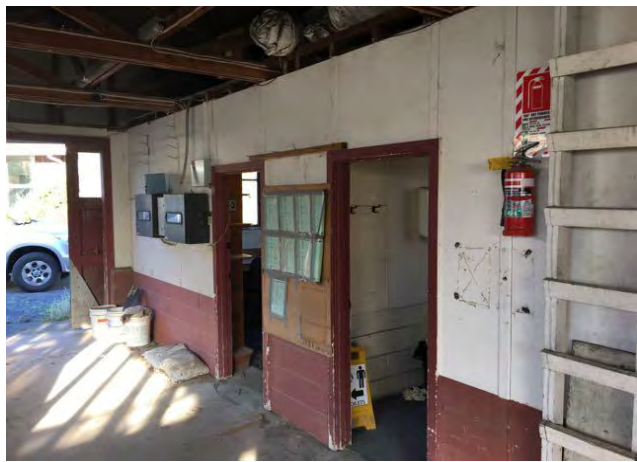
Product Type	Asbestos reinforced composites etc.	1	Condition	Low damage	1
Surface Treatment	Sealed	1	Asbestos Type	Amosite	2
Material Score	5		Risk	Low

RISK ASSESSMENT 11 / 24 LOW

Recommendation: Label and maintain

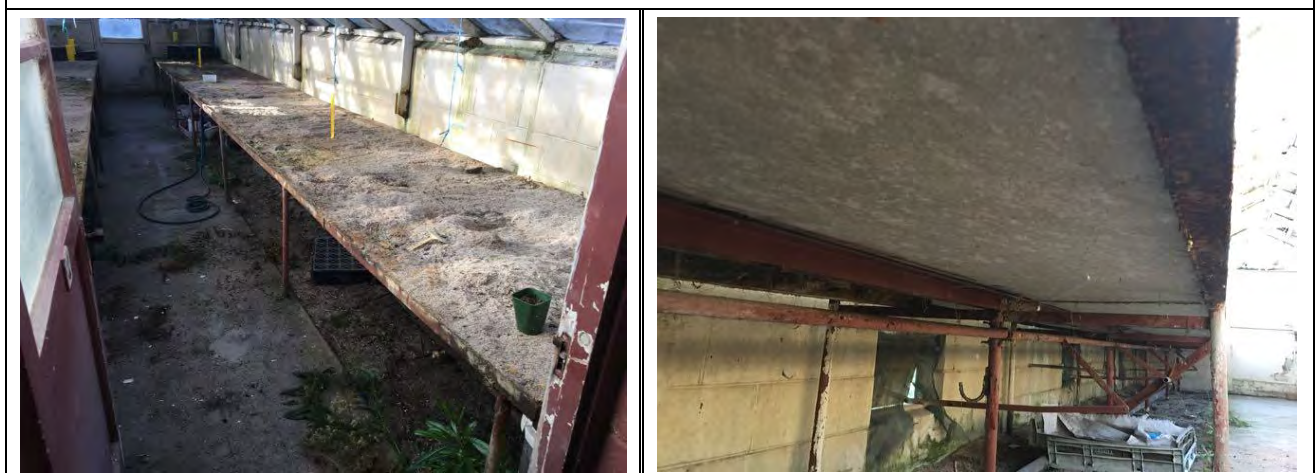
Product Type	Asbestos reinforced composites etc.	1	Condition	Low damage	1
Surface Treatment	Sealed	1	Asbestos Type	Crocidolite	3
Material Score	6		Risk	Low

RISK ASSESSMENT 12 / 24 LOW

Recommendation: Label and maintain

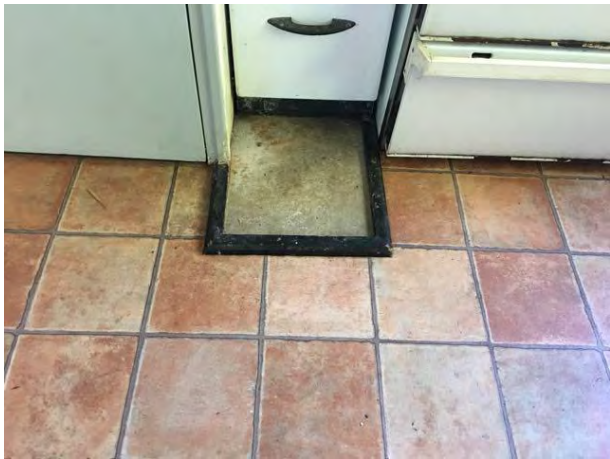
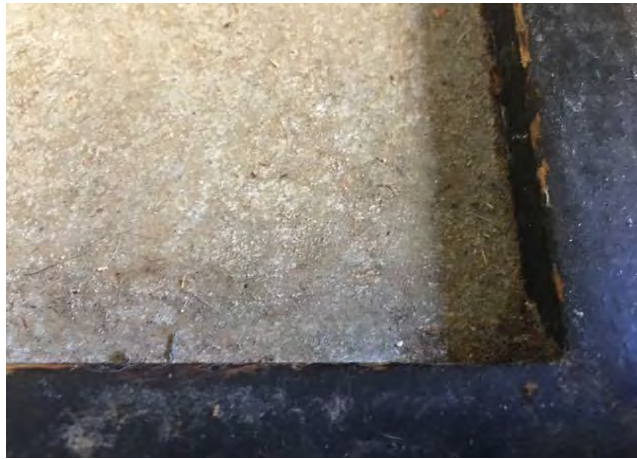
Product Type	Asbestos reinforced composites etc.	1	Condition	Low damage	1
Surface Treatment	Sealed	1	Asbestos Type	Amosite	2
Material Score	5		Risk	Low

RISK ASSESSMENT	9 / 24	LOW
------------------------	--------	------------

Recommendation:	Label and maintain
Comments:

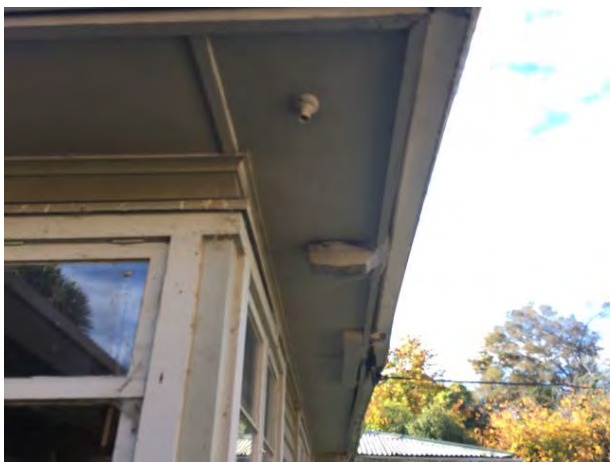
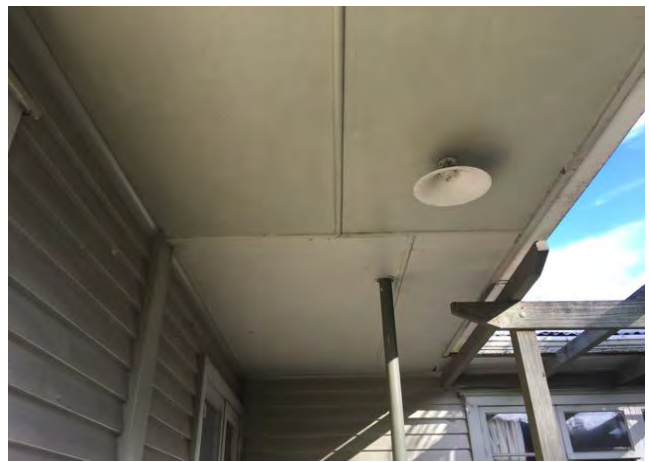
RISK ASSESSMENT
10 / 24
LOW
Recommendation: Label and maintain
