# Memo

<b>Subject:</b>	<b>Dolomite Point Walkway - Location 7: Site Observations</b>

Department of Conservation  
 Dolomite Point Walkway, Punakaiki  
 Visitor Risk Management - Geotechnical Quantitative Risk Analysis  
 Engineering Geology Site Plan

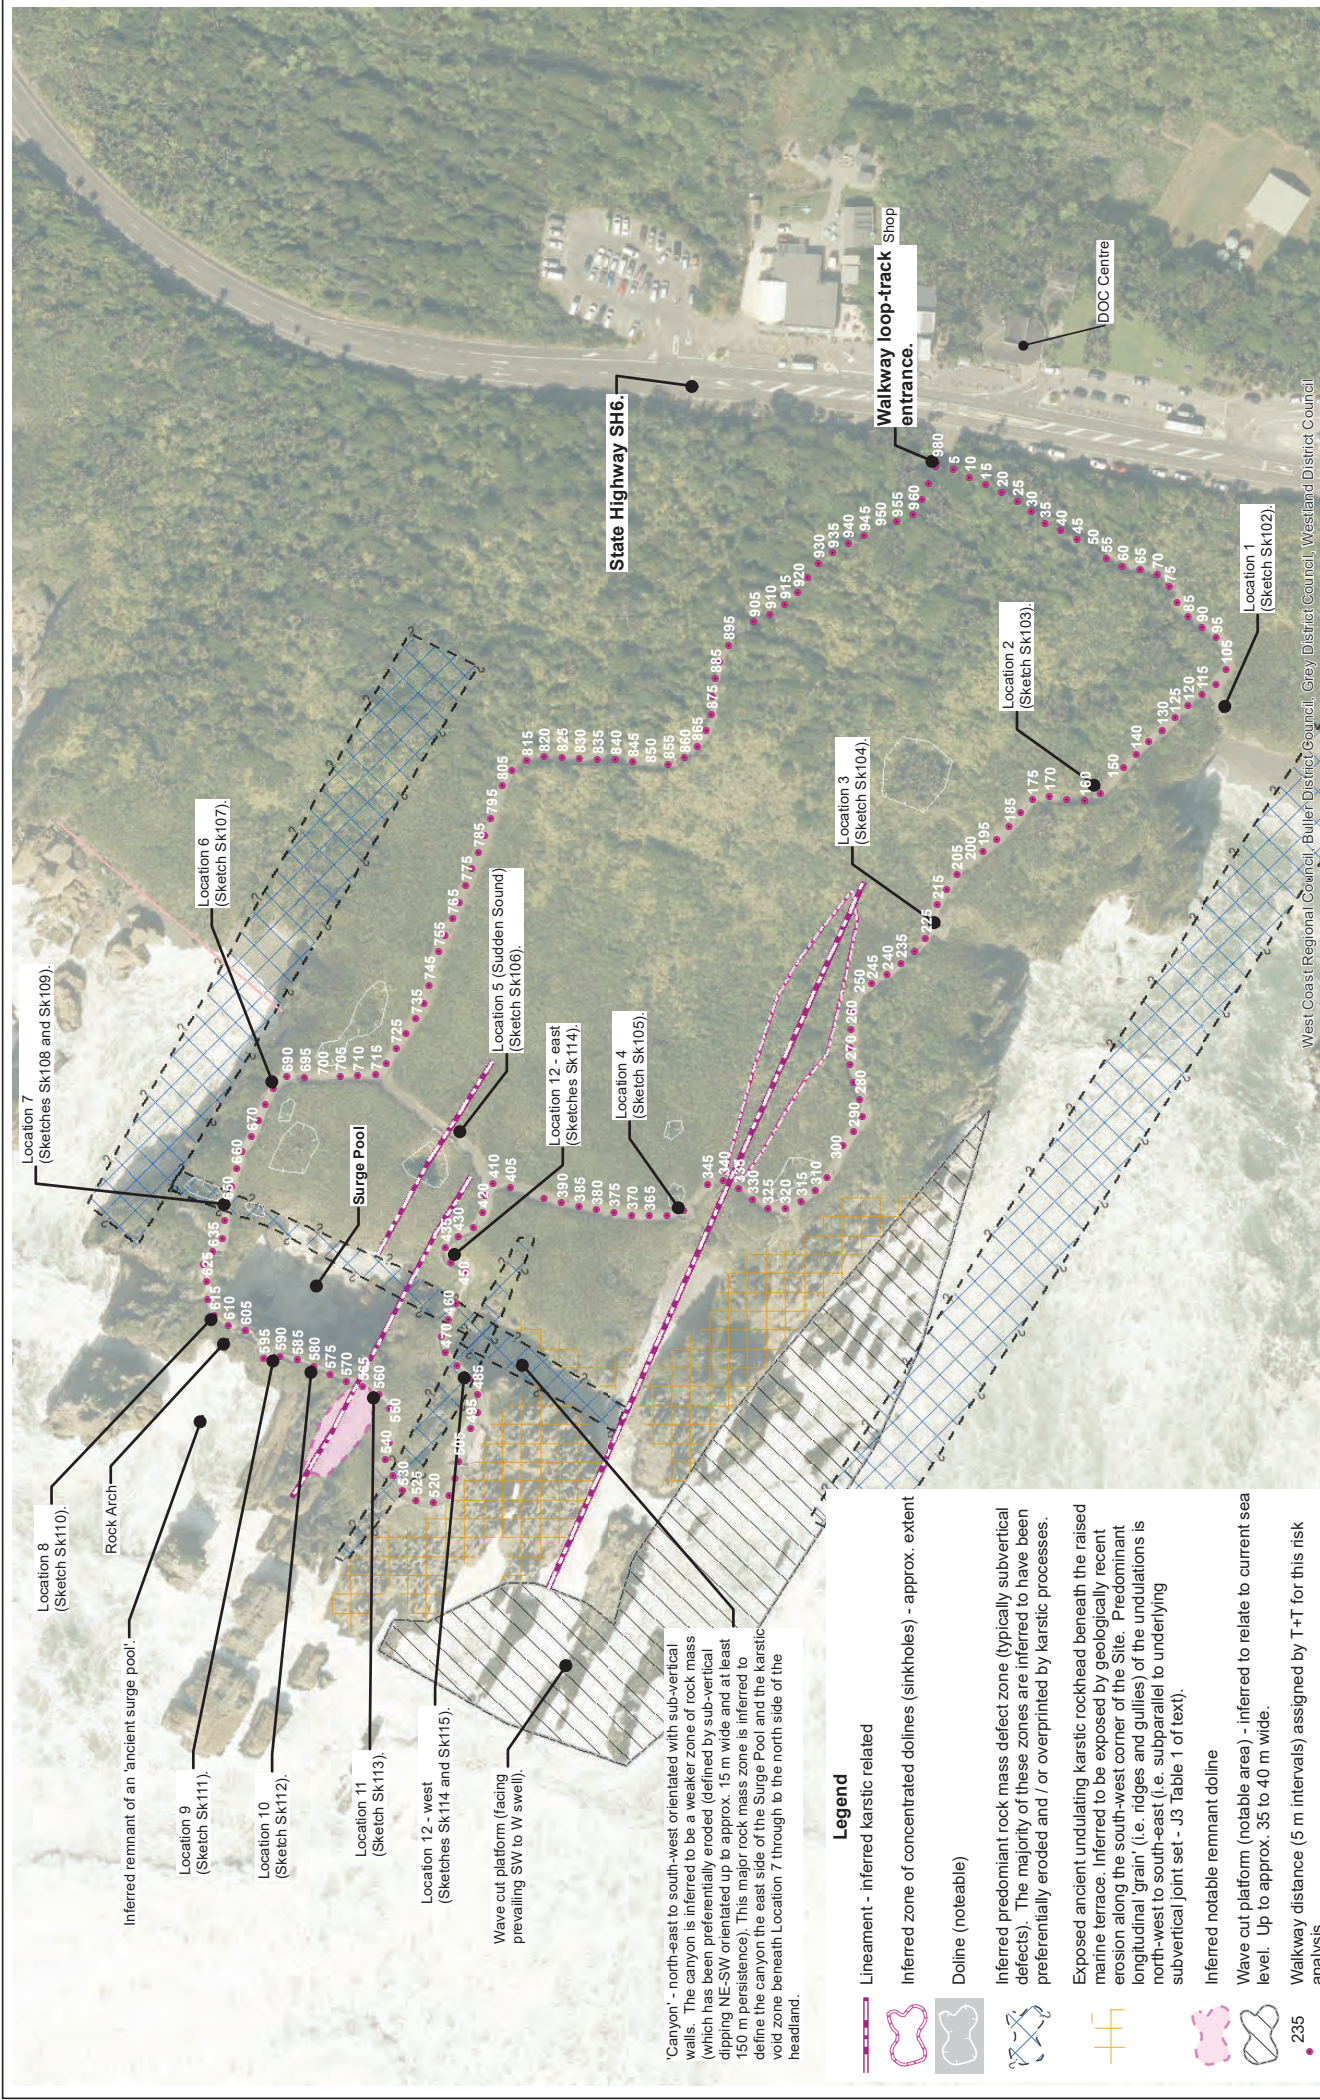
FIGURE No. Sketch - SK203

In early December, the Department of Conservation (DOC) noted slight movement of the pathway during routine monitoring along the Dolomite Point Walkway. This movement was characterised by 5 mm of extension between monitoring Pins 7C and 7D at Location 7 (shown on Attachment 1), which are positioned either side of a historical crack within the sealed pathway.

1. Location 7 is located at the north end of the Dolomite Point walkway approximately 20 m east of the Arch (shown on Attachment 1).
2. An 8 m long crack trends parallel with the pathway and is located approximately 100 – 300 mm from the edge of the pathway, which is supported by a grouted stone wall (See Photograph 1).

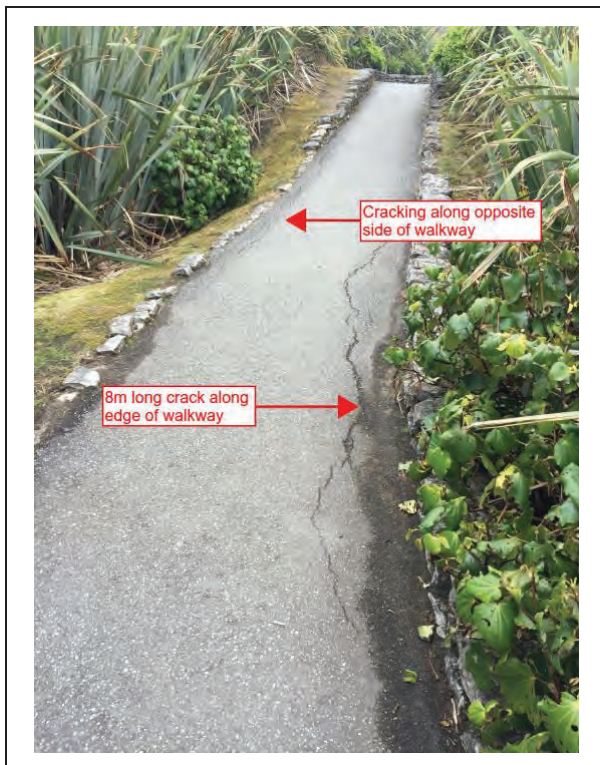
6. A lesser extent of cracking/slumping is also noted in the same location on the opposite side of the pathway (See Photograph 1).
7. An inspection was undertaken of the grouted stone wall that is located downslope of the crack (See Photograph 4). There were no indications of slumping or rotation of the wall, which would likely cause cracking of the grout and ‘popping’ of the stones after a small amount of movement. A DOC employee on site at the time of the inspection indicated that the wall may be about 20 years old and is not aware any repairs to the wall in the past.

Based on the observations described above in Section 3, it appears likely that the recent movement along the crack at Location 7 has been caused due to minor slumping of fill materials. This mechanism is unlikely to cause a sudden failure of the walkway so does not appear to present a high hazard for visitor safety.

Photograph 1: Location 7 crack location.

1. Continue daily monitoring between monitoring points 7C and 7D. A trend of movement between these pins would indicate that slumping / creep movement may be occurring and may indicate whether movement is consistent or accelerating. T+T should be alerted if further movement greater than an additional 5 mm is observed.
2. Daily visual inspection of the grouted stone wall including cracking of the grout, loosening/separation of the stones from the grout, and rotation / slumping of the wall.

- 3 Daily visual inspection of the ground, including looking for further cracking or voids. T+T should be alerted if any new cracks are observed, with particular urgency if new cracks occur in the direction across the path (i.e. perpendicular to the current cracks which run in the direction along the path).
- 4 Isolate cracked portion of the pathway from visitors using cones and plastic railing or tape (or similar). This could be revisited in a month based on the ongoing monitoring results.

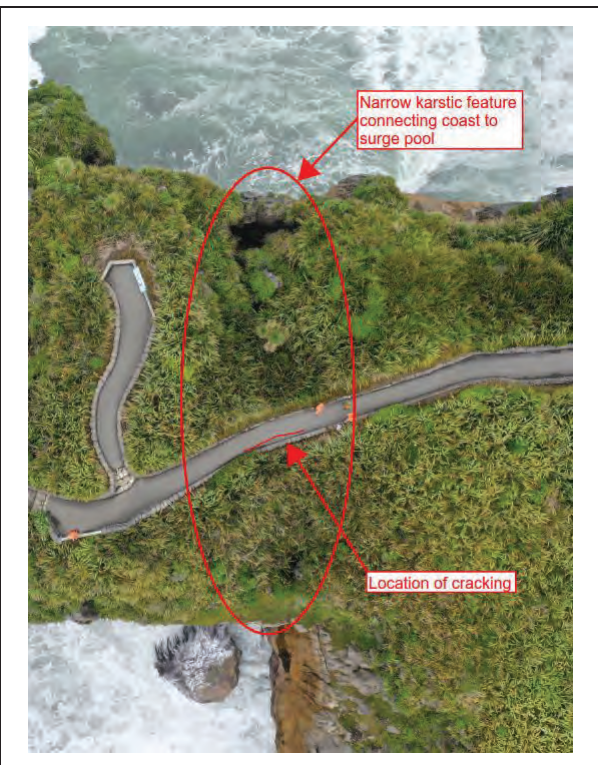
3. Monitoring points 7C and 7D are set up across the crack and have been measured daily by DOC over the previous year period.
4. The location of the cracking generally coincides with a north to south trending karstic feature, which allows water flows from the coast into the surge pool (See Photograph 2). This feature is susceptible to erosional processes and will continue to erode in the future.

Photograph 2: North to south trending karstic feature.

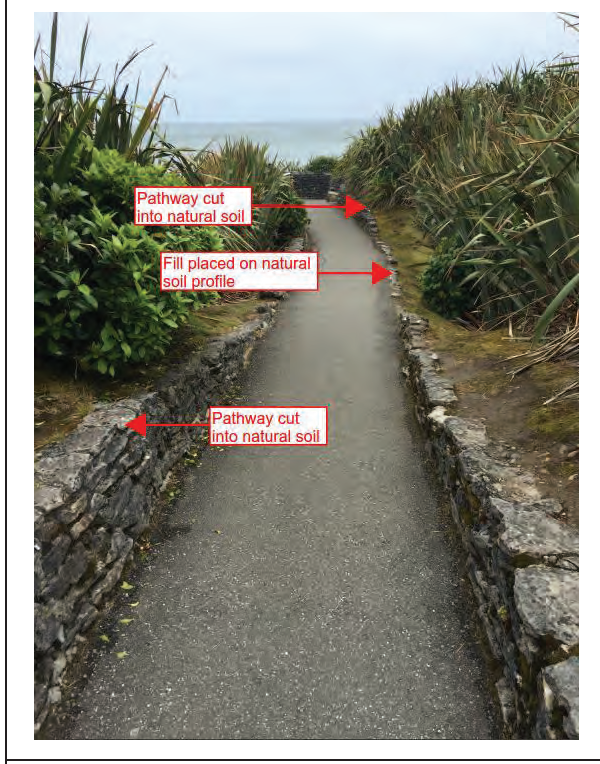
5. The pathway at the location of cracking is also located on approximately 1 m of fill and appears to be located within cut ground either side of the cracking location (See Photograph 3). This fill placement indicates a generally lower natural ground profile at the location of the karstic feature, which may be due to progressive shallow soil slumps / creep movement prior to placement of the track.

Photograph 3: Observed cut/fill locations at Location 7.

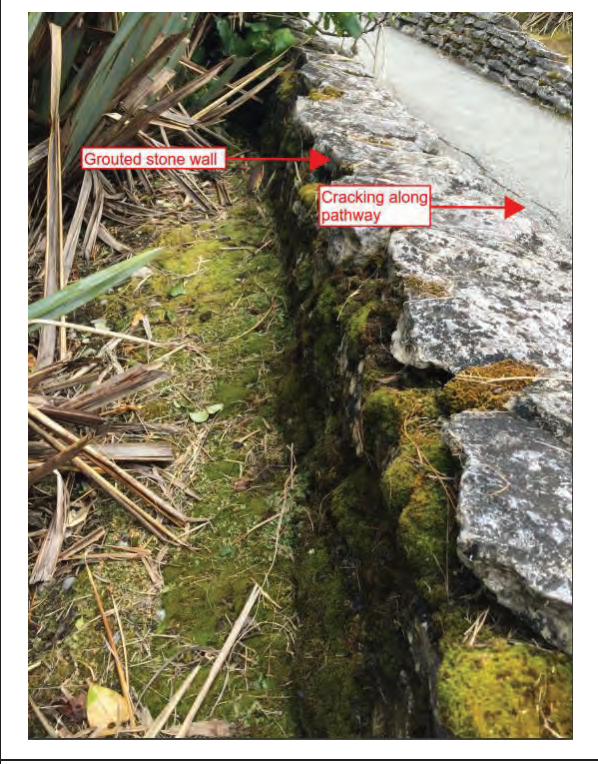
Photograph 4: Grouted stone wall downslope of crack.
