Charming Creek Walkway

Baseline Inspection Report

Jackie Breen and Amy Findlater West Coast *Tai Poutini* Conservancy

A report prepared for the Buller Kawatiri Area Office

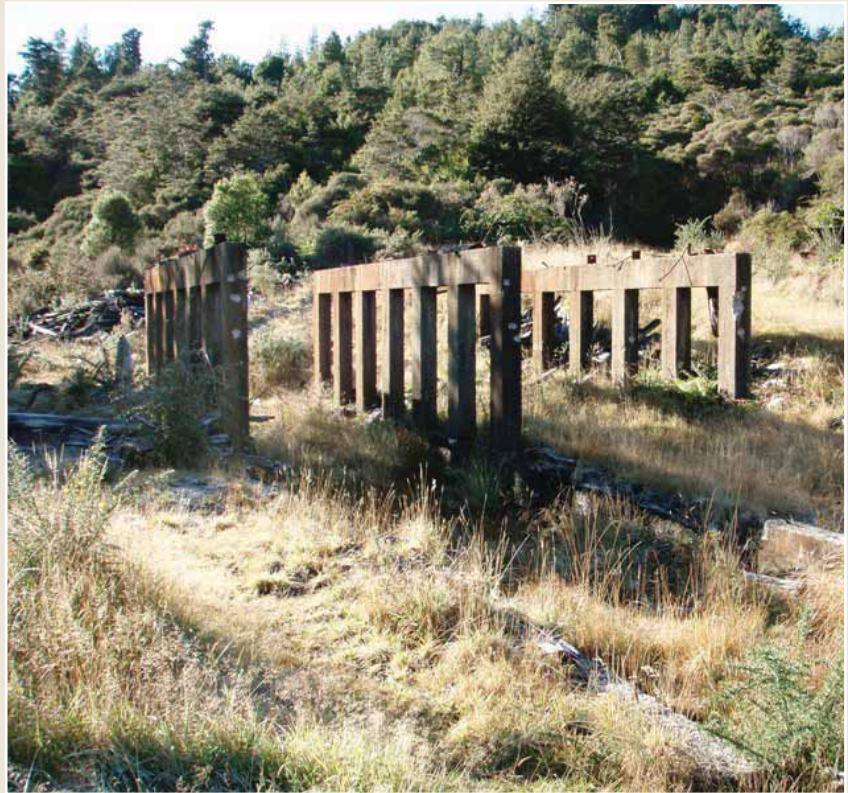
Of the bins, only the parallel concrete foundations are still present. They are a dominant feature at the site. Other remains from the bins include wooden beams, trap doors and four sliding gates (for dropping coal into trucks) now found NE of the bins. The bins were modified during their use (1956 to 1986), mainly to accommodate a transportation change from rail to road..

Photo 5 top: Remains of the bins
Photo 6: Ruston Lokey remains

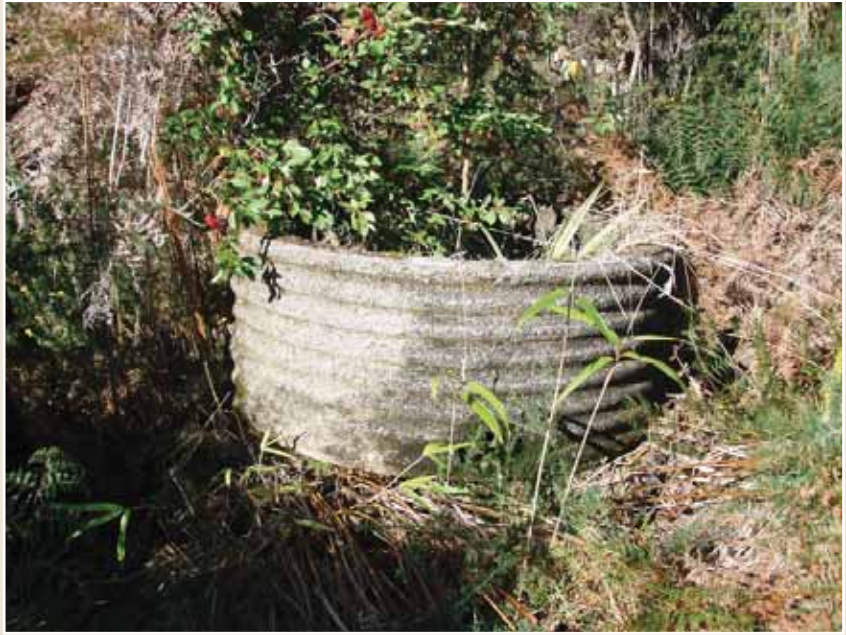
Photo 9: Water tank

A circular concrete water tank (Photo 9) is situated near these foundations. It is mounted on stone blocks and rails. The tank has been set in corrugated iron. The tram to the bins used to be between these buildings.

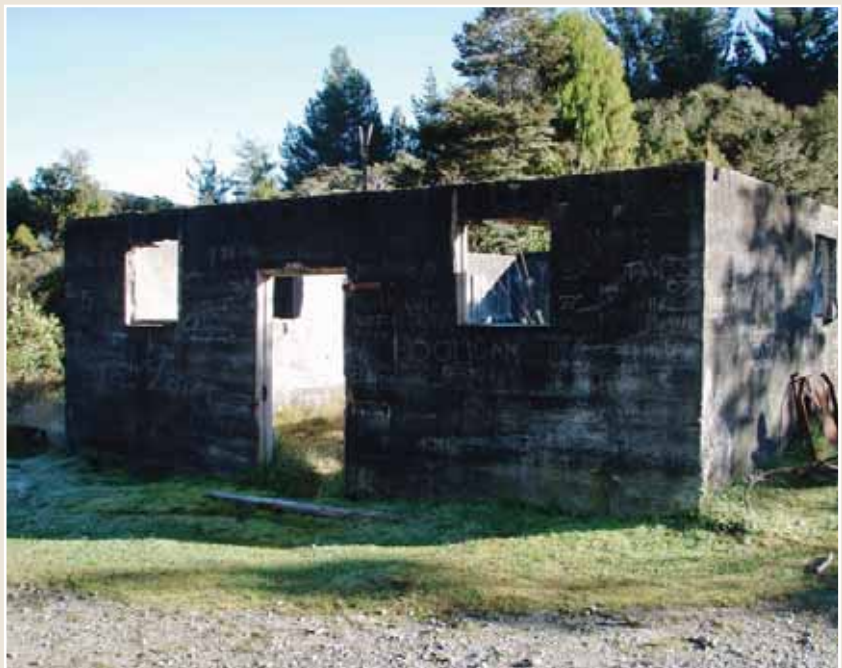
Photo 12: Close up of bathhouse

At the start of the walkway, as you come across the bridge, is the 1948 bath house.. All that remains (photo 12) is the concrete shell and some wooden framing around windows and doors. While the condition of the bathhouse remains is good, this structure has been subjected to extensive graffiti..

- 5) The condition of the historic features should be monitored. This should be a minimum of once per year.
- 6) Investigate ways to minimise vandalism to historic fabric, specifically the issue of graffiti on the bathhouse.

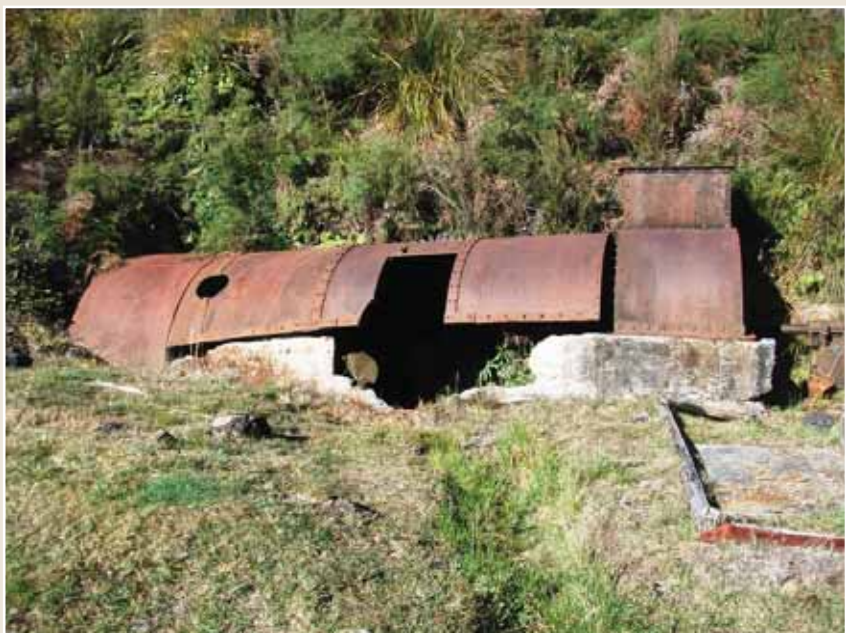
Photo 14: Fan house at the mine.

Some 15m further down the track is the fan house site. There are substantial remains here including the fan, metal fan housing, and concrete foundations for the engines that drove the fan. Air was expelled through a vent at the top of the fan house using a sirocco fan. This was originally driven by a diesel engine which was superseded by an electric motor mounted on a concrete foundation (see photo 14 and 15 for a historic view of the area).

3. Re-assess the maintenance regime being carried out on historic features such as the fan house to determine how effective they are. If required update the maintenance specifications written by J. Green in 2002. For other features not covered in these specifications, with assistance from TS, produce condition reports and maintenance specifications for the historic features in table 2 below.

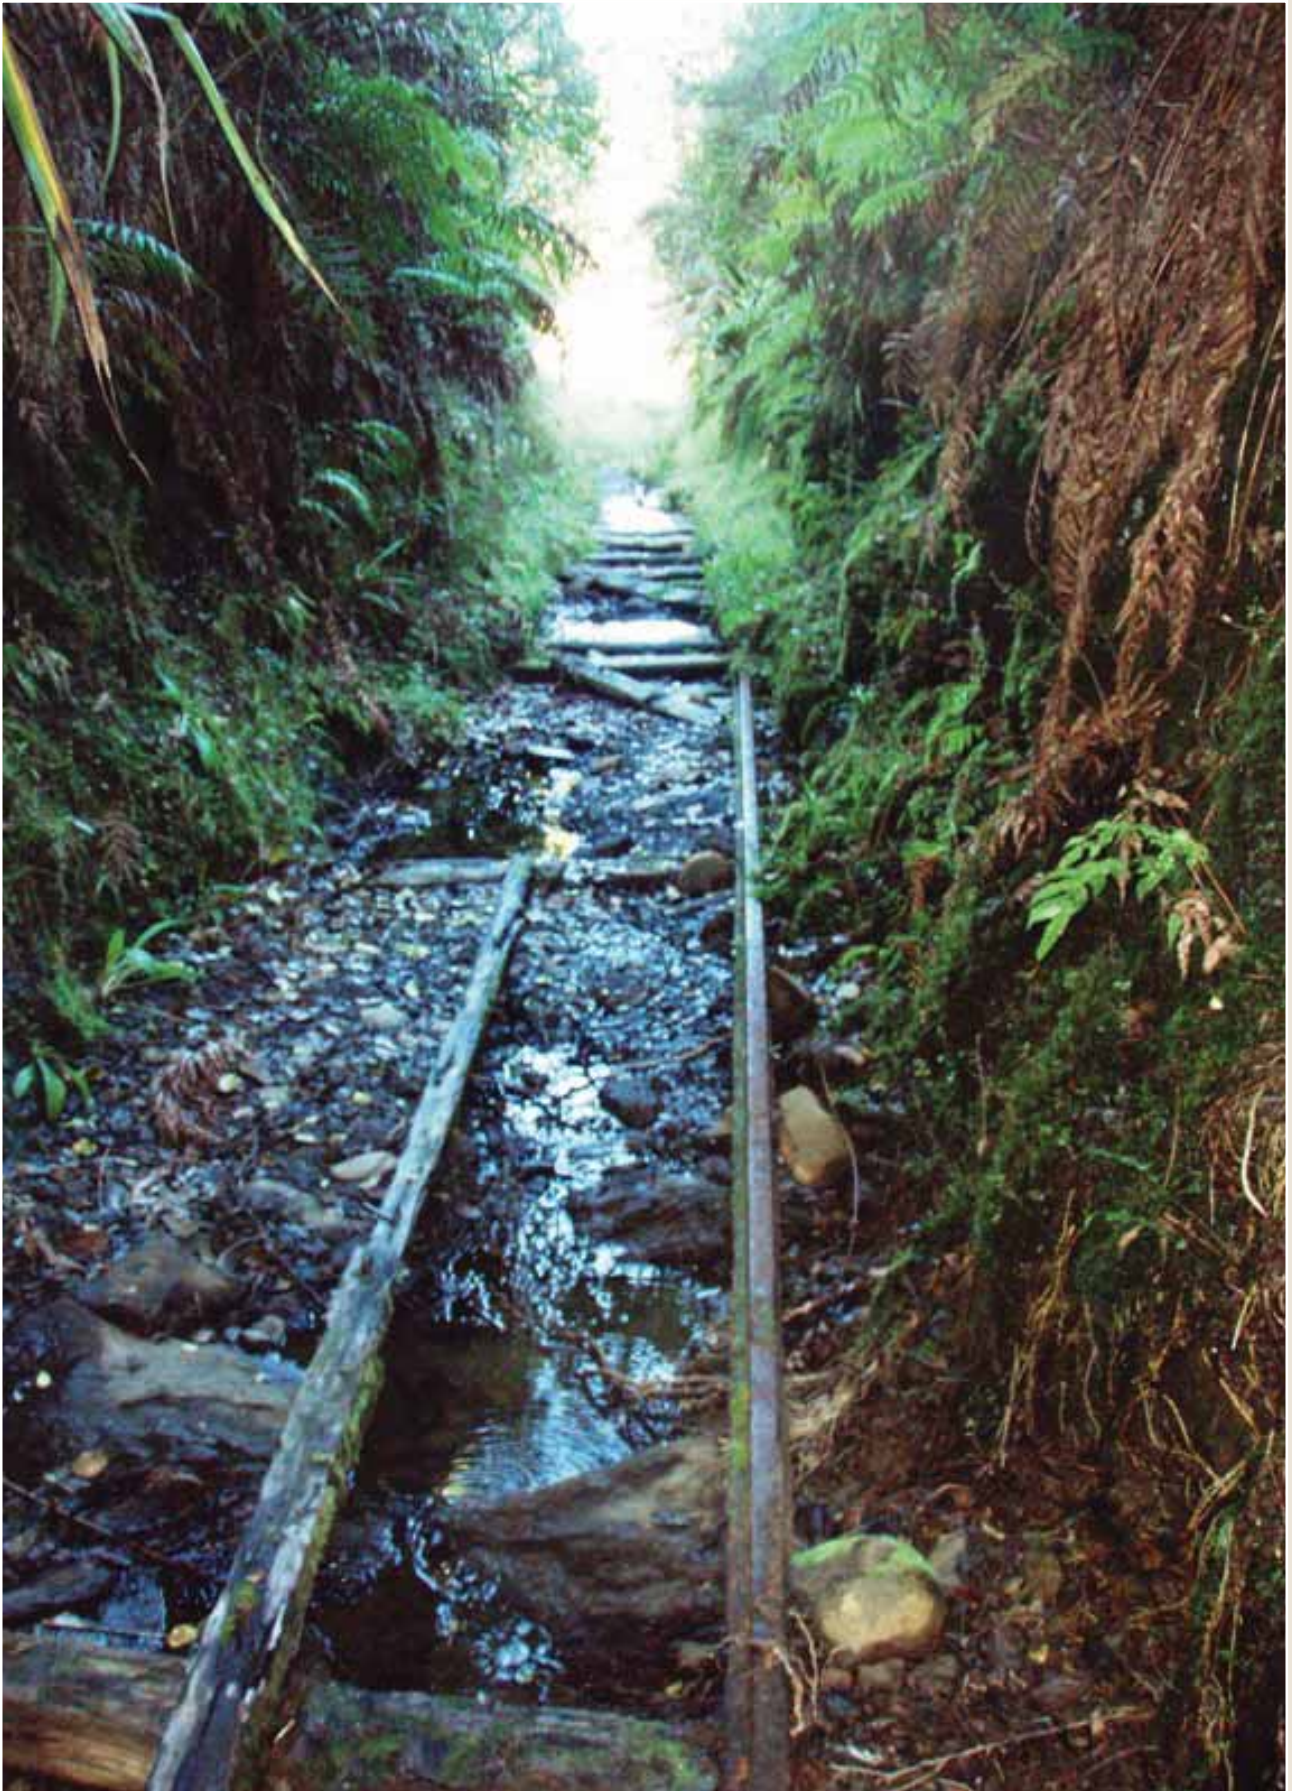
Photo 21: Looking west from Papa Tunnel entrance.

This section of tramway through Papa Tunnel is in comparably good condition with rails, sleepers and the centre rail break all visible in-situ in places. When the tunnel was part of the walkway, gravel had been placed over some of the remnant sleepers and rail to create an even walking surface. Displacement of some of the rails in the tunnel is also evident (photo 22). Because this section of tramway is currently not used as a walkway as a result there is vegetation re-growth encroaching upon the tram alignment (photos 21 and 23).

- 1) The drain at the western end should be cleaned in order to minimise any further damage to the tram formation from water. Care should be taken around the centre rail brake, sleepers and rails.
- 2) A routine monitoring programme to assess any changes in condition over time should be established.
- 3) Vegetation encroachment should be monitored. While it is not recommended that large scale vegetation clearance should occur at this stage, a vegetation management specification should be written. This should mediate between ongoing maintenance of historic values around the tunnel and on the tram formation to the west of the tunnel, and the need manage visitors appropriately and discourage them from venturing into the tunnel.

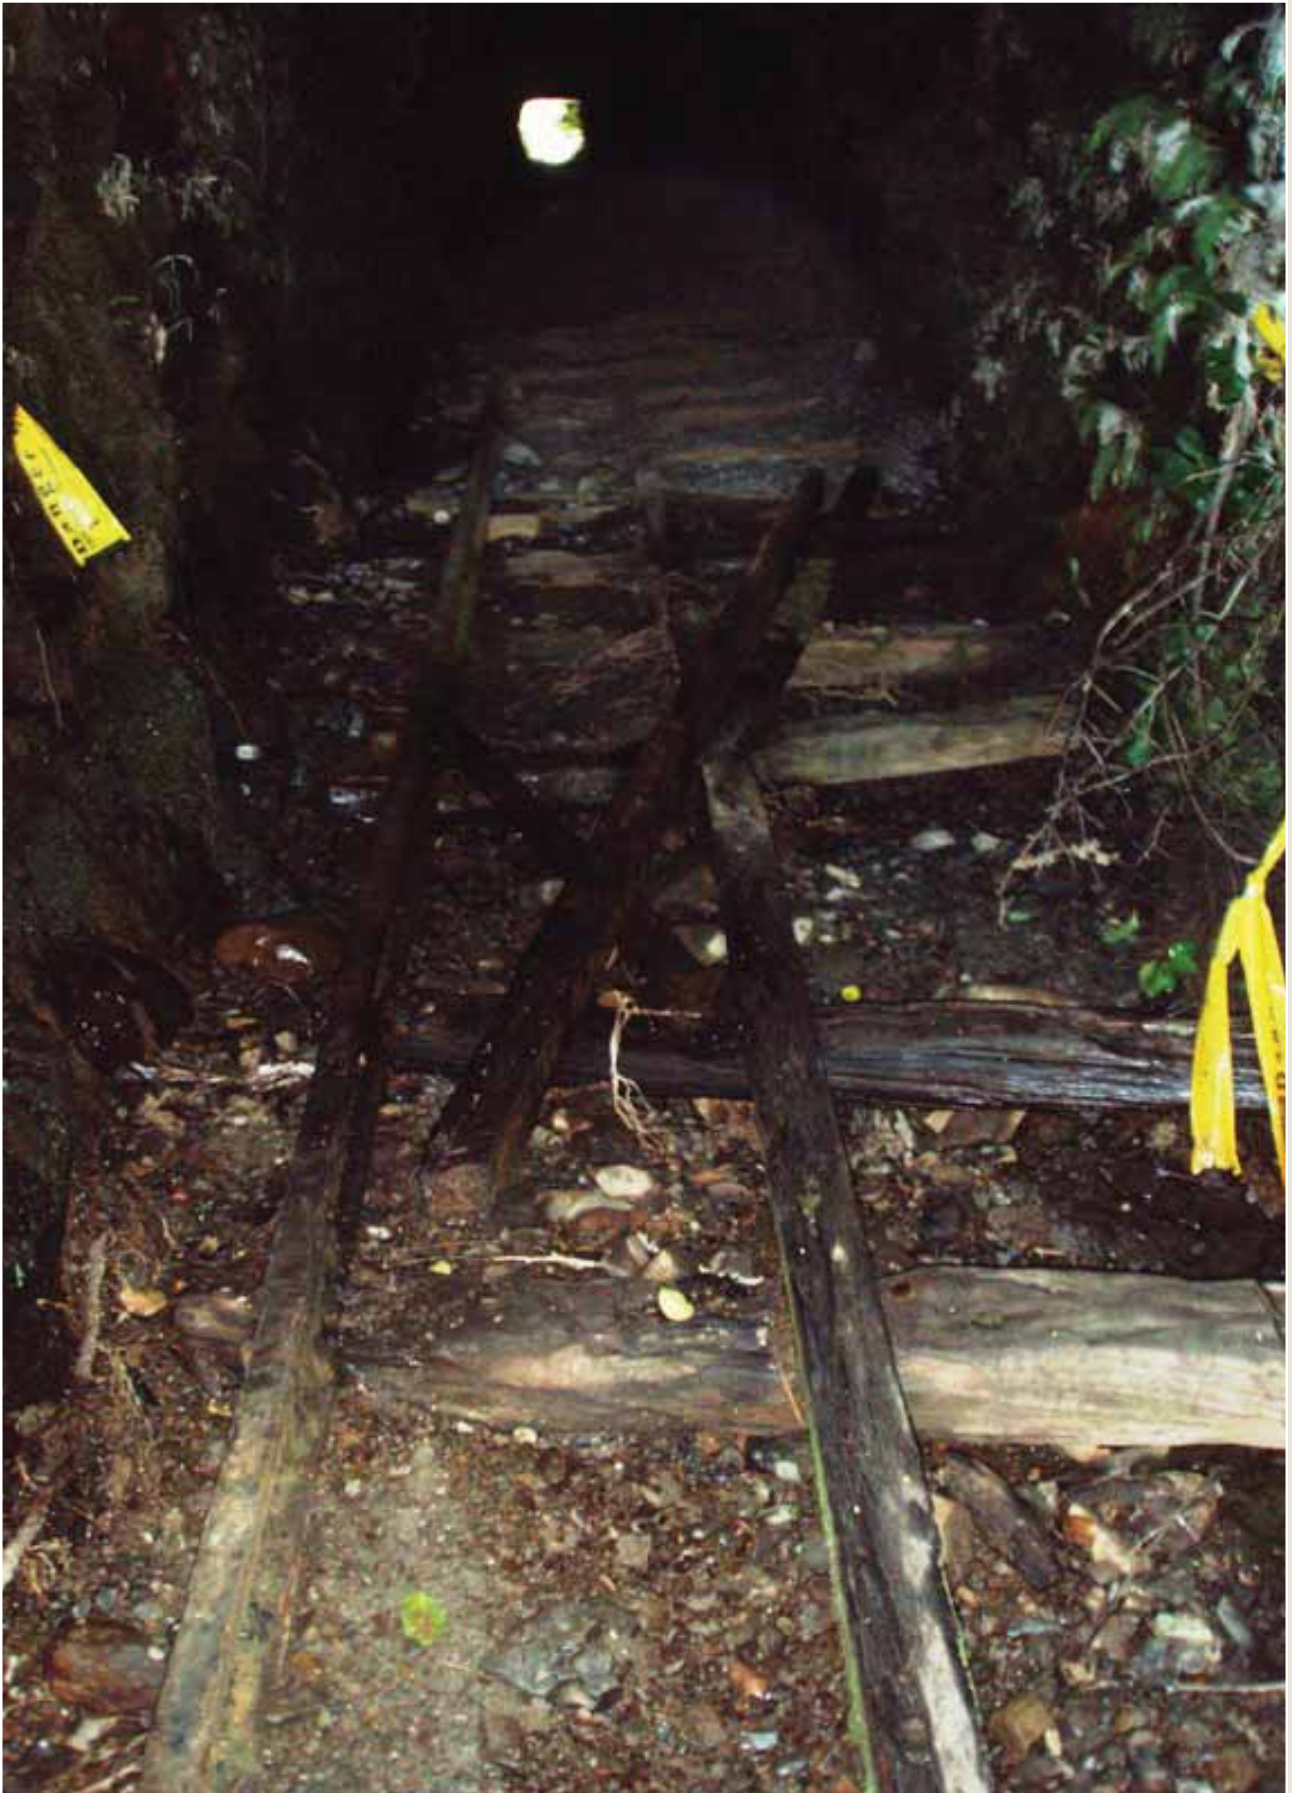
Photo 22: Centre brake rail, sleepers and rail, looking into Papa Tunnel from its west entrance. The eastern entrance can be seen in the distance.

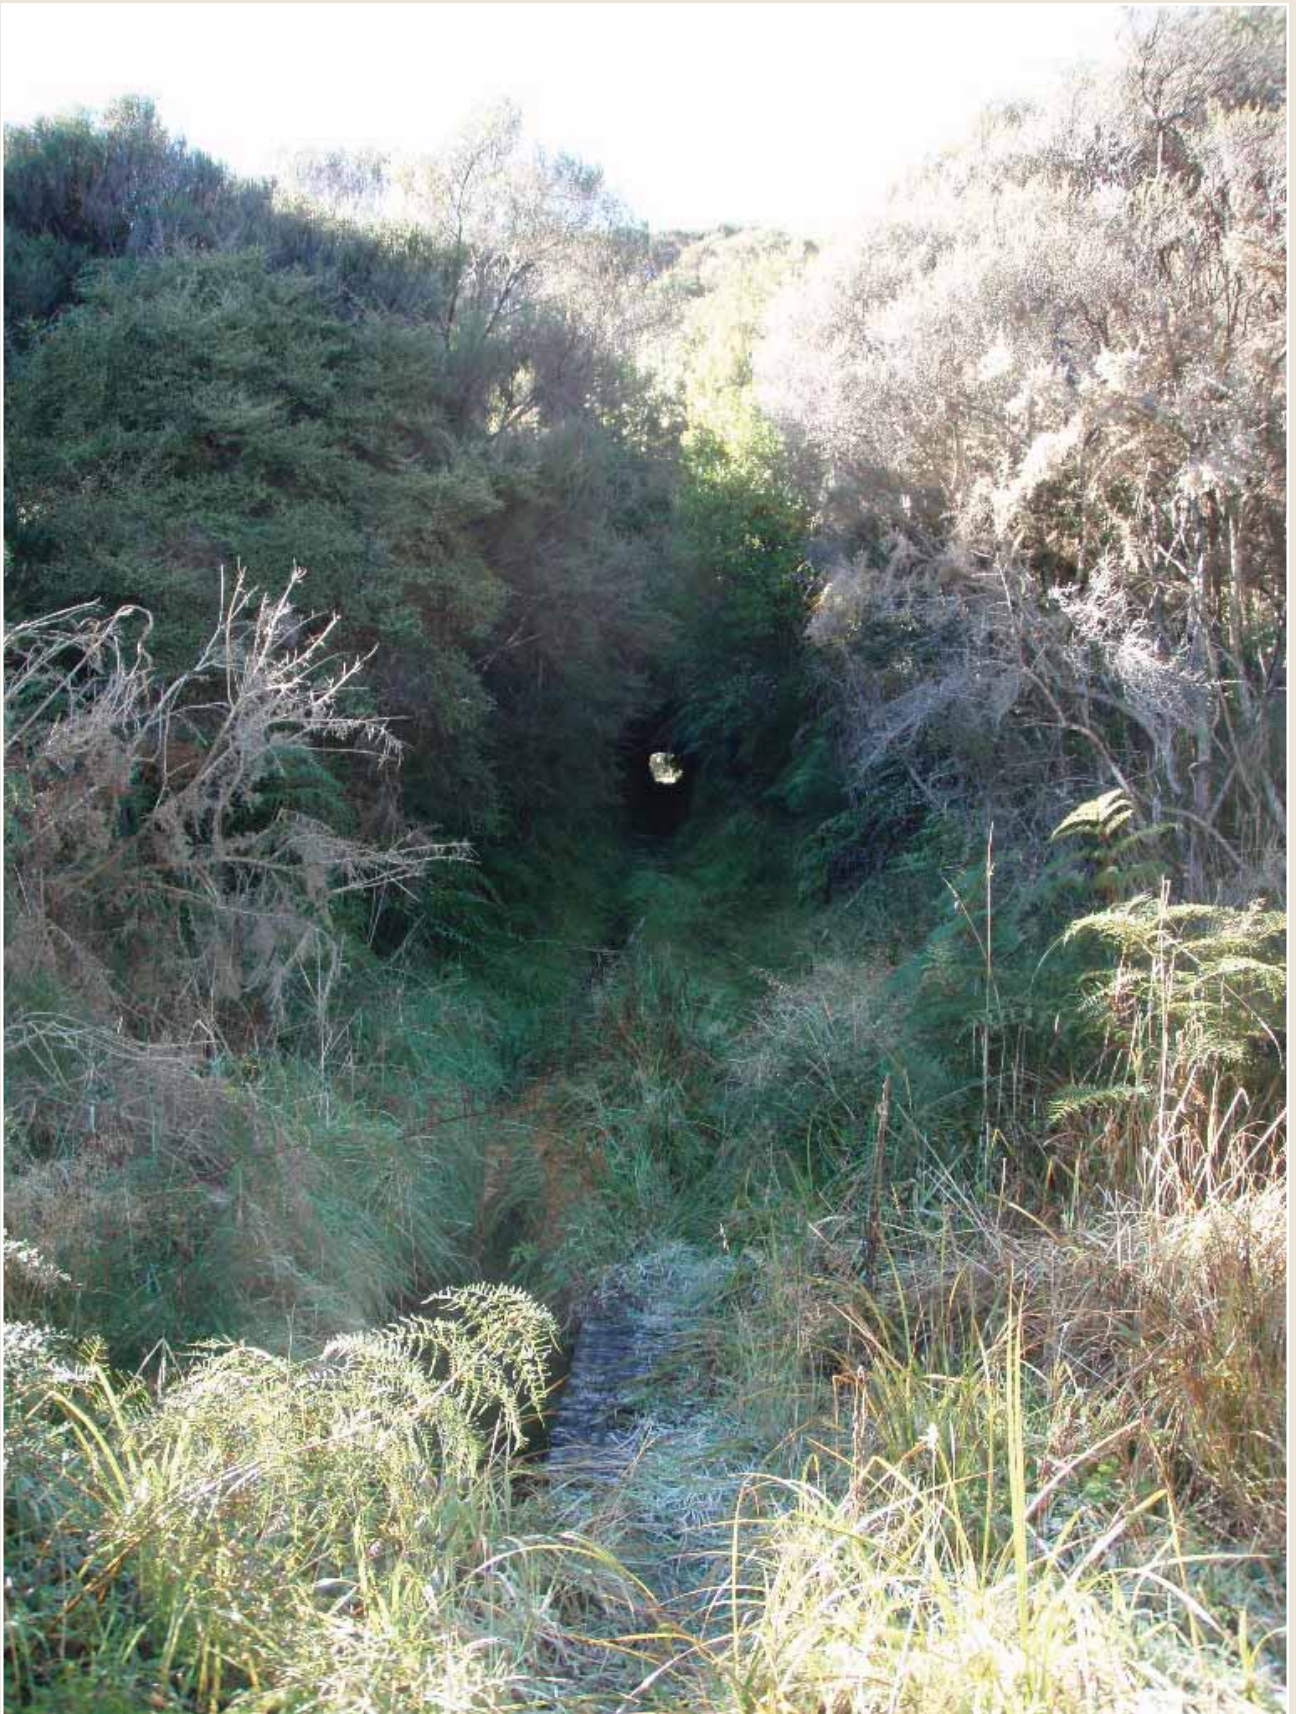
Photo 23: Looking east towards Papa Tunnel. Note the encroaching vegetation.

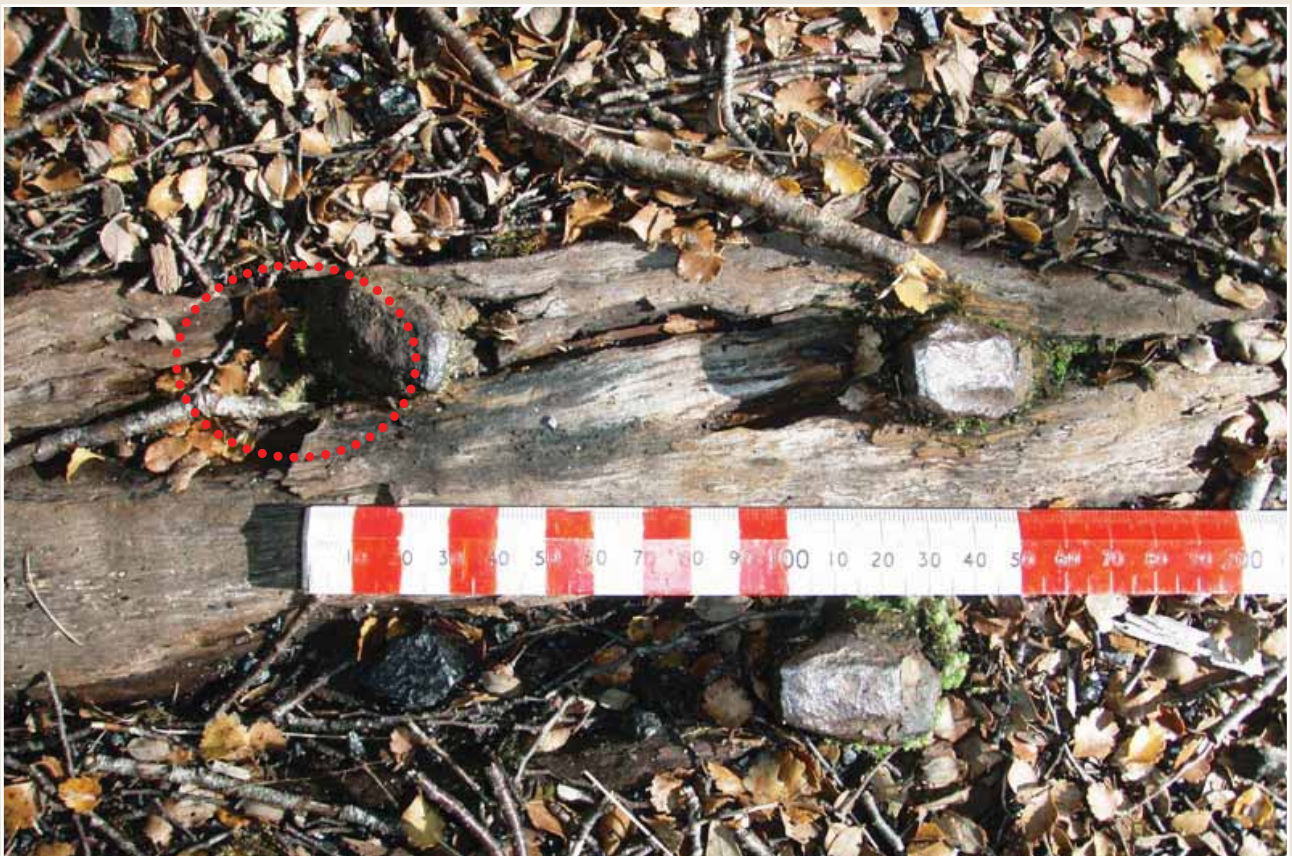
Photo 41: A set of 4 dog spikes still in the sleeper (one spike is circled).

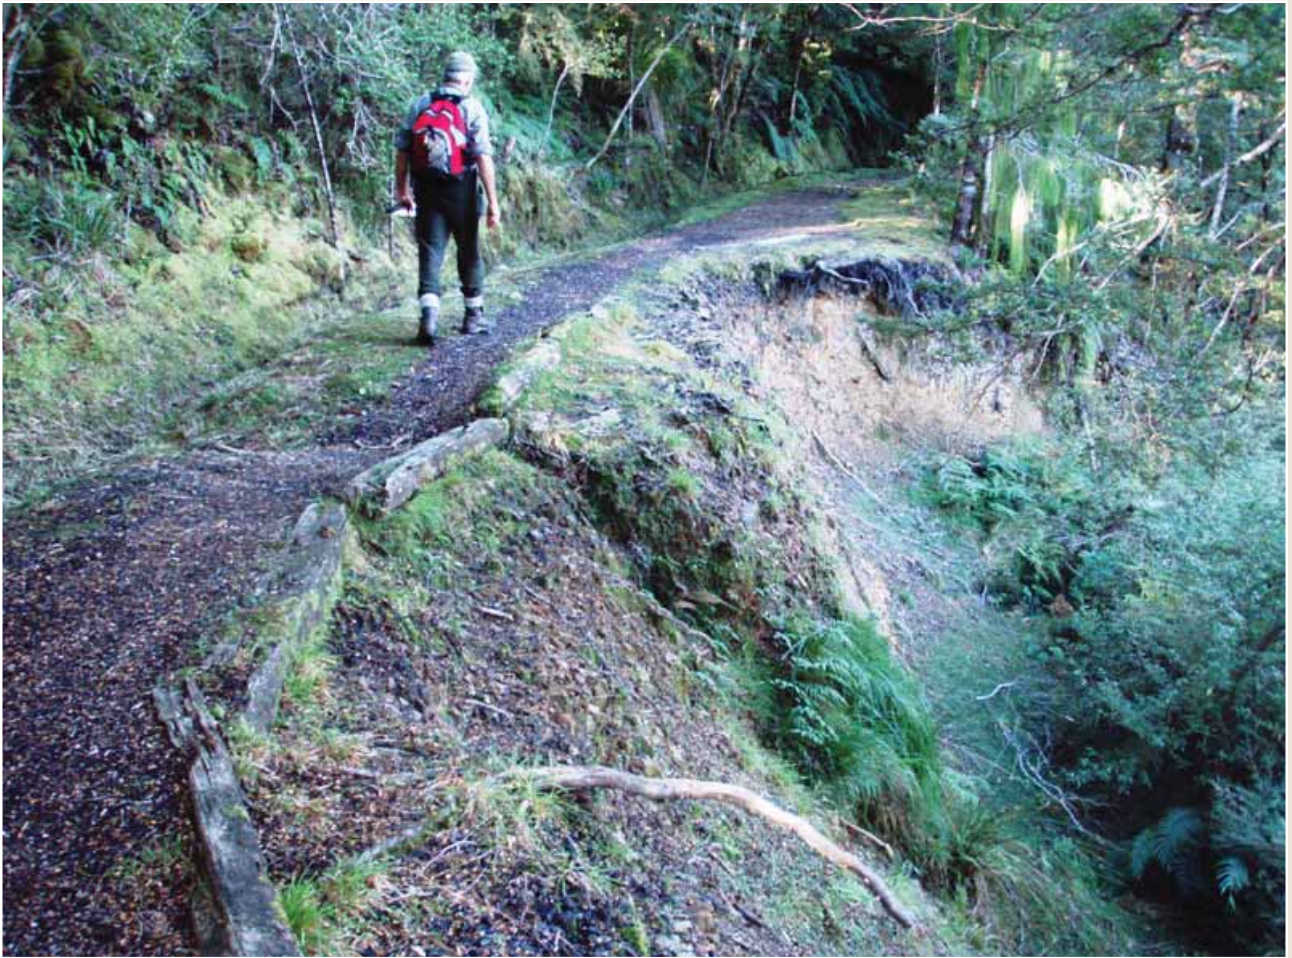
Photo 42: Edge of tramway showing a large area slumped away.

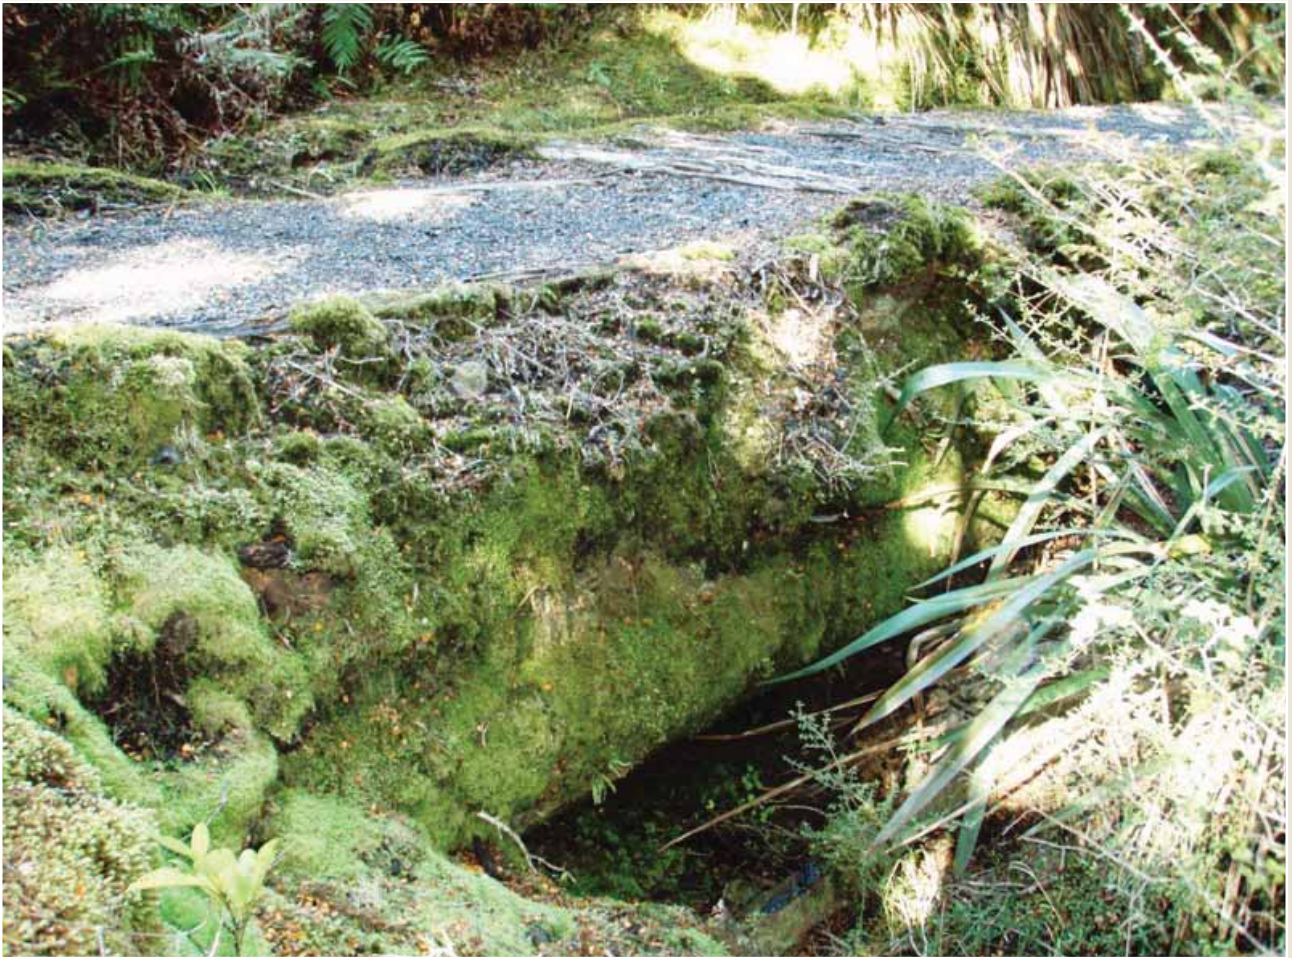
Photo 45: Original bridge. The bearer is marked with a dashed line. Tram surface with sleepers can be seen on top.

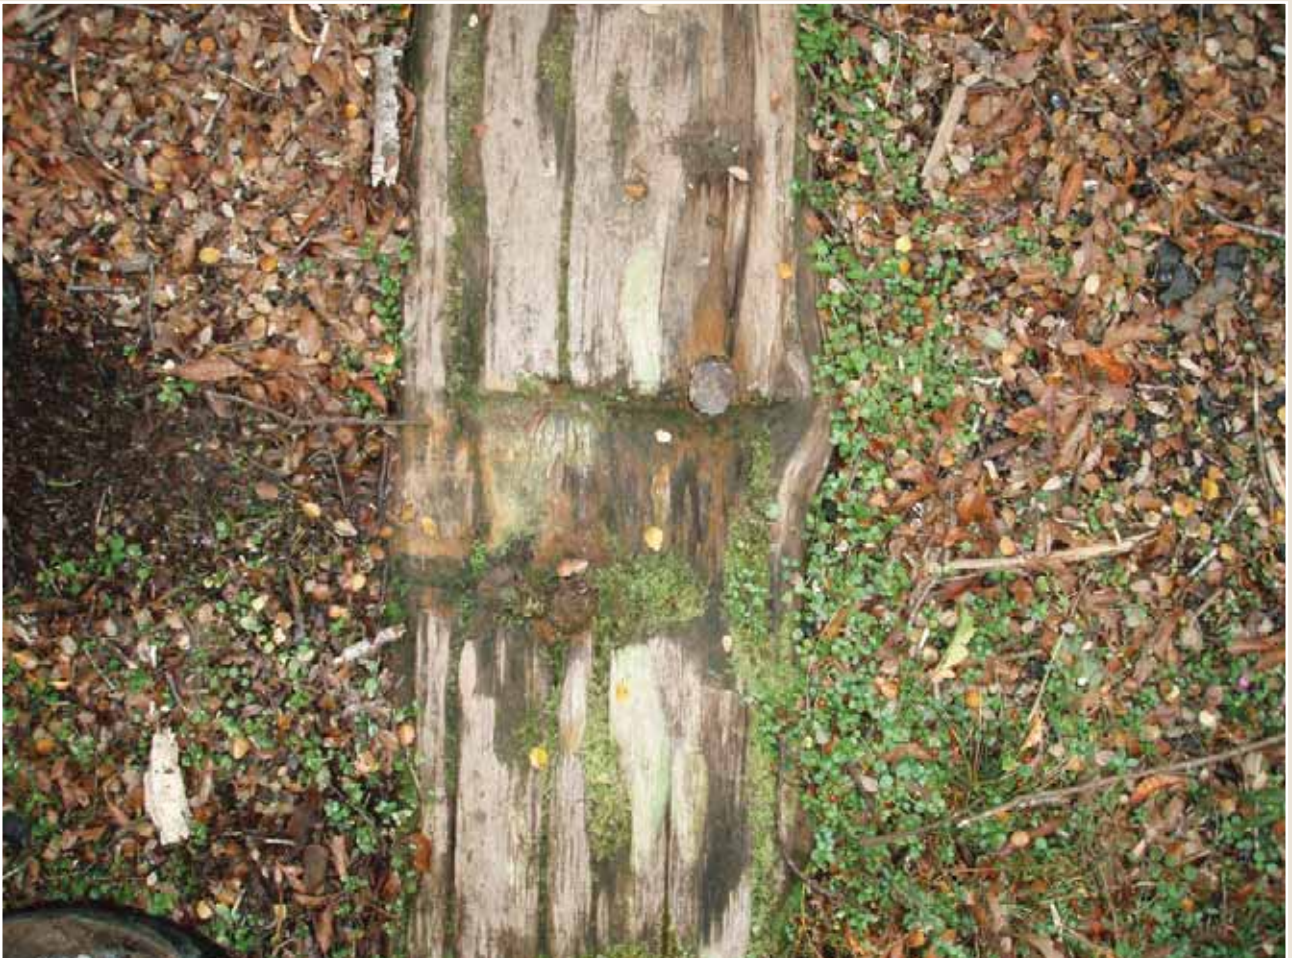
There are many examples of extant tram sleepers present in the walkway surface. Some, such as that photo 55, have notches cut out them. This notch was checked into the sleeper in order to ensure the rail was fixed at the proper level.

Photo 55: Sleeper with a rail notch adzed into it.

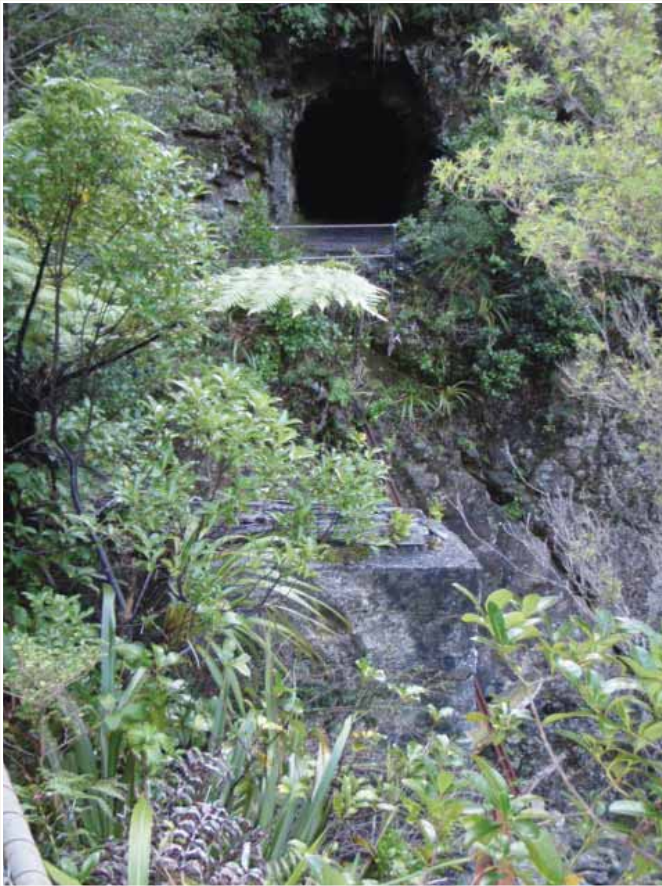
Photo 73: Irishman's Tunnel, showing that the bridge leading up to the tunnel has now all but gone. Note the concrete pier bottom centre. N. COOKE 2008

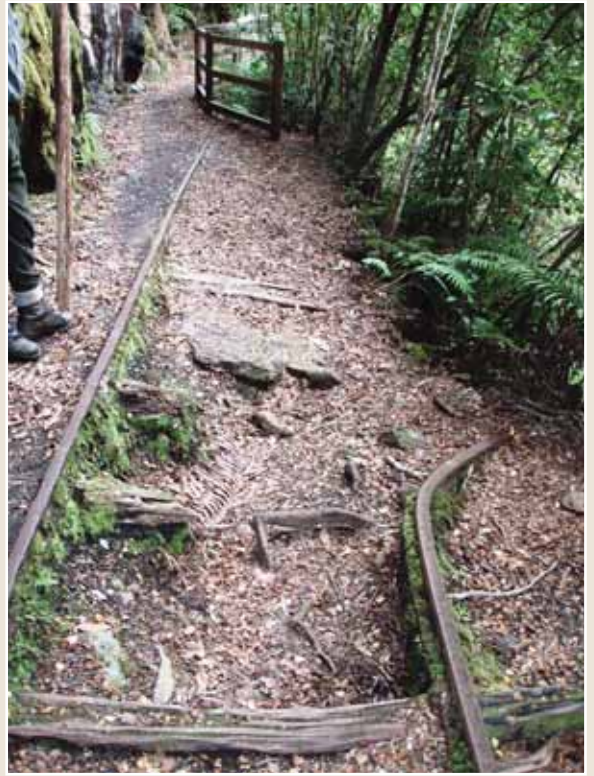
Photos 78 and 79: Two sections of damaged tramway caused by rock falls.

- 4) If the clearance of slips or rock falls is to be considered, consideration of underlying historic features is necessary. Sections where the walkway diverges around slips or the tramway has been completely destroyed do not require to be maintained to the historic profile. Slips and washouts are part of the history of this section of track, and the best route over and around such intrusions, constructed to the desired visitor standard, is appropriate.

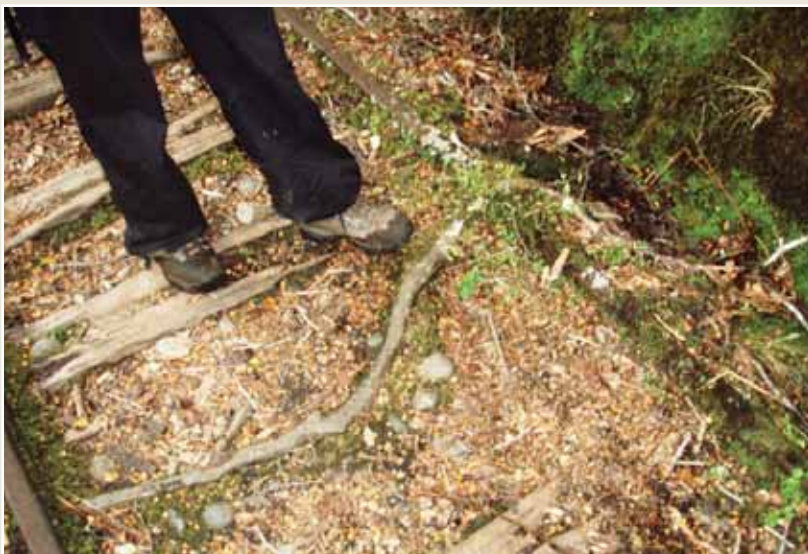
Photo 80: left: Roots growing over tramway formation.

but is really just a large modified leaning rock. At GPS ID 257 the walkway diverges from the tramway alignment for about 5m over a slipped section. There are also numerous parts of the tram where roots from the regenerating native vegetation are intruding onto the tram (see photo 80).

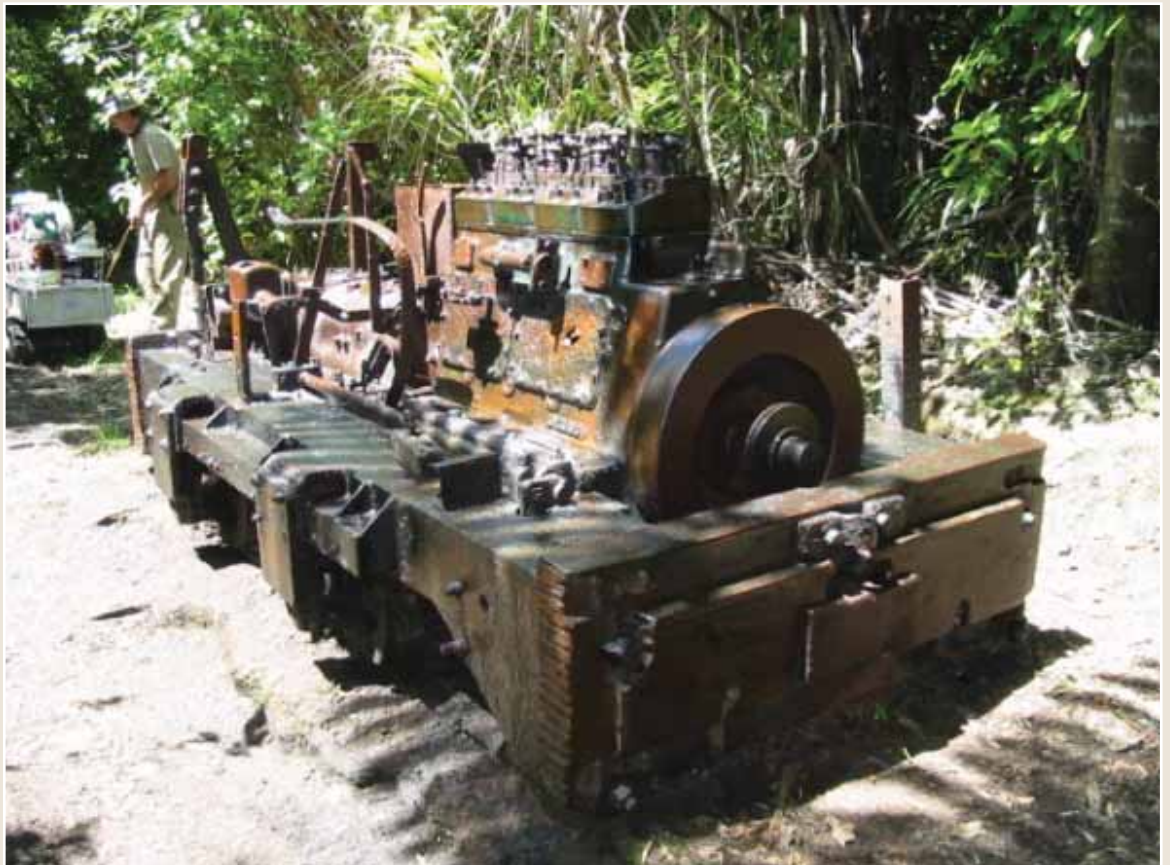
Photo 85: The remains of the Ruston and Hornsby Lokey after an application of protective oil. This lokey originally worked at the mine end of the tram.
