## Fish Passage Restoration in Tasman

Trevor James, 27 November 2013

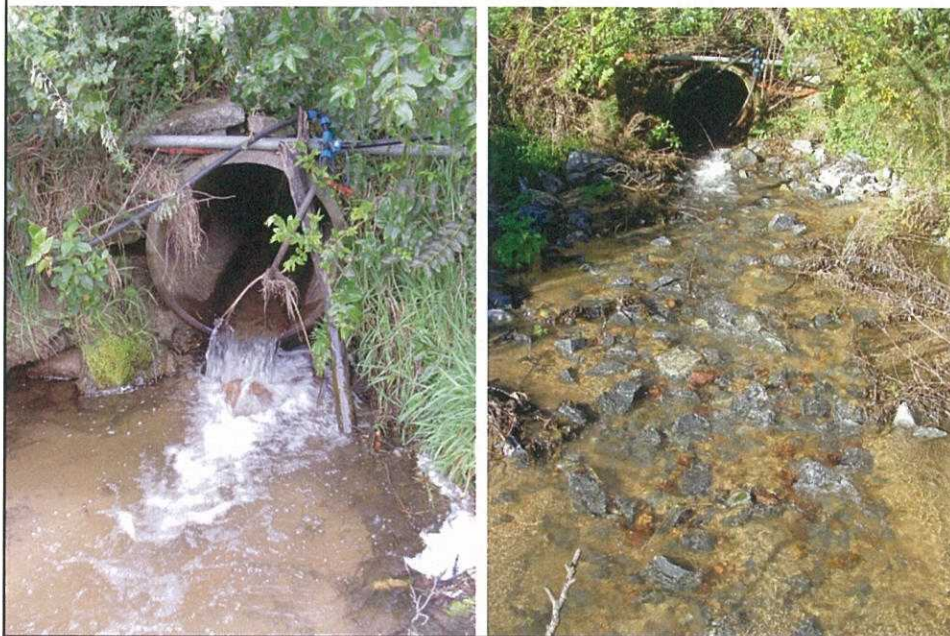
*Aprons in highly erodible ground 2*

Now our most common fix for small drops.

Large schools of inanga upstream

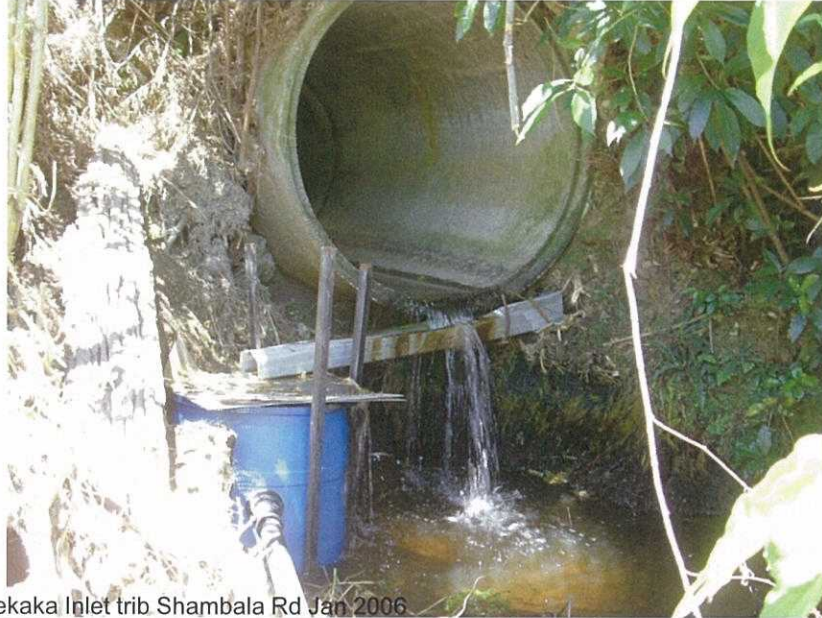
Onekaka Inlet trib Shambala Rd Jan 2006

*More squabbles 'Down the road'*

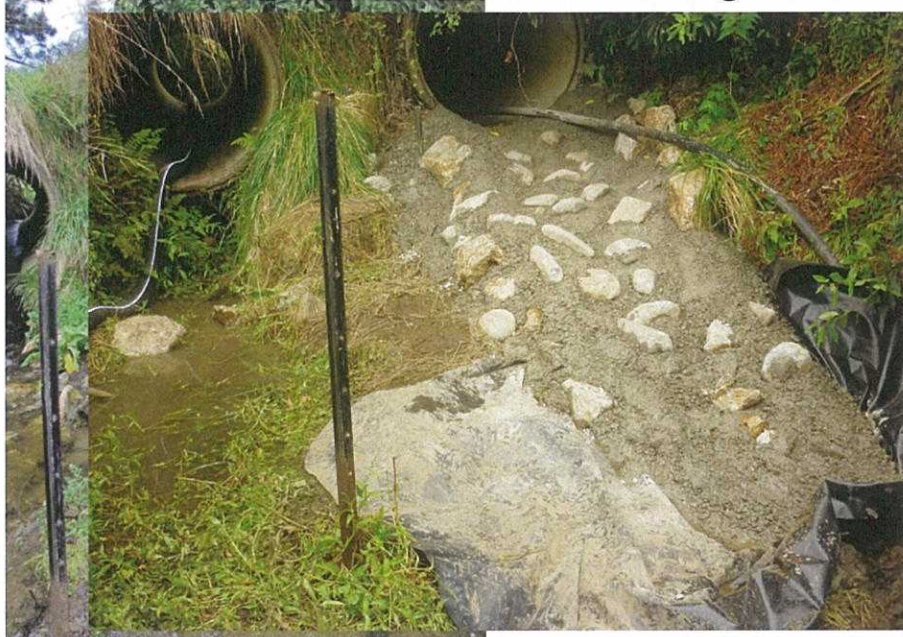
Finally a landowner did something ...but!!

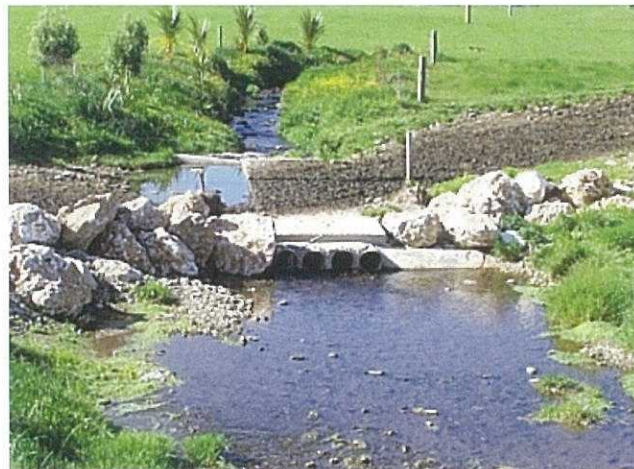
## Stock crossings - 200mm plastic multi-barrel

...but many are FPB's

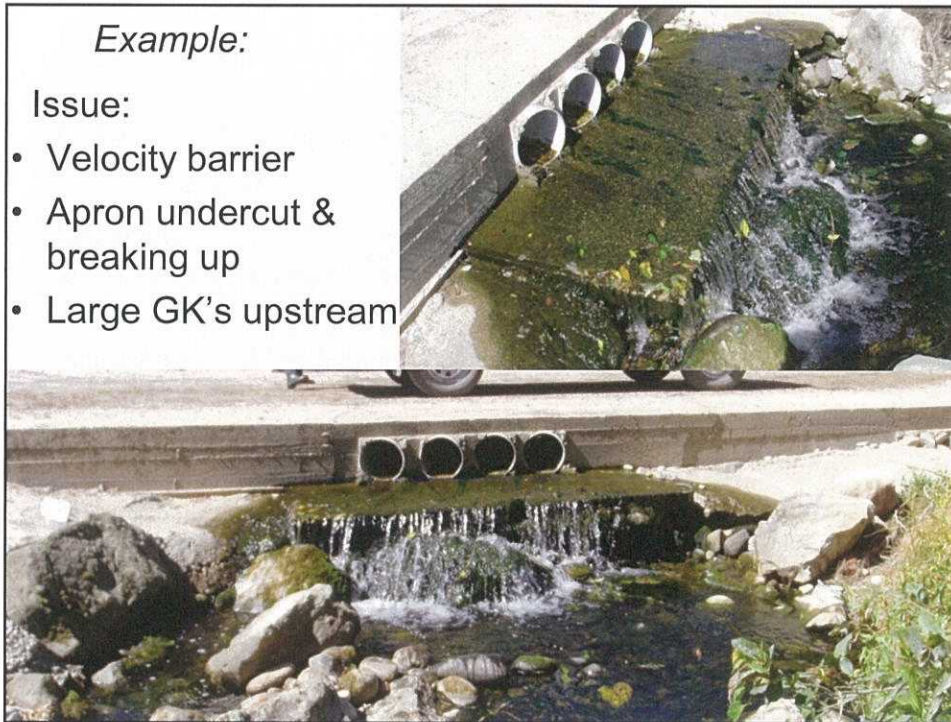
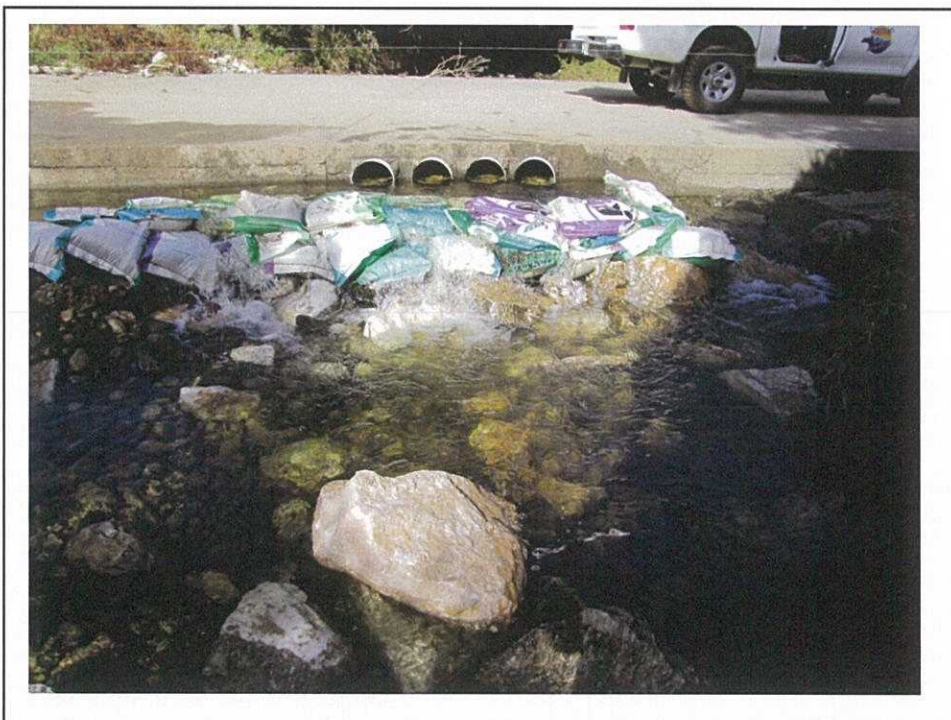
*Example:*

- Velocity barrier
- Apron undercut & breaking up
- Large GK's upstream

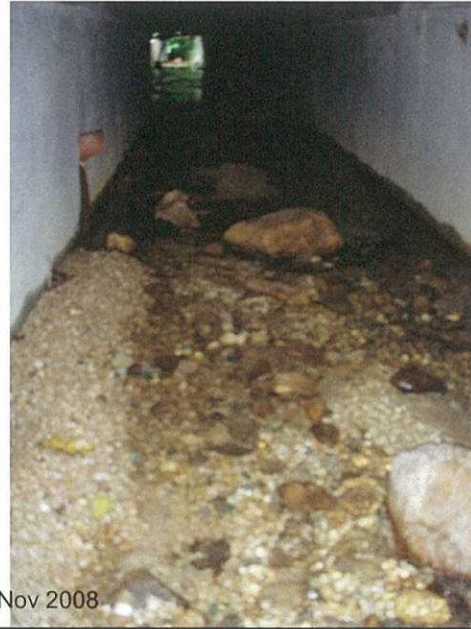
Kaiteriteri Stream Trib at Bethany Park Nov 2008

Short culverts (~50m) can be productive habitats if they are wide enough and contain good substrate
