August 2019

**Inanga spawning investigations in the
lower Whanganui River catchment
Autumn 2019**

By
Martin Rutledge

Prepared for
Department of Conservation

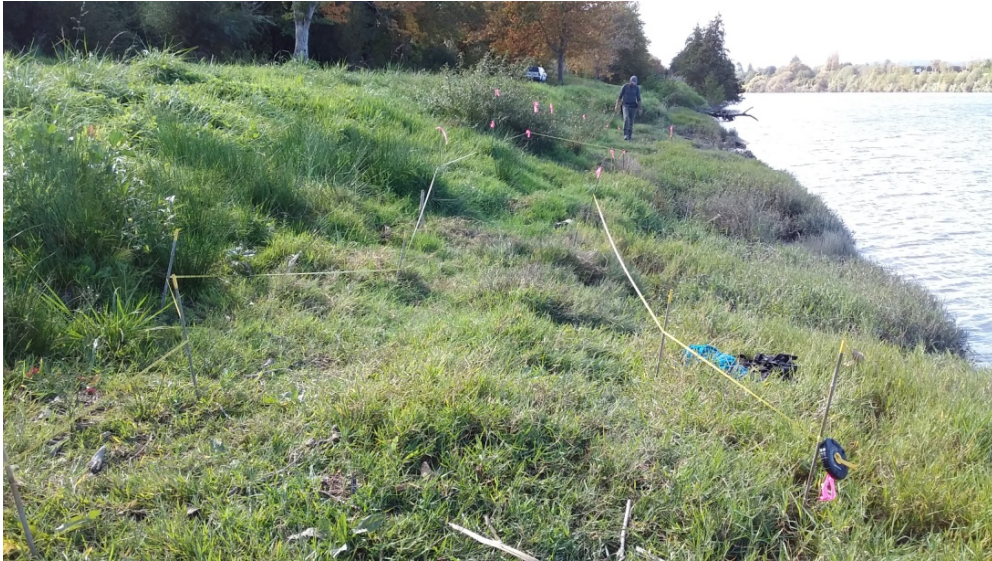
Figure 2: Measuring tape and stakes marking the shape of the extensive egg patch along the gently sloping margin at the Aramoho rowing buildings reach.

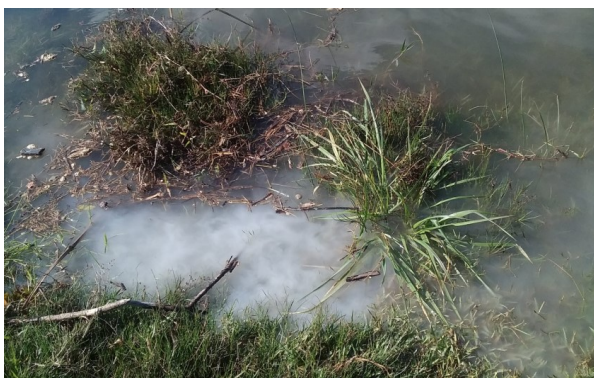
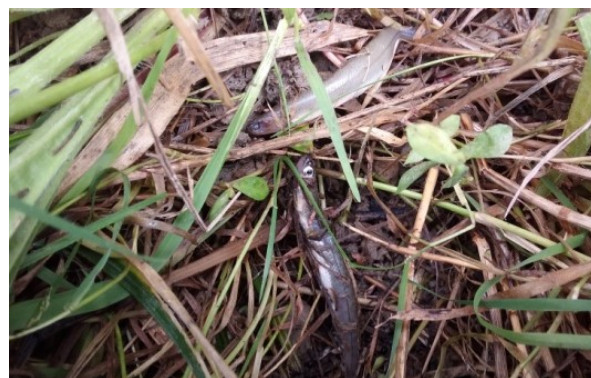
Observations on 20 April revealed very large numbers of fish spawning at the low gradient area of the site and at the small site between the boatsheds (Figure 3A; Appendix 3, Appendix 4 for additional photos and video details). Observations also showed the vulnerability of fish to predation by both eels and shags (observed on 21 April) and the risks of spawning fish getting trapped at very flat sites especially if large amounts of flotsam are present (Figure 3B).

Figure 3: A) Heavy spawning event during the 20 April survey; B) Dead inanga trapped in grasses at a flat area at the reach on 25 March.

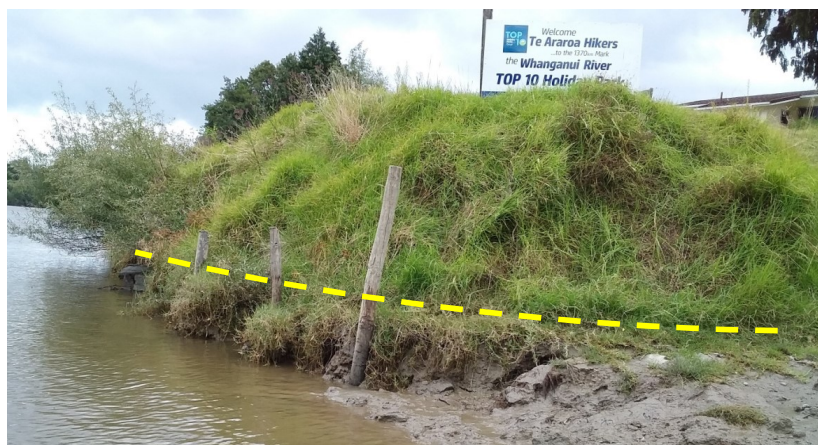
Figure 4: Highlight marks approximate location of egg band centre along benched area extending downstream into the steeper area of bank.

Encroachment of nearby willows on to the site was noted as a risk to its on-going productivity.

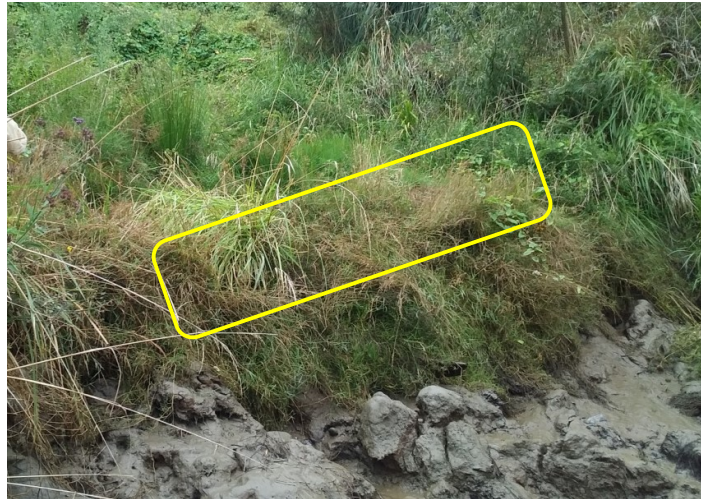
Figure 5: Yellow rectangle shows the approximate location of egg patch at the mainstem site opposite Aramoho Cemetery.

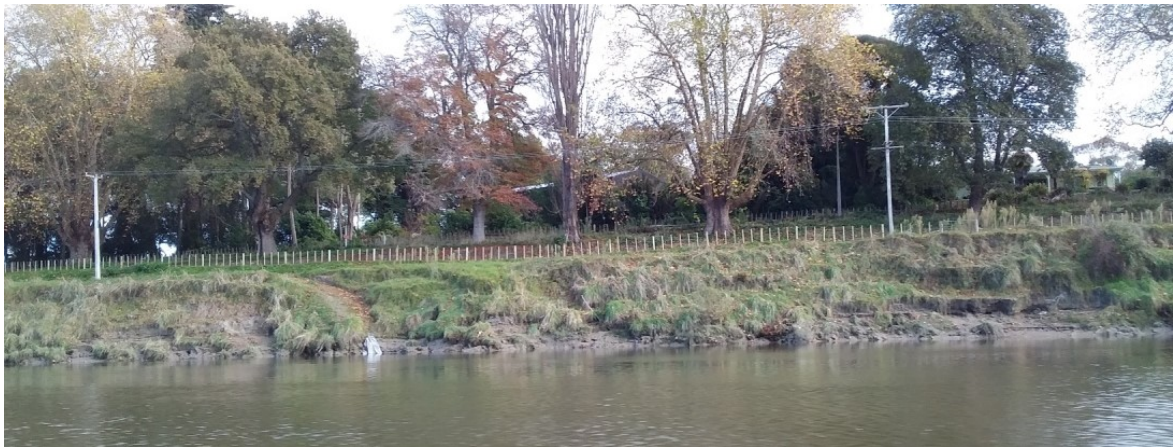
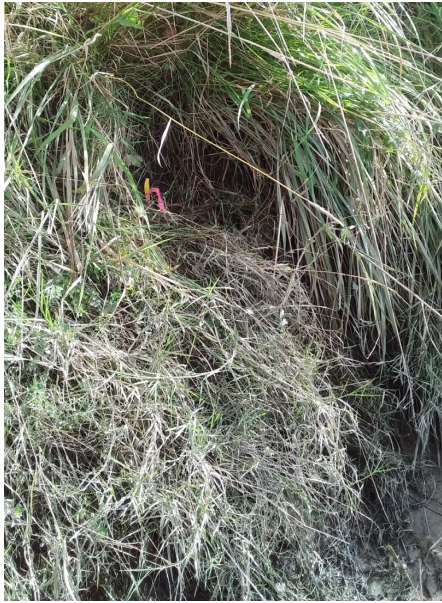
Figure 6: Papaiti Road–Waireka Road reach 27 March showing A) general bank profiles; B) small egg patch on steep bank marked by flag tape.

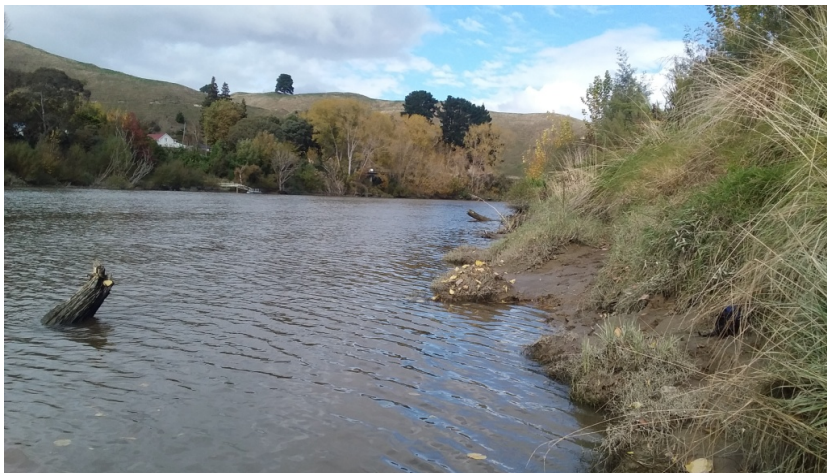
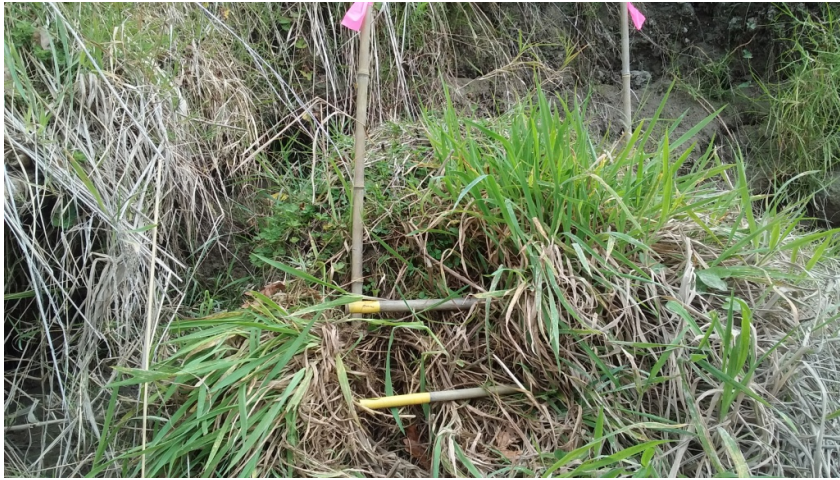
Figure 7: Opposite Upokongaro reach A) general bank profile; B) Small egg patch on steep bank, lowest horizontal stake marks bottom of egg patch.

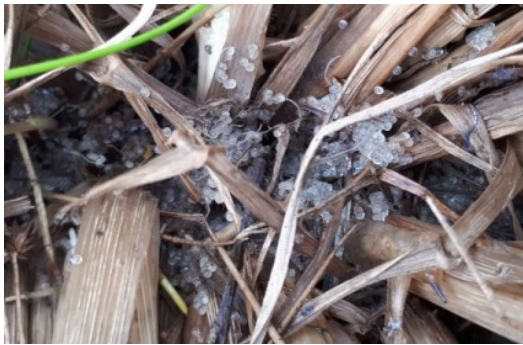
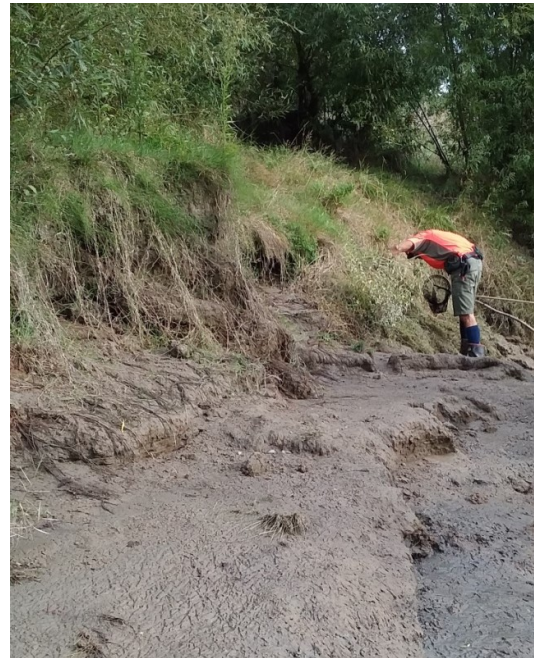
This reach was reasonably long at 350 m. There was one small egg patch in a tall fescue clump (Figure 8A) with a few hundred eggs. This smaller clump was located during the April survey. Eggs were found again in the same location during the general check in May. However, eggs were found nowhere else making productivity just a few hundred eggs for the reach. Steep and tall banks (Figure 8B) with limited areas of more gently sloping surfaces within the spring tide zone characterised the site. Spawning has not been recorded from this location previously (Table 7).

Figure 8: Papaiti Road Middle; A) Small egg patch in tall fescue; B) Typical bank profile.

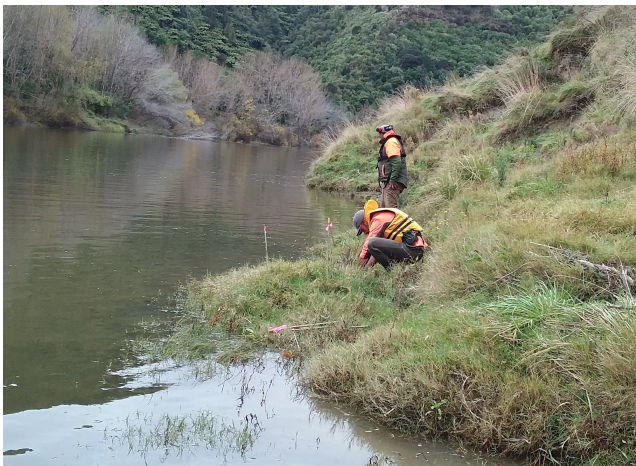
Figure 9: Poutama Road. Site of egg patch showing low gradient bank with thick cover of creeping bent and mercer grass.

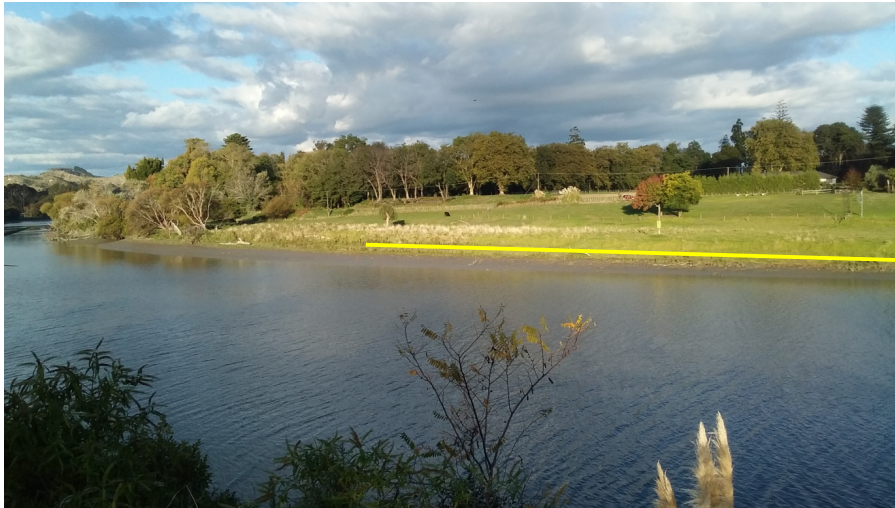
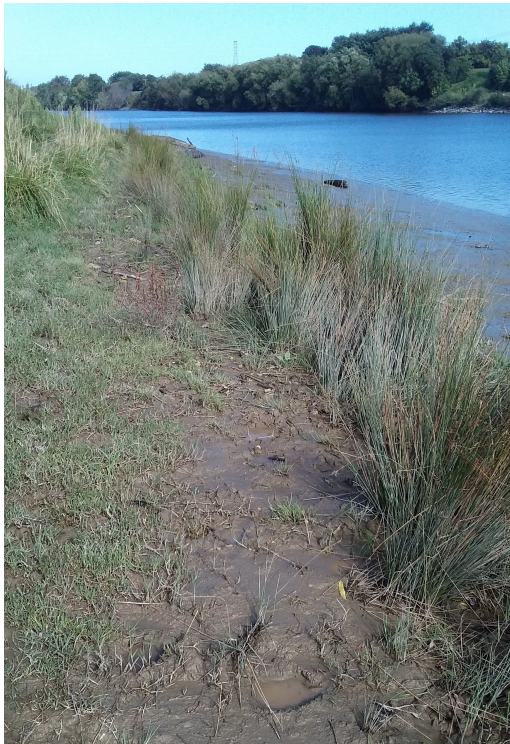
This is a new location for inanga spawning. Several small to medium sized egg patches were found across the reach (Figure 12A) during each survey in March, April and May. The predominant vegetation where spawning was located was mercer grass, tall fescue and creeping bent. Egg productivity estimates for March and April were 46,502 and 34,403 eggs respectively (Table 10). Except for the absence of larger egg patches at the downstream end of the site, the May survey indicated a similar spawning pattern to April, however, eggs were observed to be deposited higher up the bank than in April with large amounts of flotsam occurring through the egg patches reflecting higher tides and greater debris. The site has been grazed and damage to the banks (Figure 12B) and pugging as well as drying out of the riparian margins was noted. Spawning vegetation including grasses and rushes had been subject to browsing. Egg survival under grazed vegetation is typically very low.

Figure 11: A) View of the mainstem downstream of Mateongaonga Stream, highlight indicates area where several small egg patches were found; B) 28 March view of bank area where isolated egg patches were found.

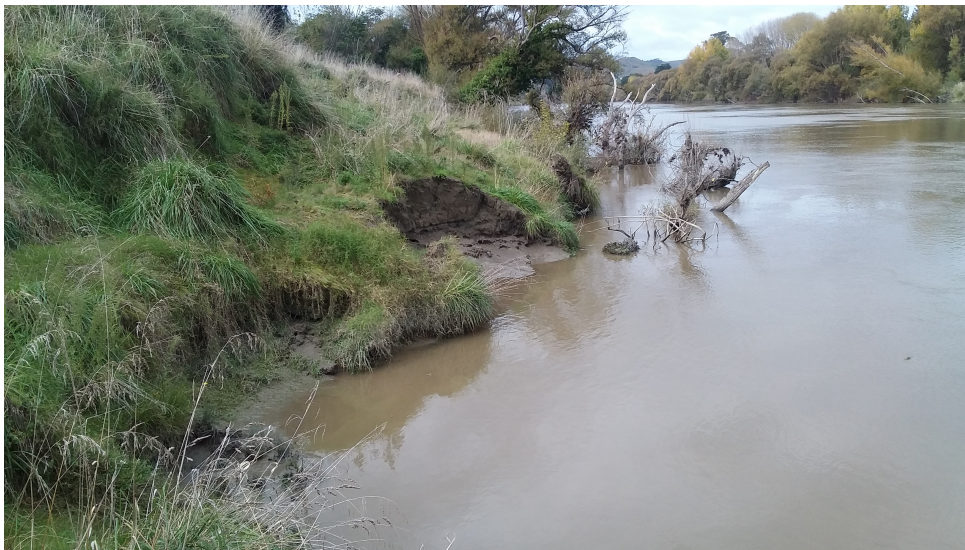
Figure 12: Kaiwhaiki Road Lower site, 30 April, showing bank features.

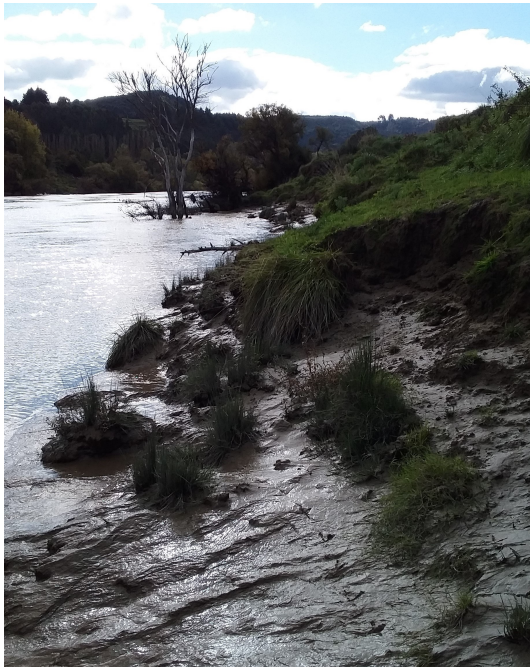
are characteristic of the reach. The reach has been grazed and shows damage to banks and spawning habitat along the river margins.

Figure 13: Kaiwhaiki Road Middle 1 May showing bank features.

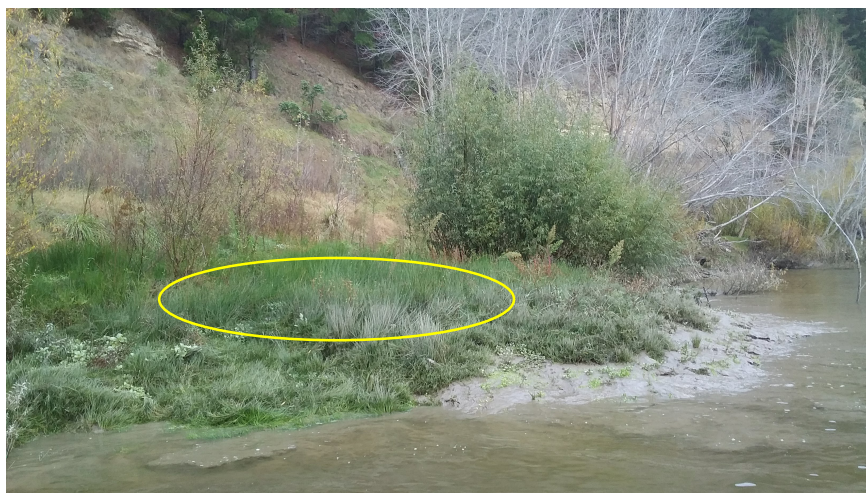
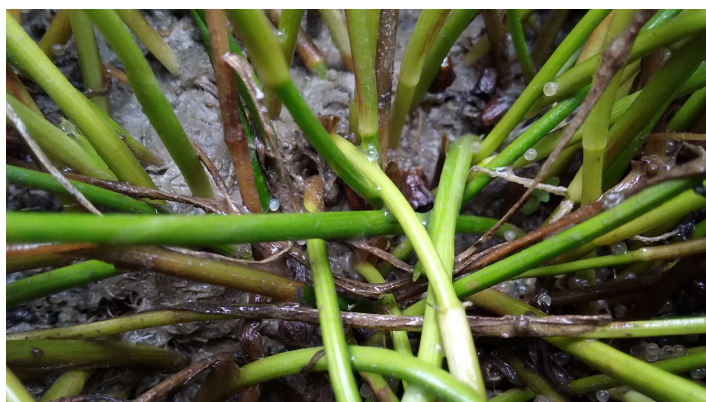
Figure 14: Kaiwhaiki Road Upper 21 May; A) shows main area of concentration of eggs over low gradient bank; B) eggs deposited in sparse Juncus and on bare soil.

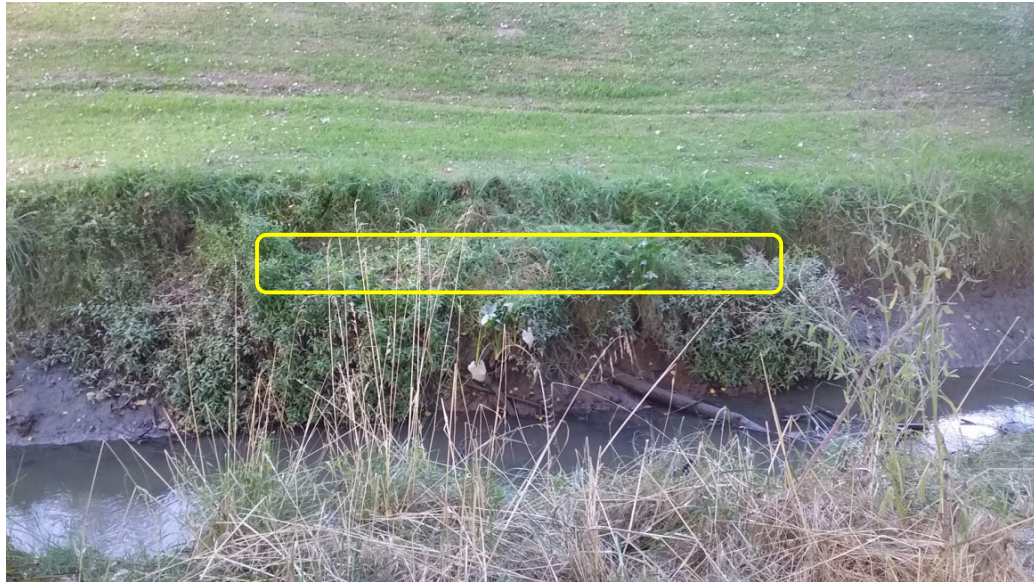
Figure 15: Matarawa Stream 23 April showing approximate area of spawning on collapsed bank area on tlb.

Besides the need to protect the spawning vegetation from further invasion by willows and weeds this urban site requires more intensive management given the high use of the area. Using signs to publicise the spawning areas, the planting of native riparian species and control of invasive trees and weedy species are options to protect and enhance productivity at the site. Bank re-contouring to a more gradual productive profile may be an option as part an enhancement programme. Location of the site lends itself to involving the wider community as part of a restoration and advocacy approach (see Recommendations).

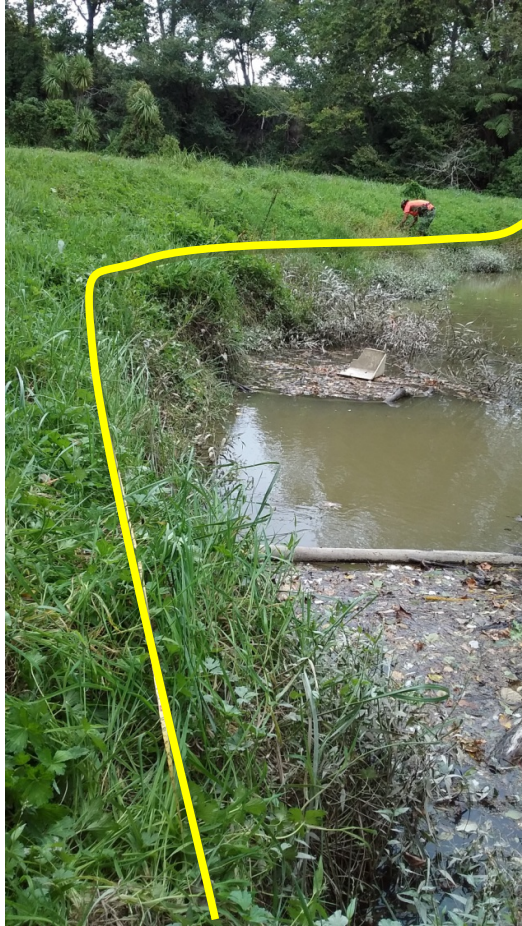
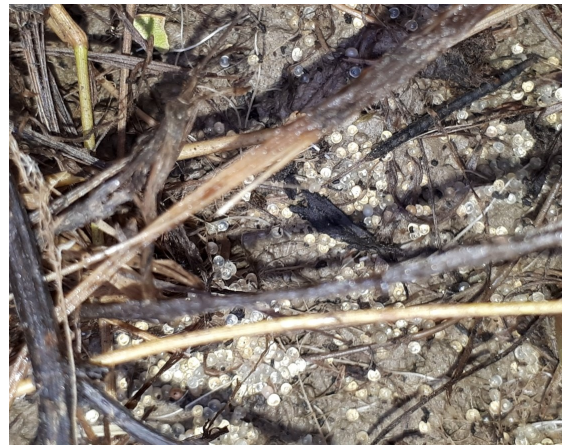
Horizons unpublished data indicated spawning at this site in April 2016. During this study, spawning was found at the site only in March. It extended in a long, narrow, nearly continuous band for approximately 100 m across the flatter-topped margin of the bank (Figure 16A). The band covered an area of 25.6 m² and had an estimated productivity of almost 1.05 M eggs (Table 15). The thickly developed vegetation with high density stems and rootlets and dense tradescantia (Figure 16B) supported large numbers of eggs. The stream provided good cover for adult inanga that were aggregating to spawn. Visits to the site in April and May showed that vegetation had become extremely thick and wet and no eggs were found. Key issues for the site are maintaining the spawning area free of encroaching willows and other weeds. There is also the possibility that existing vegetation may need to be cut to prevent it becoming so thick inanga cannot enter into it to spawn and to prevent them from getting trapped in vegetation when they try to leave the site. The area is popular for whitebaiting so there may be benefit in signage to increase awareness of the spawning area and prevent unnecessary damage by whitebaiters.

Figure 16: A) Mateongaonga Stream 27 March highlight marks continuous egg patch along top of bank; B) Dense eggs under tradescantia at western end of spawning patch.

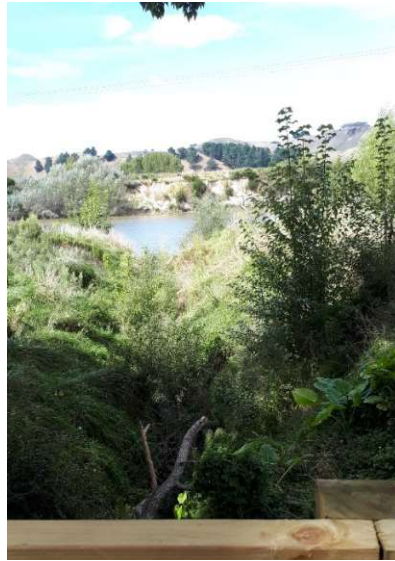
This is a new location for inanga spawning. The stream is small, incised with steep banks and has only limited areas of more gradual slope suitable for spawning. It is currently relatively free of large shading vegetation except for the area immediately downstream of Papaiti Road (Figure 17). The culvert under the road provides passage for fish and there is good cover in the stream for adult inanga especially further downstream. Rank grasses and herbaceous vegetation provided the spawning vegetation for the four very small egg patches found in March producing a total of 1,510 eggs (Table 16). No spawning was recorded in April and the May general check showed fresh spawning in the same locations as March at similar density. Small alders and willows are establishing along the stream margins.

Figure 17: Looking downstream from Papaiti Road Bridge at the unnamed stream (site number 15).

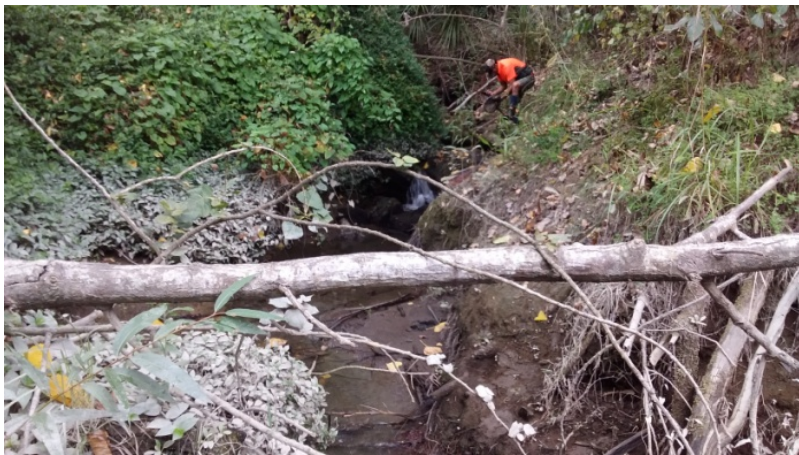
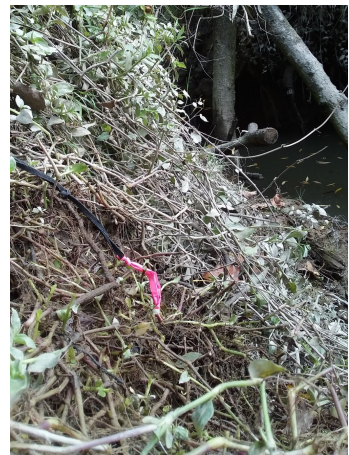
This is a new location for inanga spawning. The stream enters the mainstem approximately 1.2 km upstream of Mosquito Point. It is the most upstream tributary where spawning has been recorded. The stream has very tall steep banks (Figure 18A) and is heavily shaded by large trees. Three very small egg patches found during March supported a total of 598 eggs. One patch of 788 eggs was found in April (Table 17) and two small patches were found during the May survey. Tradescantia (Figure 18B) was the main plant used for spawning in this shady stream with some creeping bent and ranunculus mixed in where there was increased light. A complex series of culverts under Papaiti Road block upstream passage for fish to the significant catchment upstream; improving fish passage is highly desirable for inanga and other native fish. Control of large trees and weeds would improve the light environment in the stream, and replanting in native species could be considered.

Figure 18: A) Tauraroa Stream showing the steep banks and restricted area of suitable spawning habitat; B) Flag tape marks small egg patch on steep bank under tradescantia.
