14 April 2020 (FINAL)

REVIEW OF THE DECISION TO REMOVE A ROCK OVERHANG ON THE TRUMAN TRACK

Reference: DOC 6188284

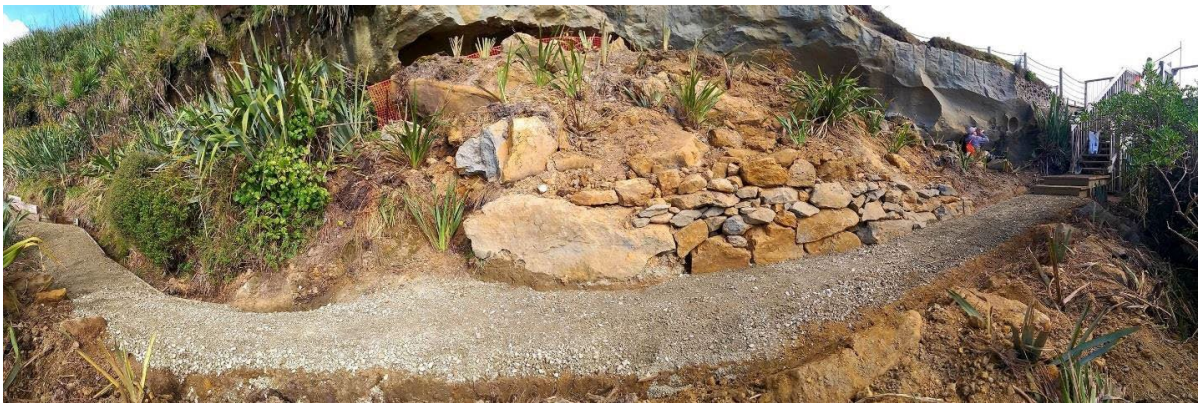
Completed work after a rock overhang adjacent to the Truman Track was removed.

Operations staff then sought a further independent assessment⁴ which revealed water seepage through surface gravels and cracks in the underlying sandstone. In their view, this confirmed that the rock overhang was a significant visitor safety risk, and they made the decision to remove the remaining section of the rock overhang. They sought advice from specialist contractors on how to do this safely with minimal impact on the natural environment. The remaining section of the sandstone overhang was removed in mid-August 2019 and landscape restoration was carried out.

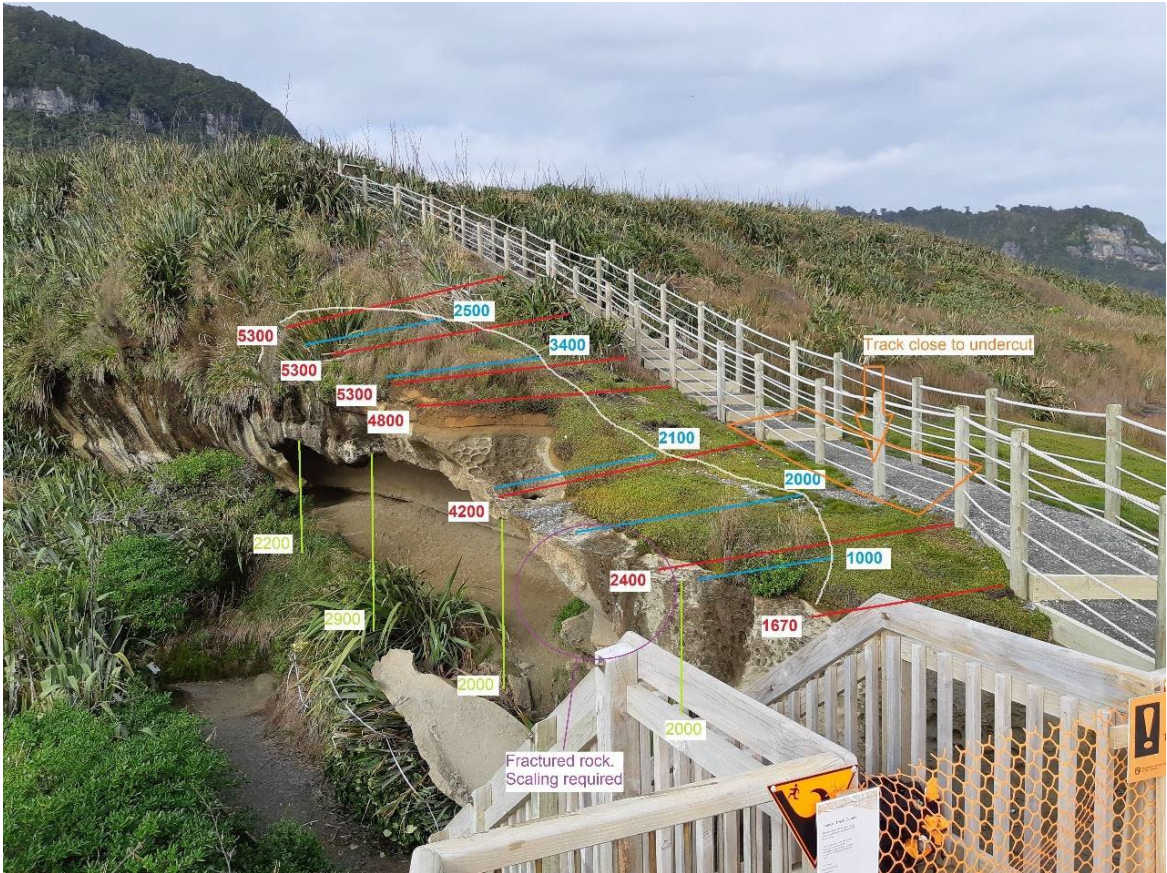
In late July 2019, a 3-4 ton³ block of sandstone fell from a rock overhang and landed adjacent to the Truman Track.

Caption: 3 -4-ton rockfall adjacent to the Truman Track after the July 2019 rockfall event.

The section of track was immediately closed, and geotechnical advice obtained to assess the risk of further rockfall and identify mitigation options. The geotechnical report recommended two options:

- Remove the remaining sandstone overhang, or
- Install a rockfall barrier
