Subject: Visitor expectations of Short Walks and Day Hikes

Cape Kidnappers Visitor Survey 2018: Intercept

The observations and recommendations made through this Scoping Report are based on: background information provided by DoC at the outset of this project and sourced from the DoC website, one site visit undertaken by DoC/ Opus technical experts¹ and one workshop attended by DoC/ experts. Due to the limited extent of research underpinning this Report, further investigations are recommended to verify the observations and recommendations made.

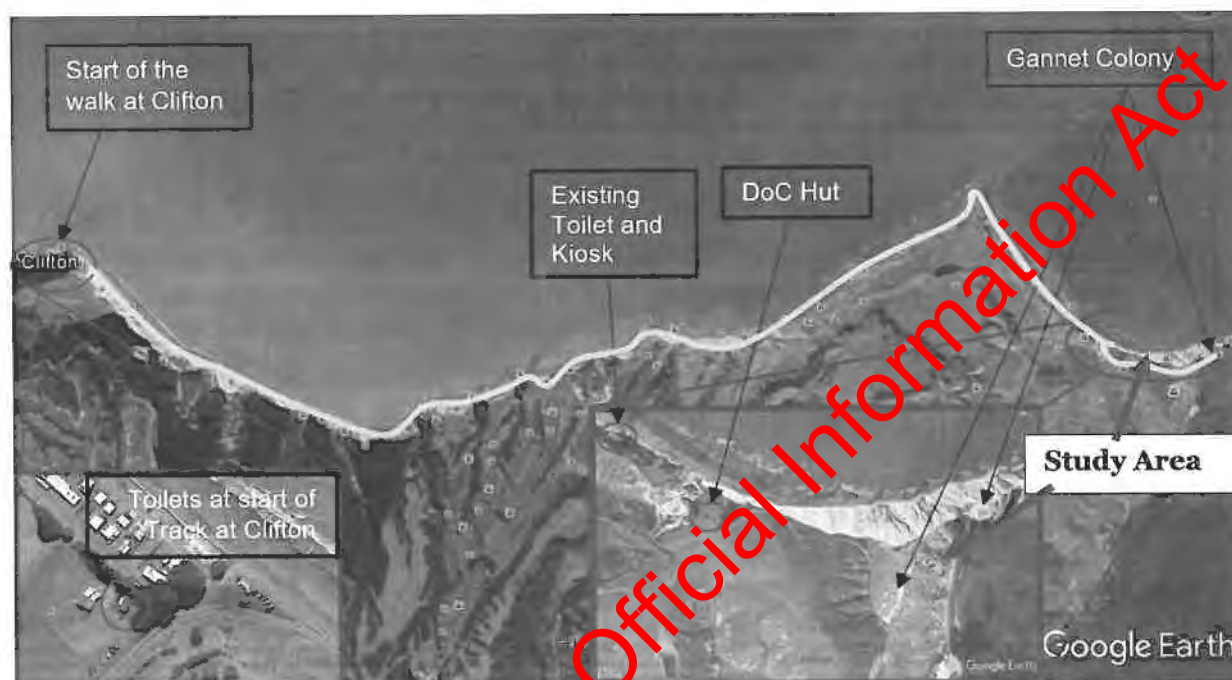
Figure 1 Extent of Study Area

The Cape Kidnappers 'site' consists of; the gannet colony access track and amenity area (refer to Figure 1 below). For the purposes of this Scoping Report the study area specifically refers to the area of the walking track which rises from the beach onto farmland up to the gannet colony. The map below demonstrates the extent of the study area. The Cape Kidnappers walkway entrance area at Clifton (the entrance at the Clifton Camp Ground) and the area of the walking track along the beach are excluded from this scoping study, except where recommendations are made regarding the need for overall site masterplanning for the entire Cape Kidnappers 'Great Day Walk'.

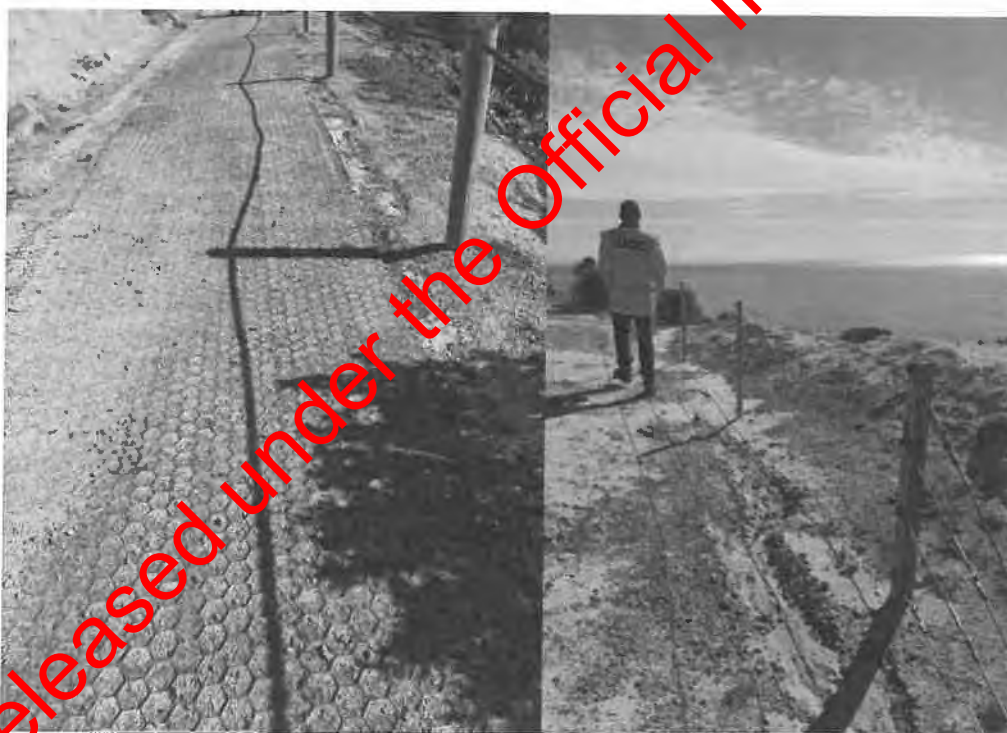
The walking track has been susceptible to erosion (the section from the visitor shelter/ toilet block area to the farmland has a section that is particularly prone to erosion) and has required realignment several times to remain safe and to provide access to the end point where the gannet colony exists. Image 3 below shows the most erosion prone section of the walking track known as 'The Gallery'. DoC staff have advised that the closest point from the walking track to the cliff edge is approximately 3 metres⁹. Any realignment of the walking track will require acquisition of land, or permission from the land owner (Cape Kidnappers Station Limited) to do so through such measures as an easement or formal agreement.

Image 1 Existing rubber track materials

Image 2 Existing wire barrier fence

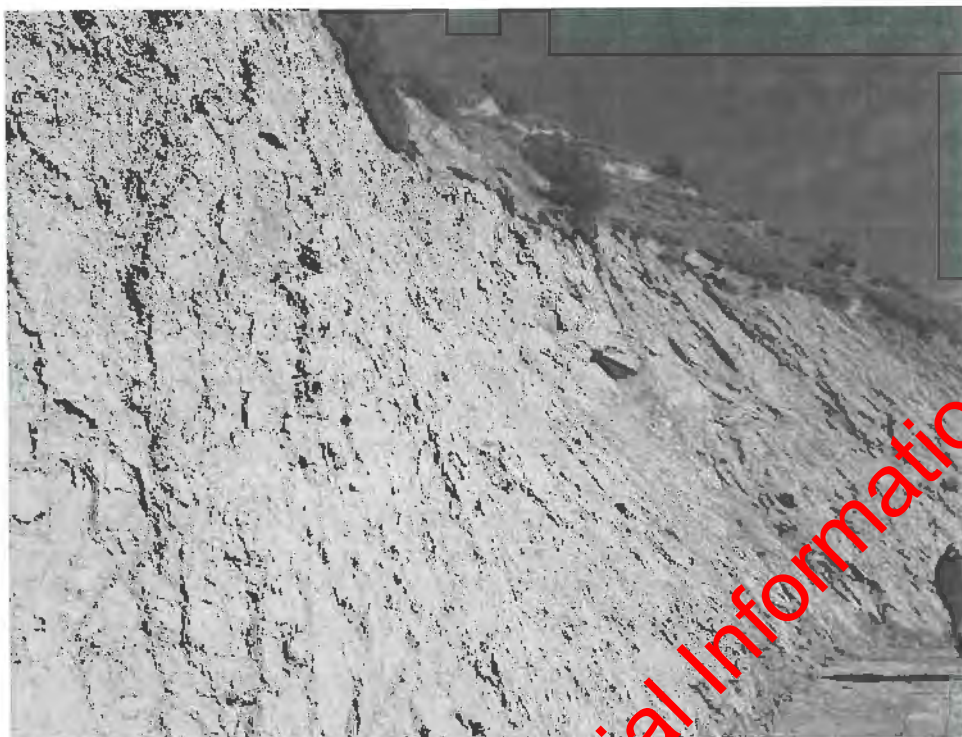
Image 3 'The Gallery' experiences significant erosion onto existing walking track

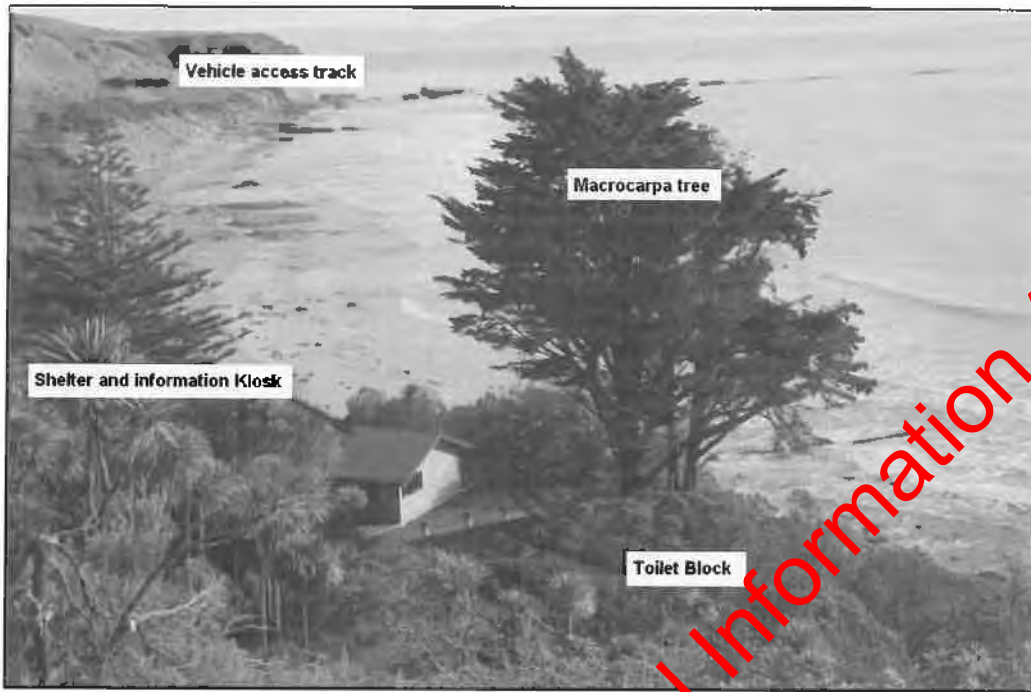
The amenity (toilet) block is located at the point where the end of the beach track begins to ascend up onto DoC land and along the constructed track towards the end of the peninsula (Refer to Figures 1 and 2). It was built in 1988 and has been currently assessed as in 'reasonable condition' (40%). It has a remaining useful life of 5 years¹⁰.

A key concern for this facility is that the septic tank has not (to anyone's knowledge) been emptied since being built in 1988. Concern has been raised by Waste Management Hawke's Bay Ltd that there may be a crack or another source of seepage from the containment system. The containment tank is made from concrete and may have cracked during an earthquake or other event. The containment tank always seems to remain at about ¾ full without any fluctuation in level.

Figure 2 Photograph showing key facilities

A number of options have been discussed as to how the septic tank could be emptied. The most likely option would be to get a truck in to remove the waste. The crack in the septic tank would need to be identified and sealed. As part of this work, the vehicle access track across private land would need to be upgraded as the current state of the track is not safe for the truck returning with a full load of sewage waste.

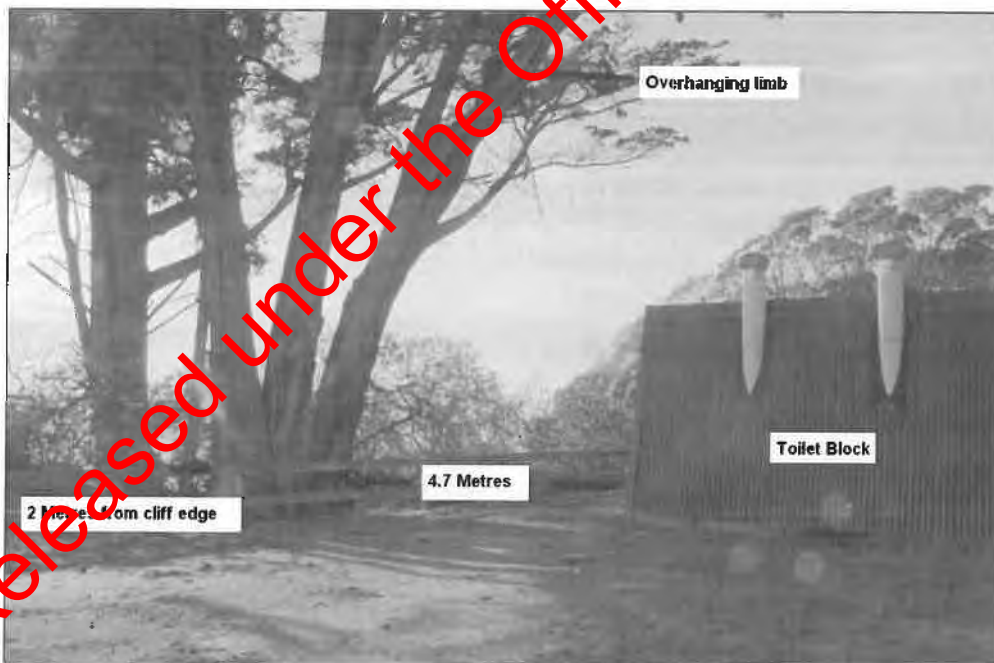
A large *Macrocarpa* tree is situated on the cliff edge in close proximity to the amenity block and septic tank (refer to Figure 2 below). If coastal erosion continues as expected this tree could potentially fall and cause a large limb to damage to the toilet block and subterranean containment tank (and thus potential environmental risk from contamination).

Figure 3 Photograph showing proximity of Macrocarpa from toilet facility

This option involves maintaining the existing facilities in the current location yet undertaking improvements – particularly with regard to the infrastructure issues such as removal of the Macrocarpa tree to eliminate its risk on adjacent infrastructure, repair (or upgrading access track to remove/ replace) of septic tank associated with toilet facility and minor upgrades to existing access track, to ensure their useful life is maximised. This option would provide an improvement on the current situation but is not considered to be desirable (as the only option) for the following reasons as described below.

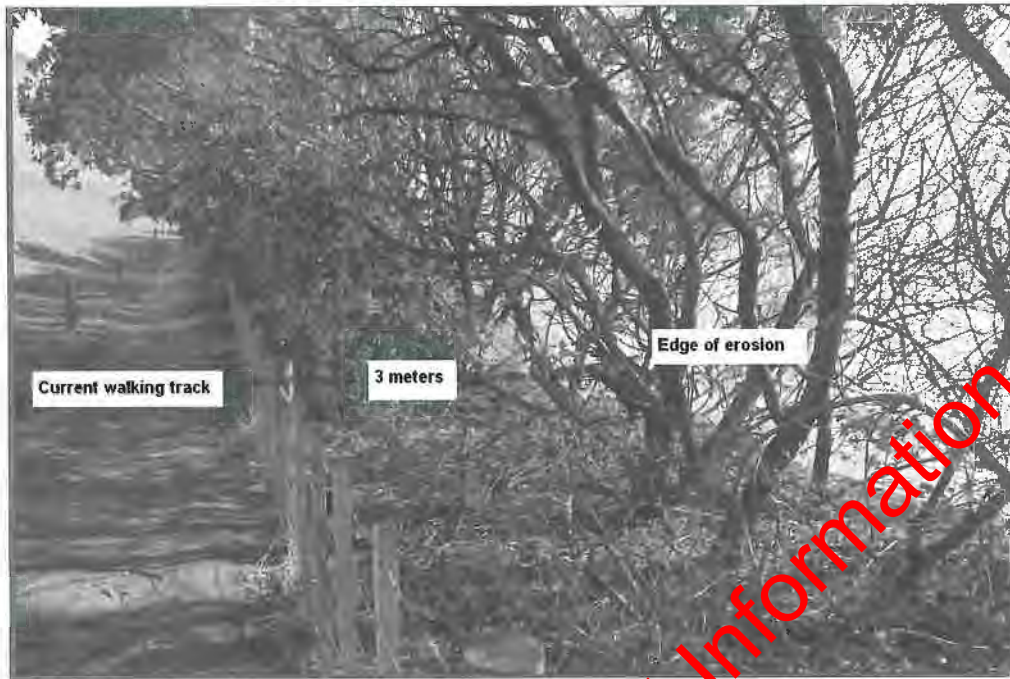
Figure 4 Photograph of walkway in context of cliff face edge

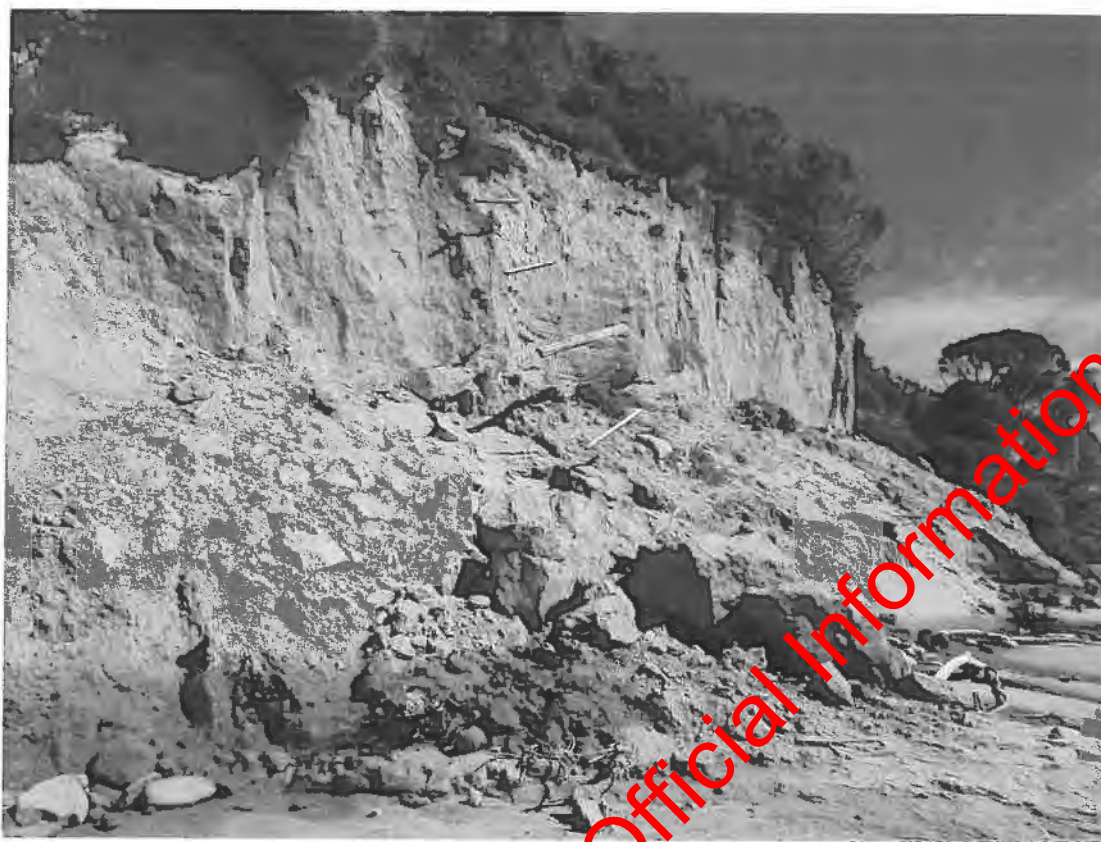
In 2011/12 storm damage to the approach off the beach onto the walking track was significant enough to close the area until repairs were made. The closure did not affect the concessionaire's activities as repair work was conducted prior to the opening of the season. A significant structure (retaining wall) was erected in such a manner as to resist erosion and provide a more stable entranceway. Currently there is no issue with the approach from the beach to the walking track. With this said, staff regularly clear slip material and repair water damage along the track from the visitor shelter/toilet block area up to the farmland in particular. DoC staff have advised that this area is being closely monitored.

In 2015 Cyclone Pam caused further erosion along the access track which now requires substantial repair to maintain to track standard.

Image 4 Example of hanging fence line that has been subject to the eroding cliff line

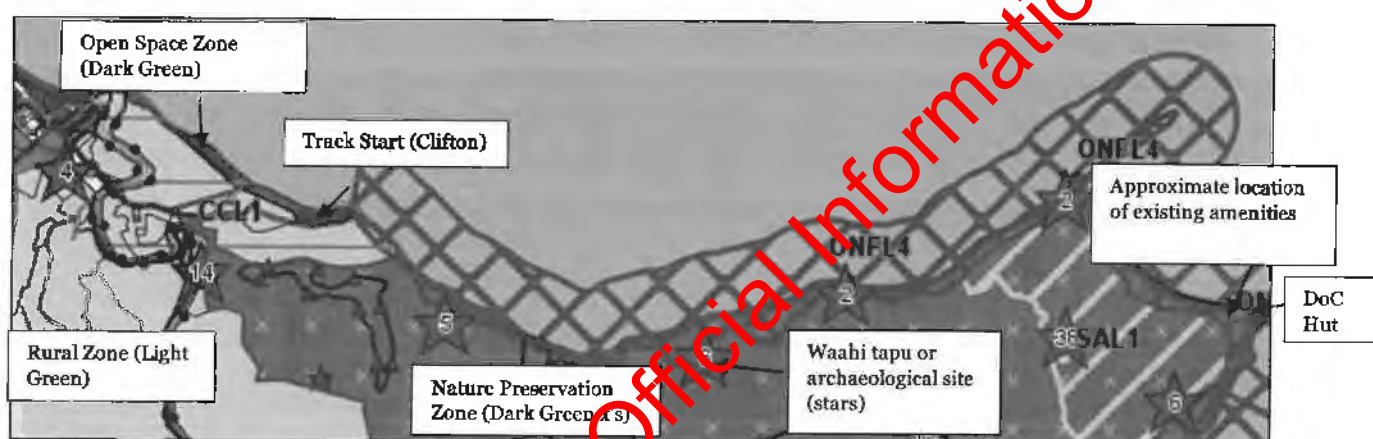
Figure 5: Hastings District Council Planning Map (Source: Hastings IntraMaps)

- The gross floor area of any new buildings built for conservation enhancement and management activities (for example a new shelter or kiosk) are greater than 100m²;
- The required earthworks in the area identified as ONFL4 on Figure 5 below is greater than 200m³ (for the entire ONFL4 area).
- New trees are planted at a density of greater than 100 trees per hectare in the area identified as SAL1 on Figure 5 below.

In addition, parts of the track at its starting point in Clifton are within the Coastal Landscape Character Area (CCL1), Open Space Zone and Rural Zone on the Hastings District Plan maps and any development at the start of the track should be checked against the District Plan rules. Large scale development (for example a new tourist centre) are very likely to require resource consent.

The Cape Kidnappers site is located within the following zones or have the following features identified on the Hastings District Plan maps (refer to Figure 5 below):

As discussed in Section 4.3 the Cape Kidnappers area has a long association of Maori history and includes many sites of significance to Maori. There are several archaeological and waahi tapu sites identified on the planning maps (refer to Figure 5 below).

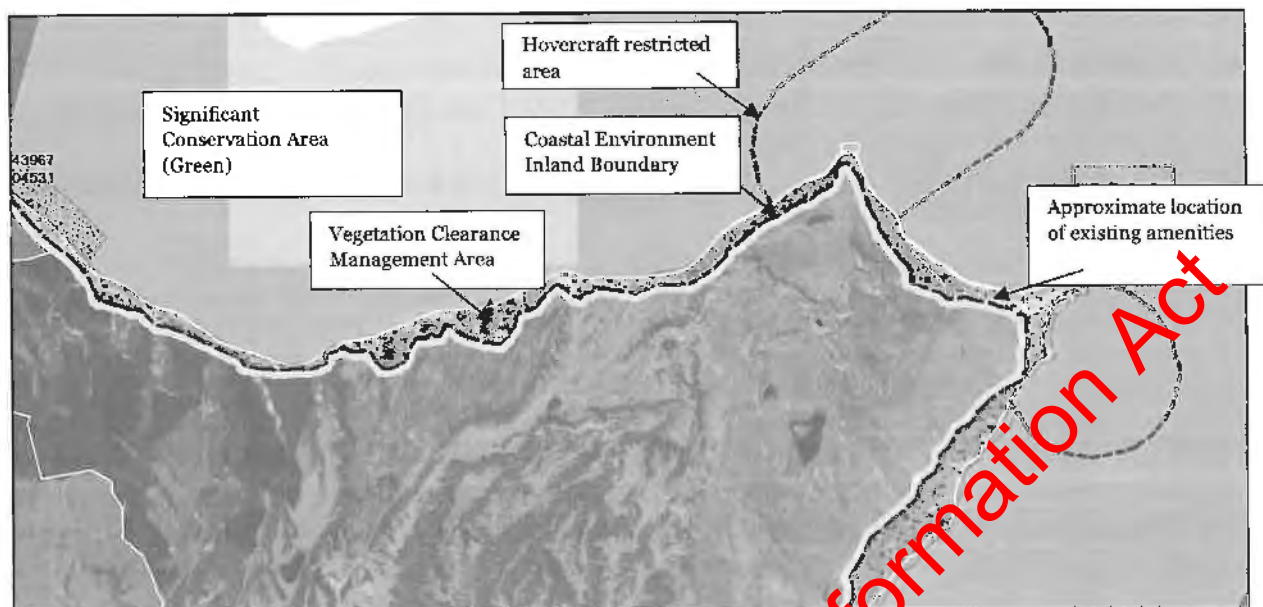
Figure 6: Hawkes Bay Regional Council Coastal Environment Map 118

Resource consent will be required under the Hawke's Bay Coastal Environment Plan (Coastal Permit) for the placement of new structures in the Coastal Marine Area. Resource consent may also be required for any new wastewater treatment systems and to discharge stormwater (small scale diversion of stormwater is permitted) and specific solutions should be checked against the performance standards in the Regional Plans when they are selected. The subject site is within a Vegetation Clearance Management Area however small-scale vegetation clearance (for example the *Macropopa* tree) is a permitted activity.

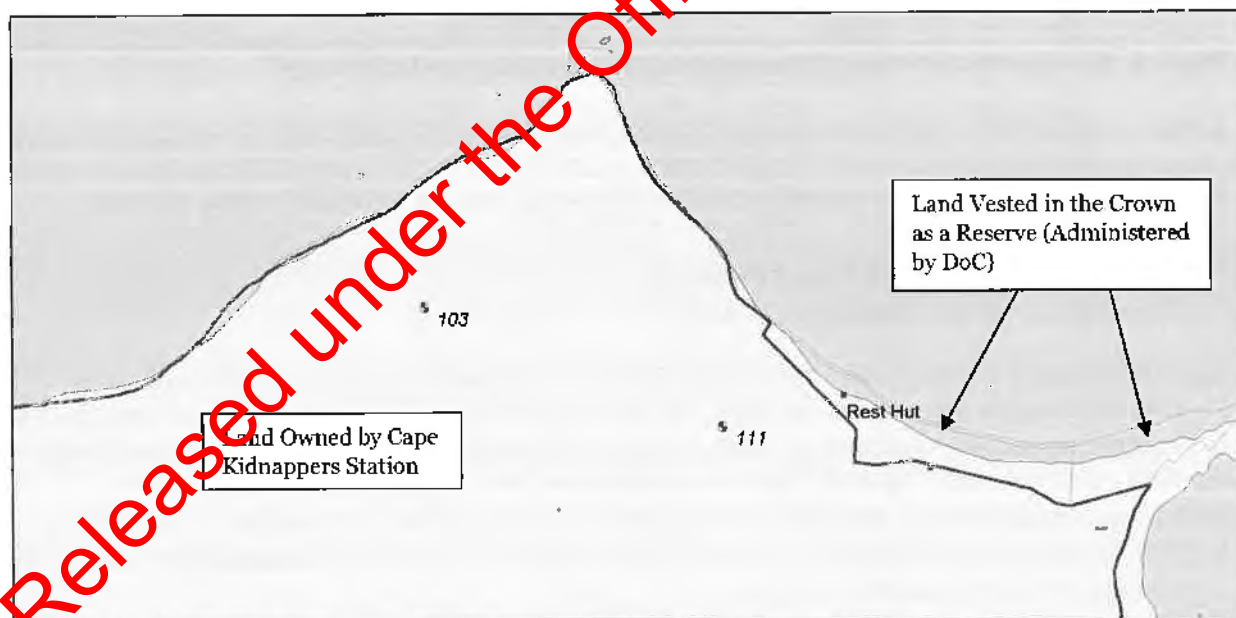
Figure 7: Land ownership

DoC owns/administers part of the land within the study area. The remaining land is owned by the adjoining Cape Kidnappers Farm (owned by Cape Kidnappers Station Limited).

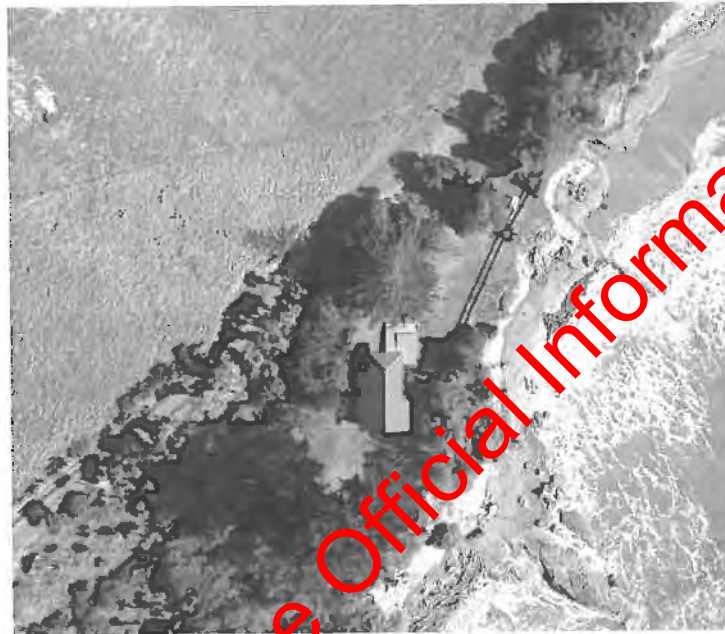
Figure 1: The site locality

The area of walking track and facilities (the site) of interest is approximately 500m east of the Gannet colony and perceived to be at risk from coastal erosion.

The facilities structures include a toilet block and light timber framed building.

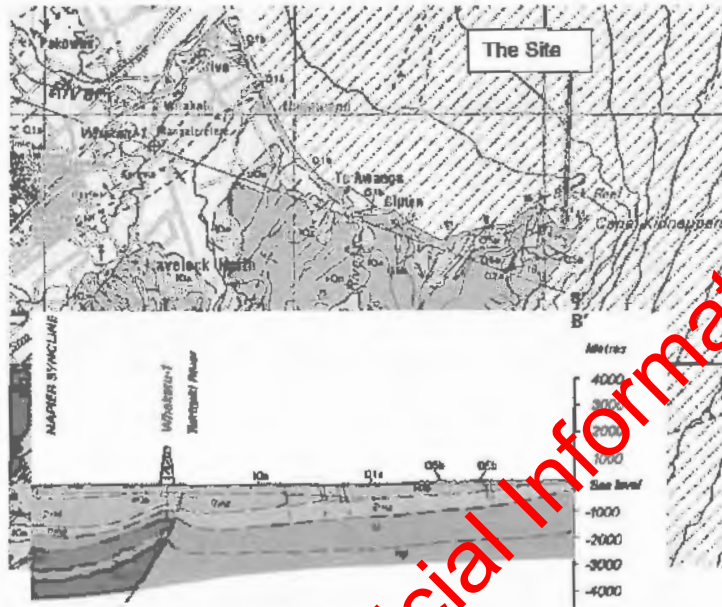
Figure 2: Geological Map

The site is shown on the GNS Science published map (Lee, Bland, Townsend and Kamp (compilers), 2011) which shows the area to be underlain by Lower Late Pliocene (1.81 – 3.6M years) fossiliferous mudstone and sandstone. An active fault is shown approximately 3km to the west.

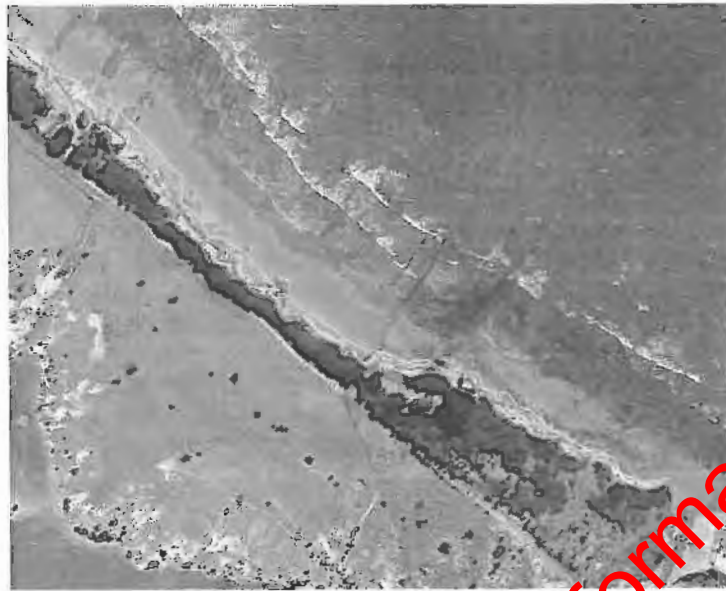
The crest and base of the slope below the facilities was traced in each image and overlaid to provide an indication of the rate of coastal erosion.

Figure 3: Crest of slope (yellow 1963, green 1980, blue 2014)

Year		
	1963 (0 years)	1963 - 1980 (17 years)	1980 - 2014 (34 years)
Base of slope	na	0-4m	3-9m
Crest of slope	na	0-5m	3-9m

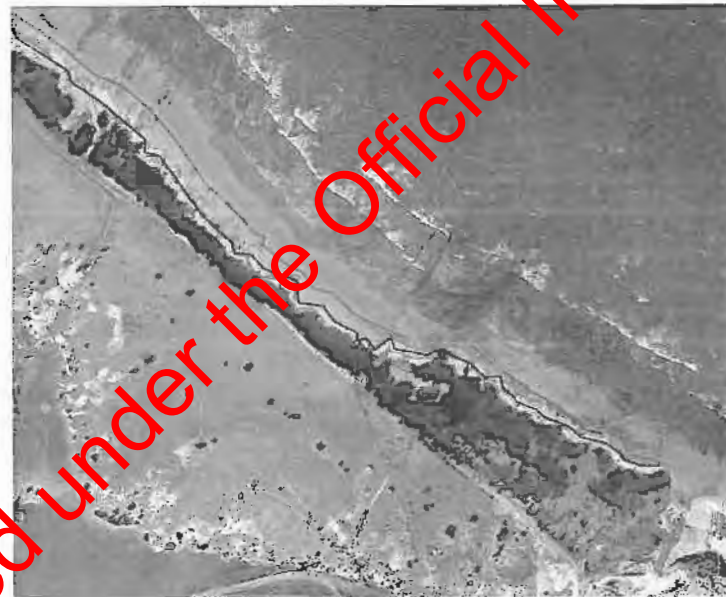
Figure 4: Base of slope

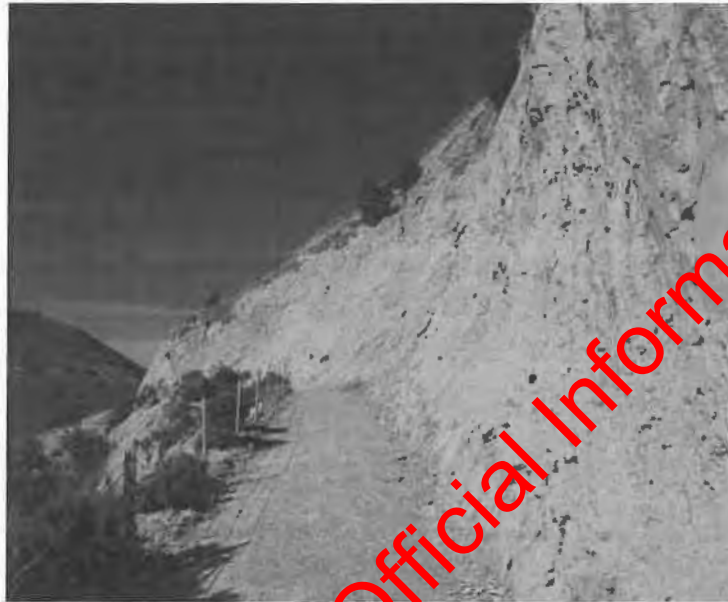
The track cut into the hill side to the east of the facilities. The bank is sub vertical and as the mudstone is exposed and undergoes wetting and drying it can 'fret' and break off in small planar slabs. Deep seated instability was not observed. The mudstone is likely to have suitable bearing capacity when dry but may be expansive and or water sensitive.

Figure 5: Track cutting

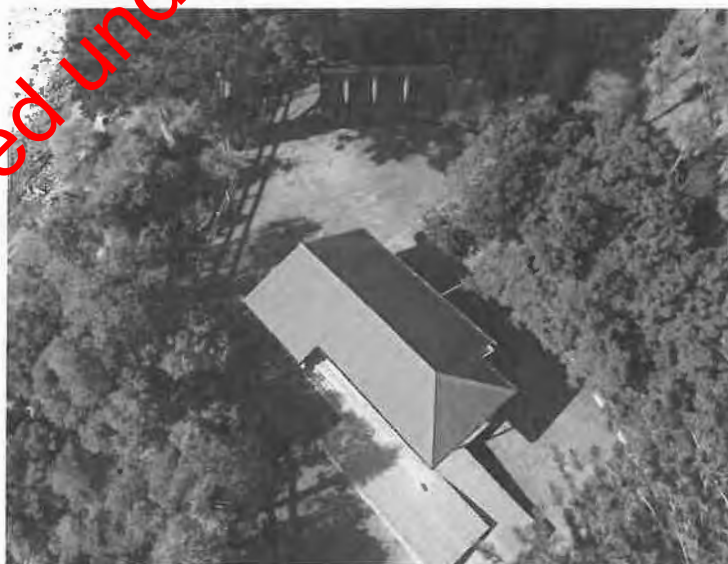
A large Macrocarpa tree is at the crest of the eroding bank near the toilet and structure. The tree is likely to have an extensive root system and may be stabilising the slope and potentially affecting the toilet sumps. The tree is on the edge of the bank and may fall during a large storm.

Figure 6: Facilities with Macrocarpa tree to upper left

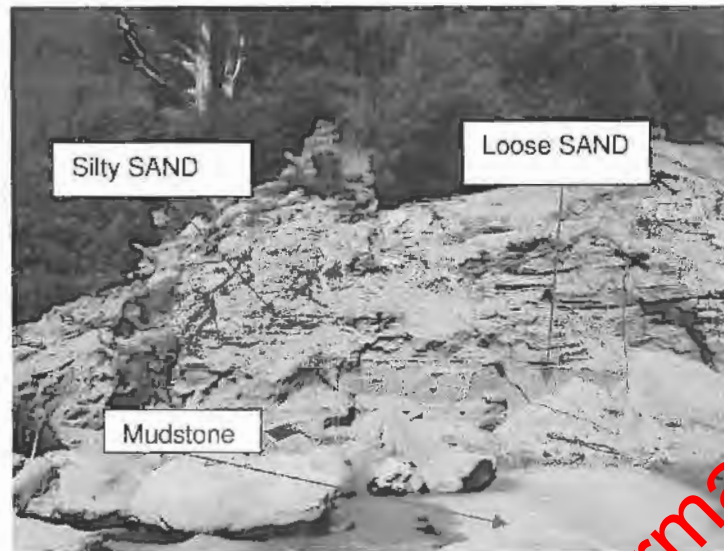
Figure 7: Bank below facilities

The slope is a near vertical bank several meters high. A sub horizontal blue grey mudstone is at the base of the bank and the bank consists of weakly cemented silty sand and loose sand. The sand has little or no cohesion when dry is as likely to be highly erodible with wind or water.
