Kerikeri Hydro-Electric Station

Historic Heritage Assessment

Kerikeri Hydro-Electric Station Historic Heritage Assessment

Melina Goddard, DoC, Bay of Islands Area Office 2011

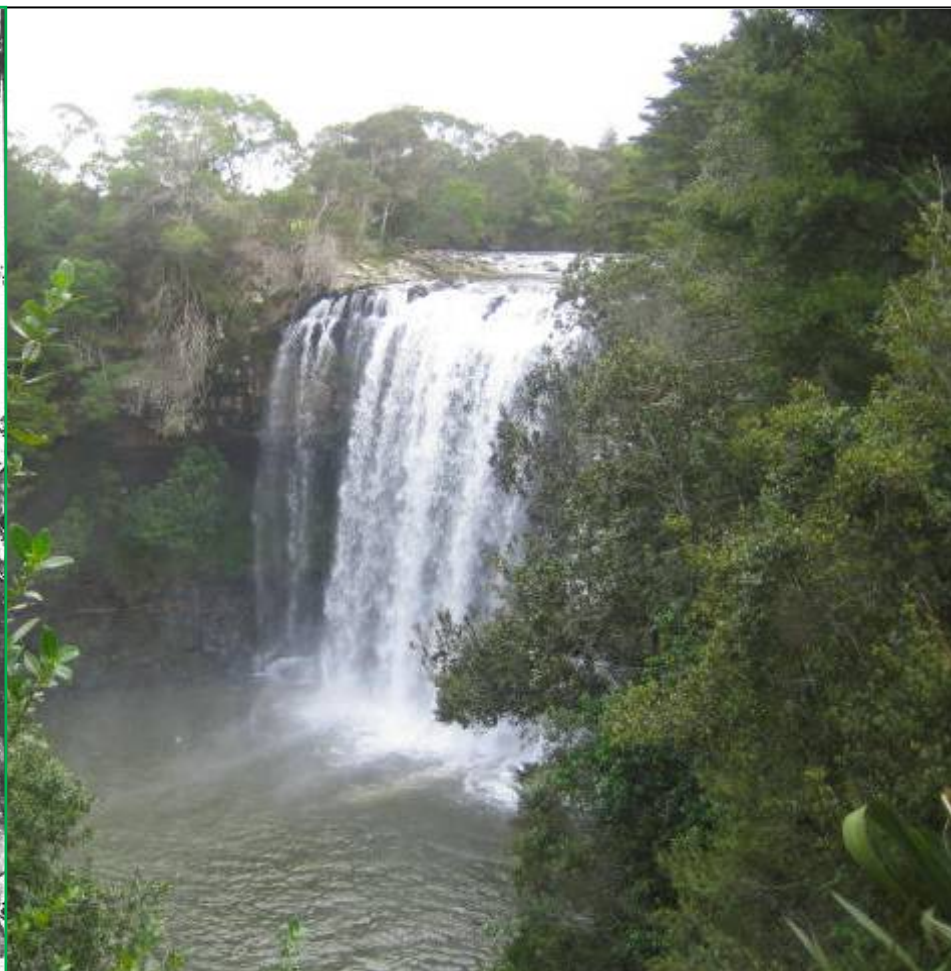
Cover image: Left: The powerhouse from 1930, showing the switchboard, and the machinery. The text of the backwall “Boving and Co LTD London” Right: Rainbow Falls M. Goddard 2011.

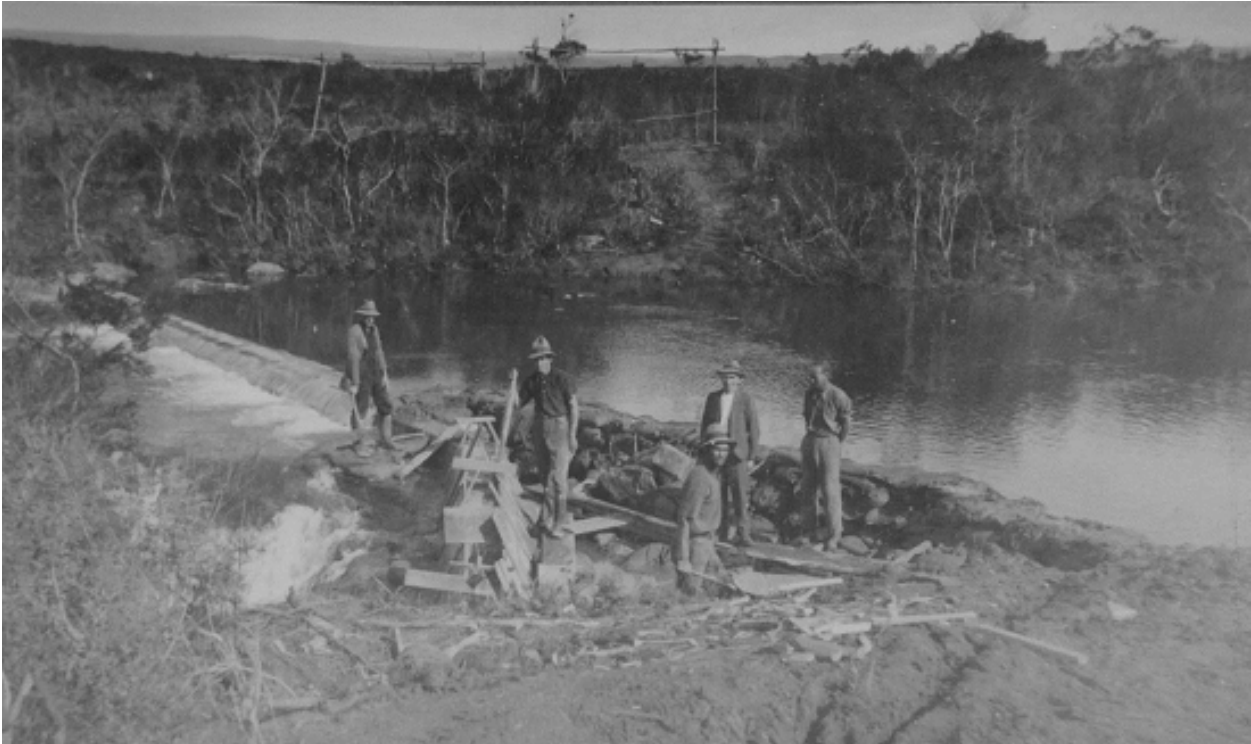
As outlined by Mandeno the concrete dam and diversion weir were constructed above the upper falls, or Rainbow Falls as it is known today (fig 2). Before construction could begin

Figure 2: Construction of the concrete dam and diversion weir at Rainbow falls (BOIEPB).

the river needed to be diverted to the south bank. This was done during a dry spell in December 1929. Earth filled bags were placed upstream from the weir site forming a coffer dam. They then grouted (mixed sand, cement and water) eight $\frac{3}{4}$ inch steel pins into the rock bed. The surface of the rock was cleaned of slime and roughened in order to make a secure bond with the concrete. They built boxing to make a tidy alignment and concrete was poured and built up to the required height.¹⁴

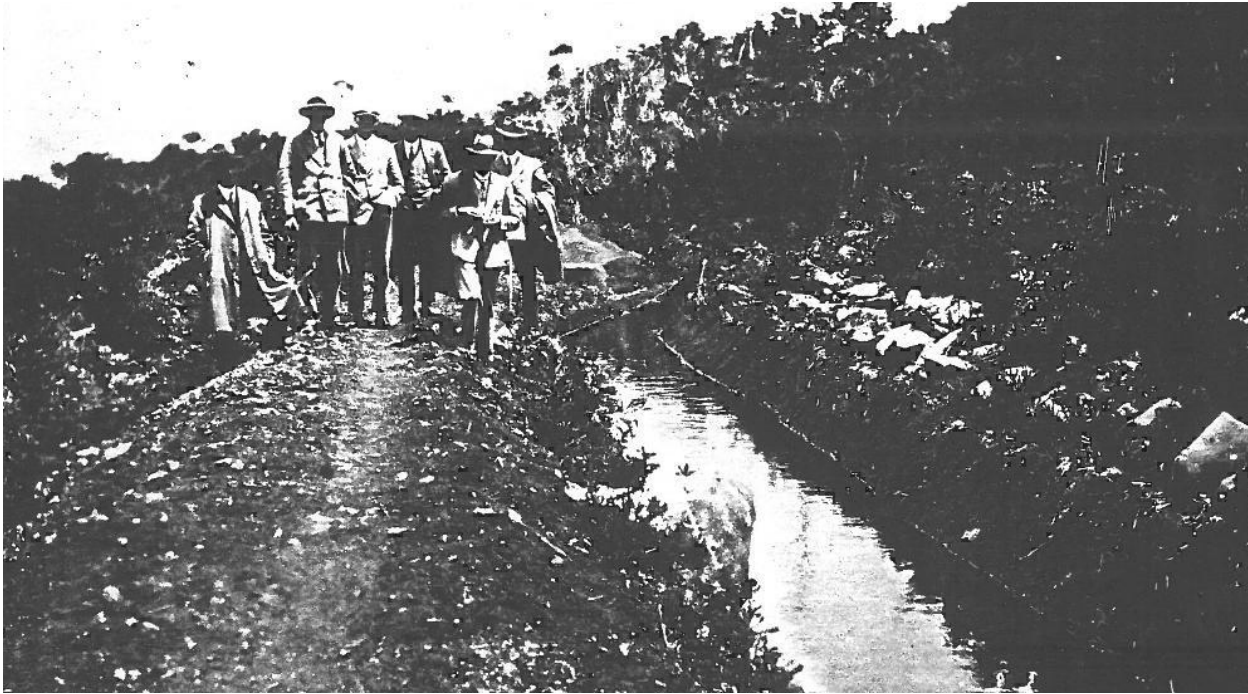
Figure 3: Part of the water race being inspected by the Russell Power Board (BOIEPB)

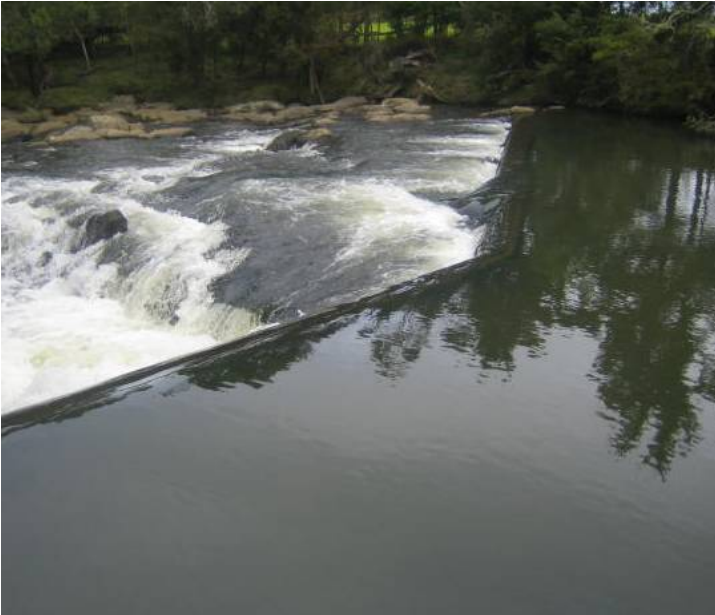
Figure 6: The concrete dam at Rainbow Falls (DoC 2011)

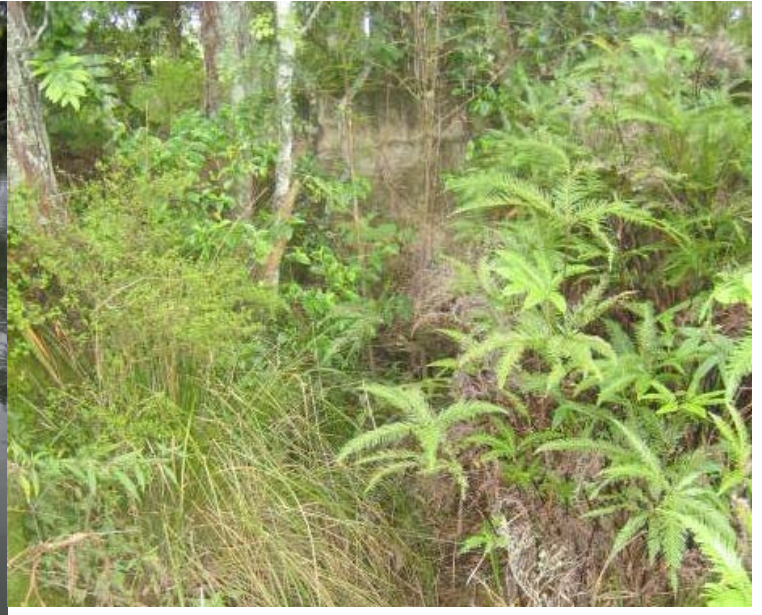
Figure 7: The entrance to the race at Rainbow Falls (DoC 2011)

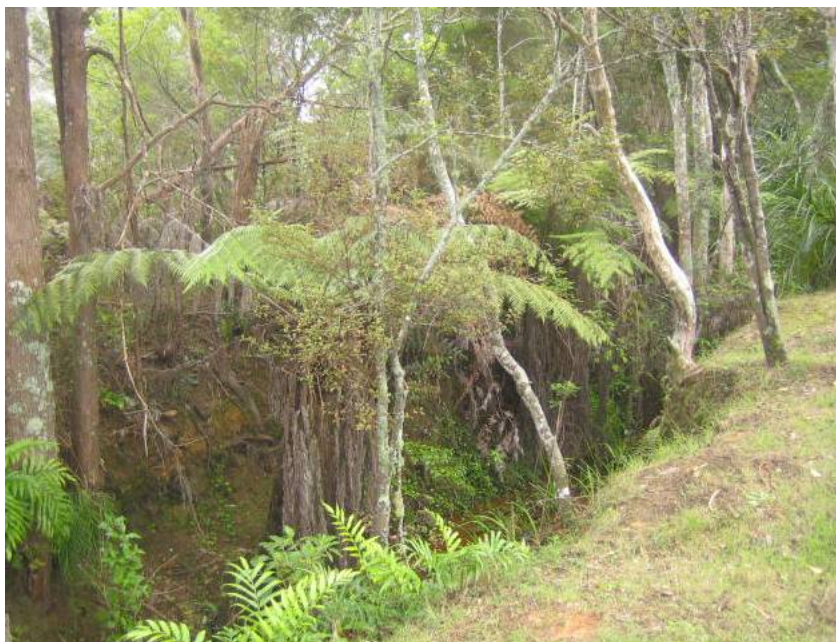
This is up to 2m deep and winds through the scenic reserve from Rainbow Falls and eastward through private property over a gully behind Blue Marlin Drive, then by means of an open wooden aqueduct flume to the top of the cliffs at the old wildlife station.

Figure 8: A section of the water race at Rainbow Falls (DoC 2011)

vegetation growth in the sides causing parts to collapse. Regular maintenance spraying can act as a preventative.

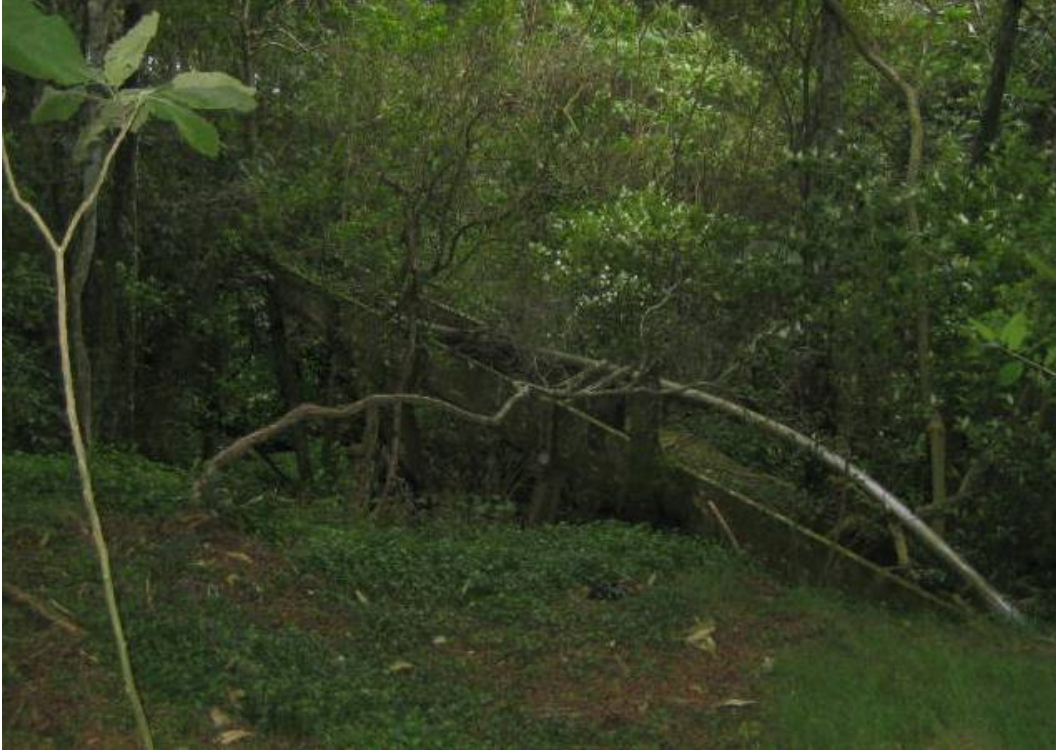
This is built on cross posts that are bolted and concreted into the ground surface and is quite stable. However the open square flume is deteriorating.

Figure 9: The totara aqueduct that reconnects the race over the gully (DoC 2011)

- Photo point monitoring of the wooden aqueduct on Blue Marlin Drive.
- Replacement of the interpretation images at Rainbow Falls which are now faded and discoloured.
- Rust treatment is required immediately on the turbine and generator. Additionally the transformers need to be treated.
- Graffiti removal from the concrete foundations of the power house.
- Monitoring and maintenance spraying of vegetation along the water race to prevent collapse of the sides. This is important to do while the vegetation is still small creating more efficient management over the long term.

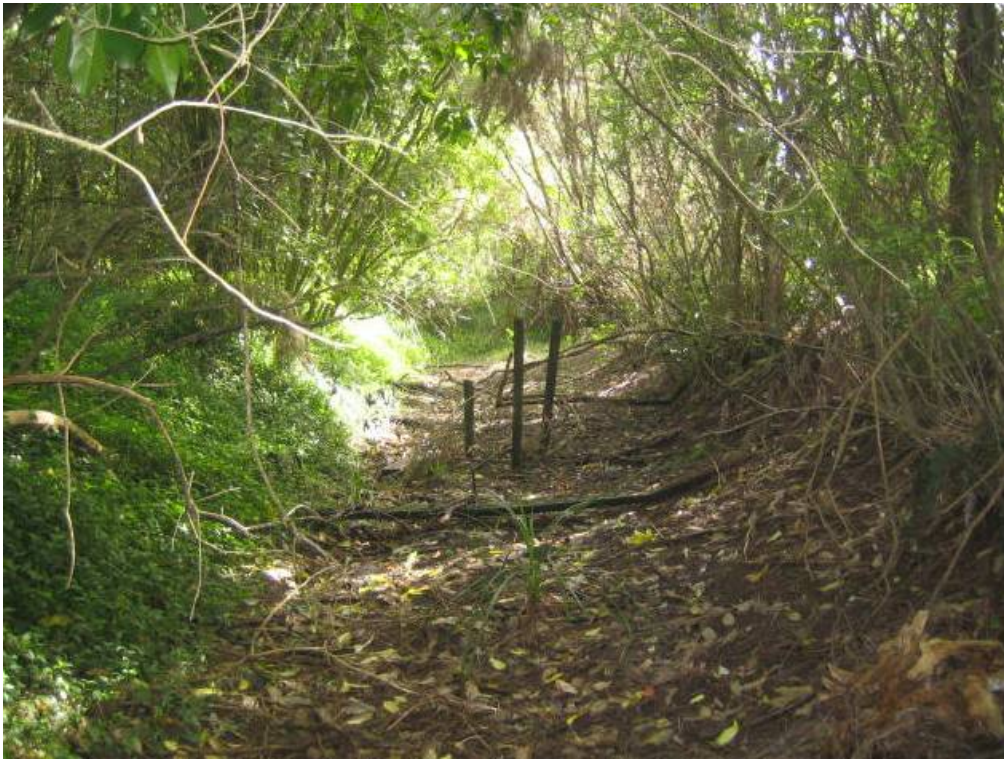
The wildlife station is closed and reportedly in 1992-93 the ponds still contained water and have small gates which allow drainage into the race. On a visit in 2011 visit these ponds were dry and the small gates described were not relocated. It is suggested that one or more of these ponds is likely to have been the earth dam that fed water to the head-gate.

Figure 10: Earth dam. Taken from the headgate forebay that narrows down into the race (DoC 2011)

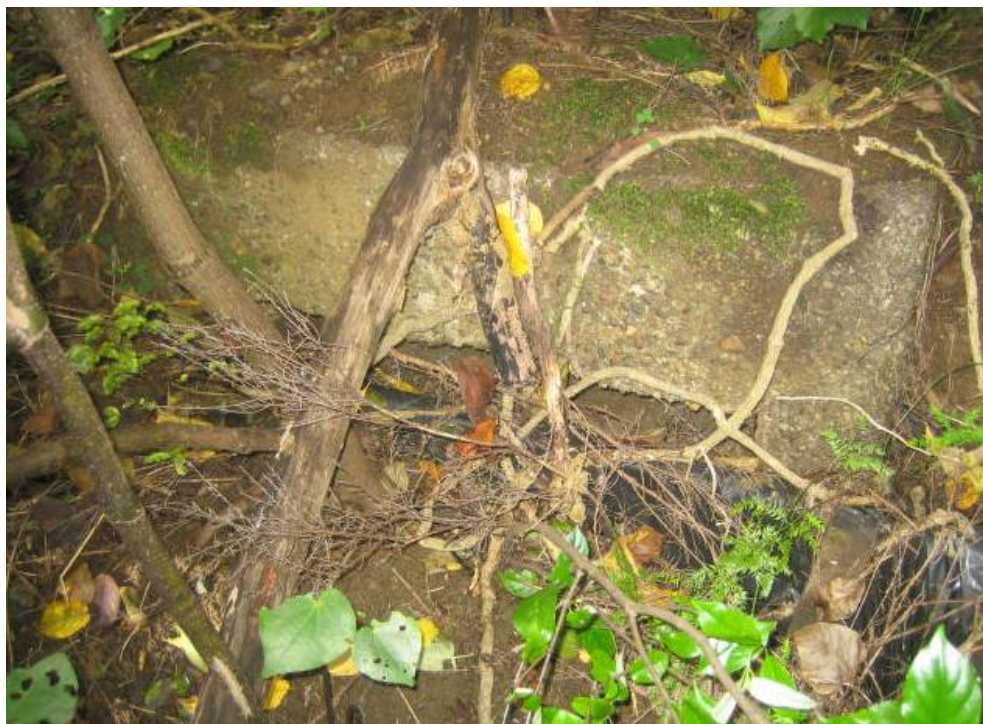
Water was fed from the race which widened into the forebay and then through the 2x3m rectangular concrete head-gate located at the top of the valley wall. This was then carried down the valley side in a concrete pipe. When the head-gate was in use it contained filters and a gate to control water flow. This gate (penstock) was winched open by a steel cable operated from the powerhouse.

Figure 11: The headgate now filled in (DoC 2011).

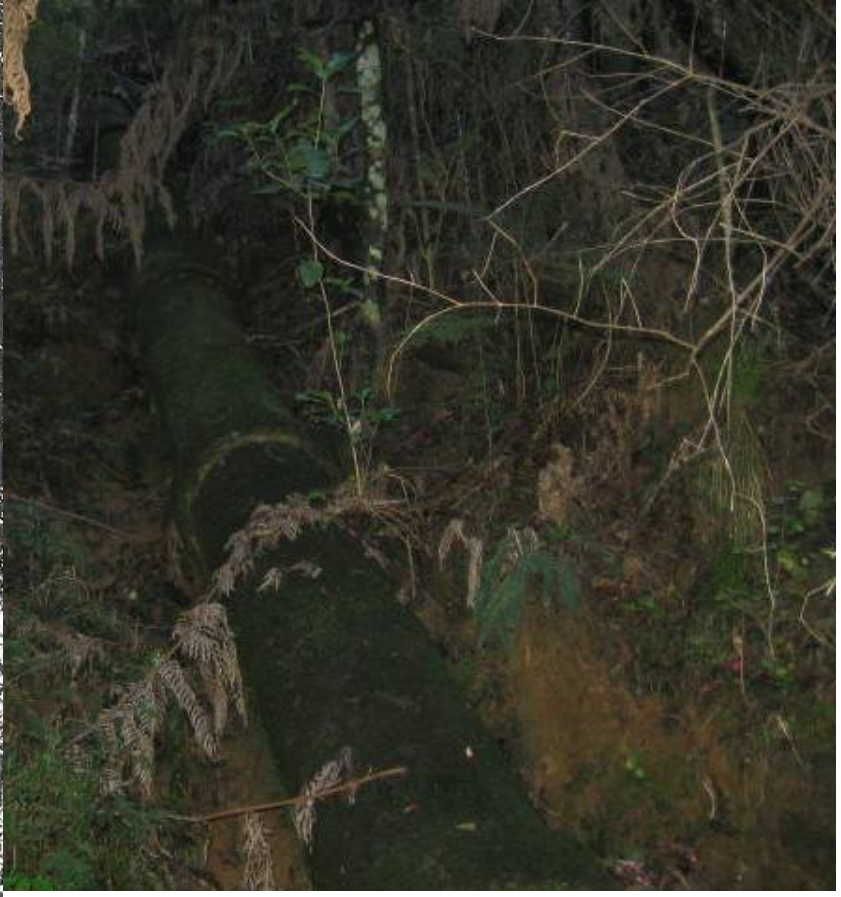
Figure 13: Part of the concrete pipes today still intact but not highly visible under vegetation (DoC 2011)

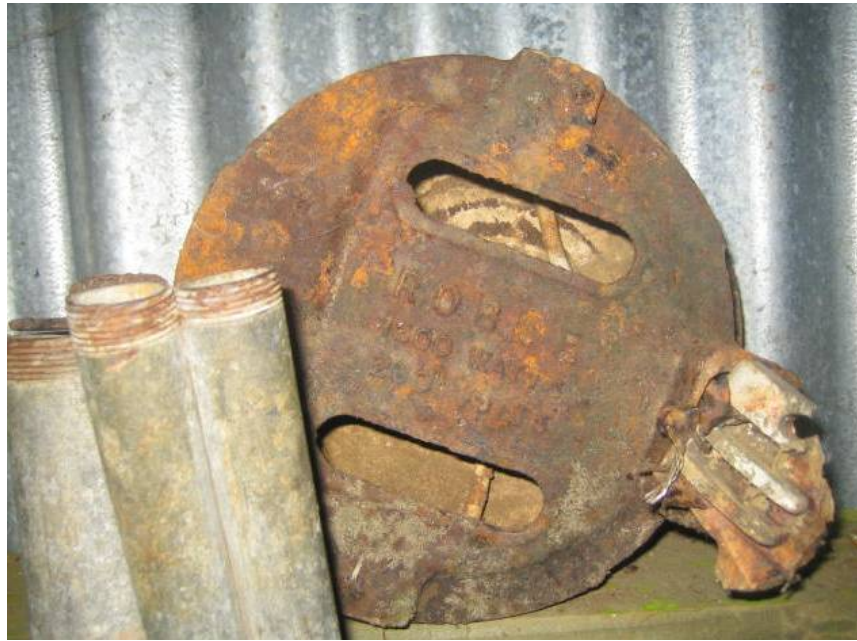
Figure 14: Part of the transformers located in the powerhouse (DoC 2011)

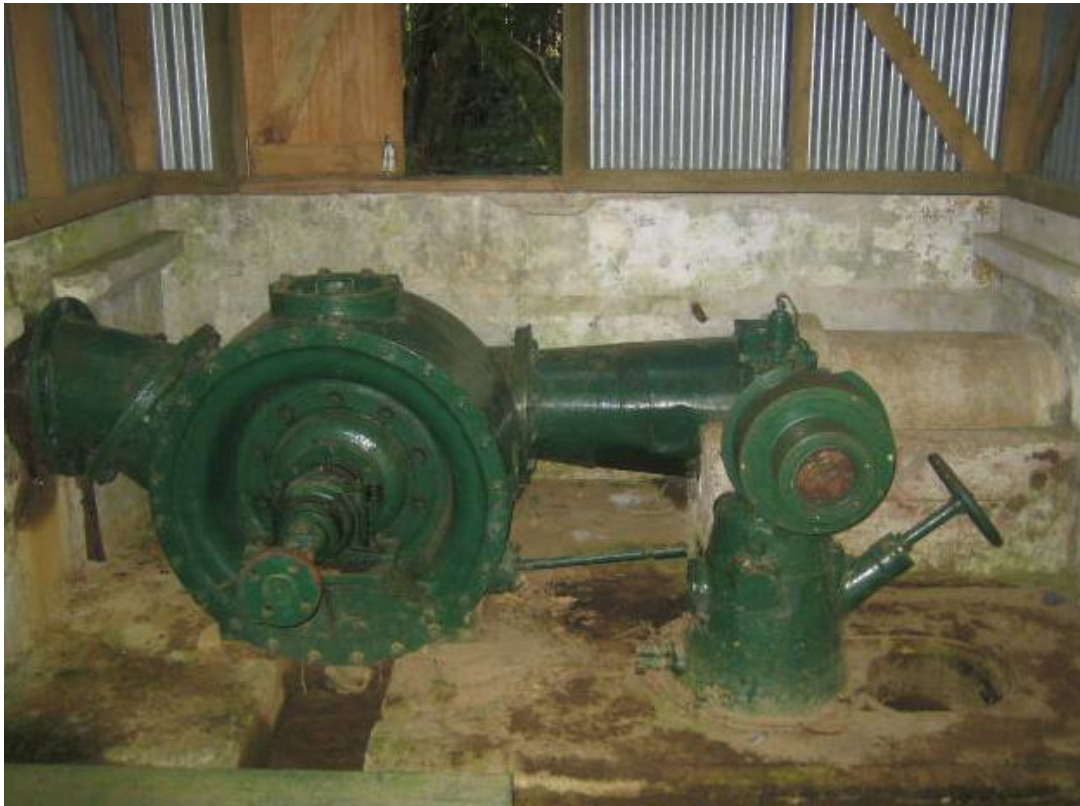
Today the machinery that remains of the powerhouse is the turbine and generator (fig 15). The turbine purchased for the hydro station was a 130 HP Francis inward-radial-flow reaction single discharge type with a cast iron spiral casing imported from overseas through Boving and Company Limited London. The following is a comment from the memoirs of Lloyd Mandeno:

Figure 15: The Francis turbine and generator in the reconstructed powerhouse (DoC 2011)
