To:	[REDACTED] (RCP)				
Copy:					
From:	[REDACTED]				
Date:	10th August 2023	BTW Job Number:	230129	Client Reference	NTVC

**Subject: North Taranaki Visitors Centre Water Resources Preliminary Design**

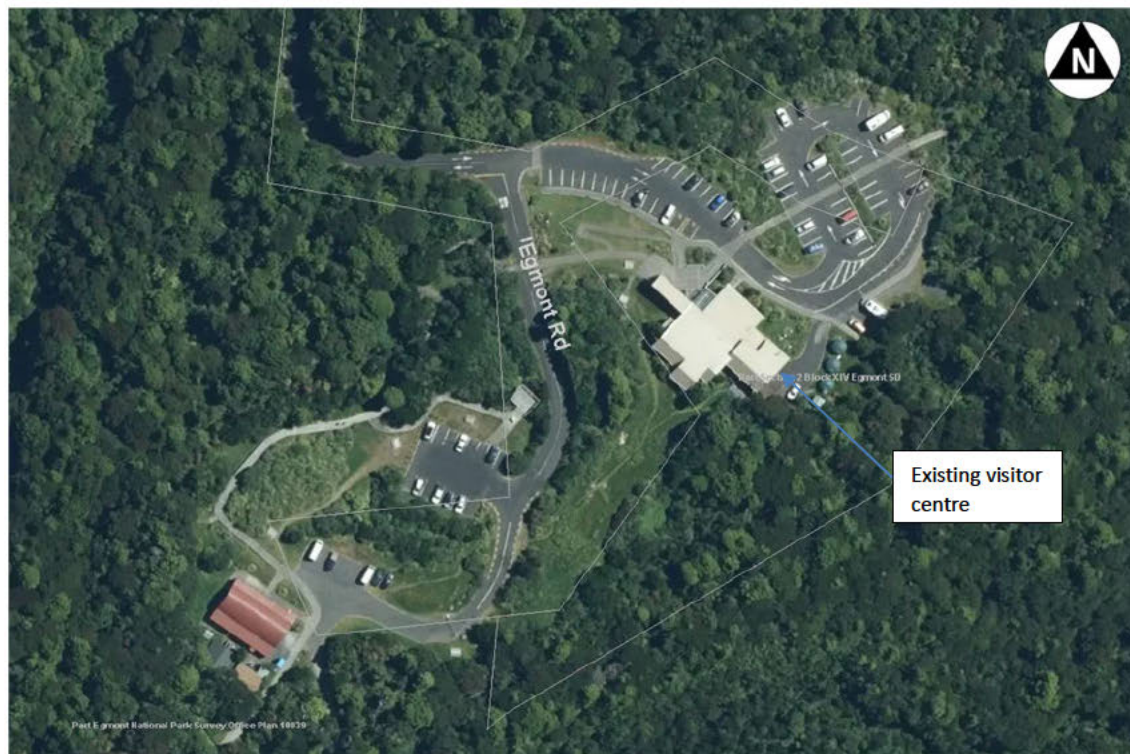
**Figure 1: Recent aerial image of existing visitor centre area and land boundaries**

The new visitor centre facilities will be located in the general vicinity of the existing visitor centre car parks and facilities, which are jointly situated on Part Egmont National Park Survey Office Plan 10039, Part Section 2 Block XIV Egmont SD, and New Plymouth District Council (NPDC) road reserve. Refer Figure 1 for an aerial image. The developed areas and clearings in this location will be hereafter referred to as 'the site'.

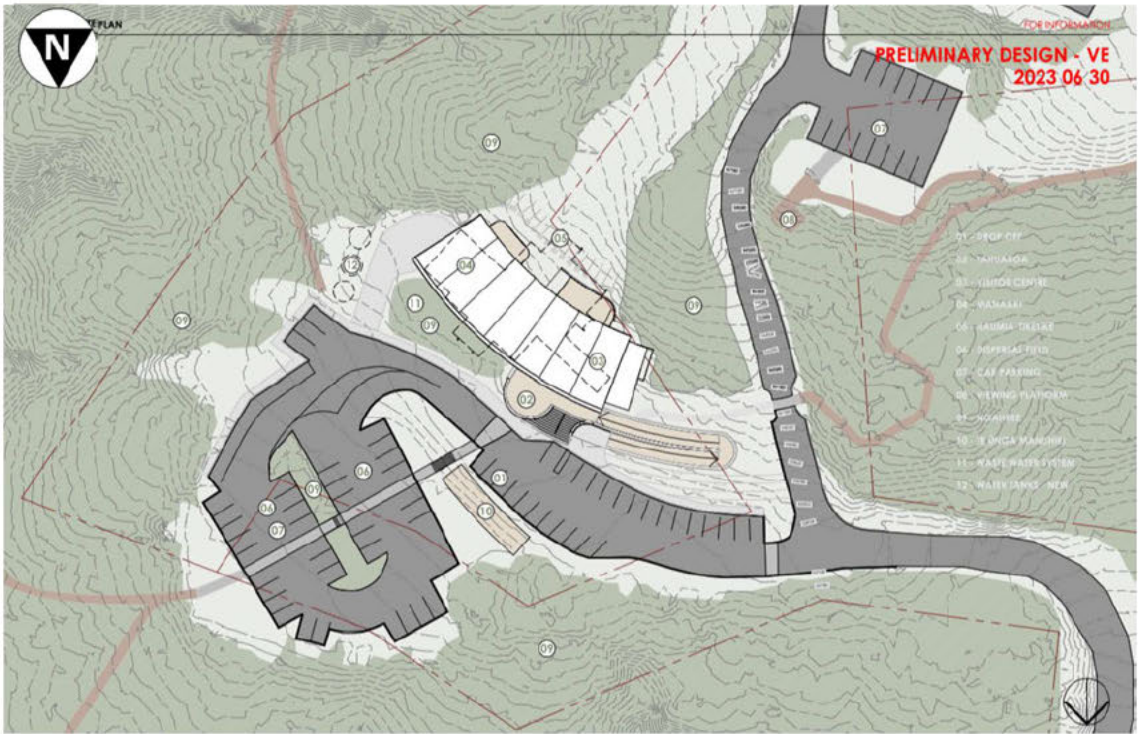
**Figure 2: Preliminary layout plan (TOA Preliminary Design Drawings - VE)**

The preliminary design drawings show a single storey building containing DoC visitor centre facilities, restrooms, a café, and a Whare Manaaki (hospitality area) situated in the approximate location of the current visitor centre. Refer Figure 2 for details.

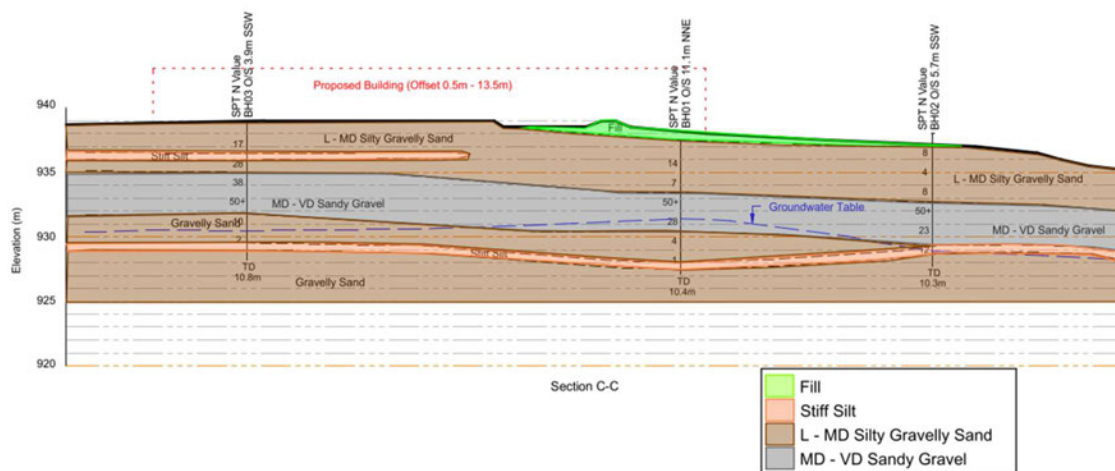
Figure 6: Geotechnical cross section, north-west to south-east (BCD GAR, 4<sup>th</sup> July 2023)

The testing confirmed the presence of the Maero Debris Flows geological unit along with uncontrolled fill material of varying depths in several locations, consistent with the observations of historical images. Refer Figure 6 for a cross-section of soils at the building platform.

Groundwater was typically encountered at depths ranging from 6 m to 9 m below existing ground level (BEGL). Groundwater was encountered at 2.4 m BEGL in a singular location although it is noted in the BCD GAR that this appear to be an outlier and is not representative of the overall site groundwater table. The groundwater table at the building is indicated in Figure 6.

In terms of Table 5.1 of AS/NZS 1547:2012 (On-Site Domestic Wastewater Management) the in-situ soil is classified as a category 2 silty sand. Further targeted investigation around the proposed wastewater dispersal field should be undertaken to confirm the soil classification and other ground constraints such as extent of historic fill, groundwater depth and underlying confining layers during detailed design.

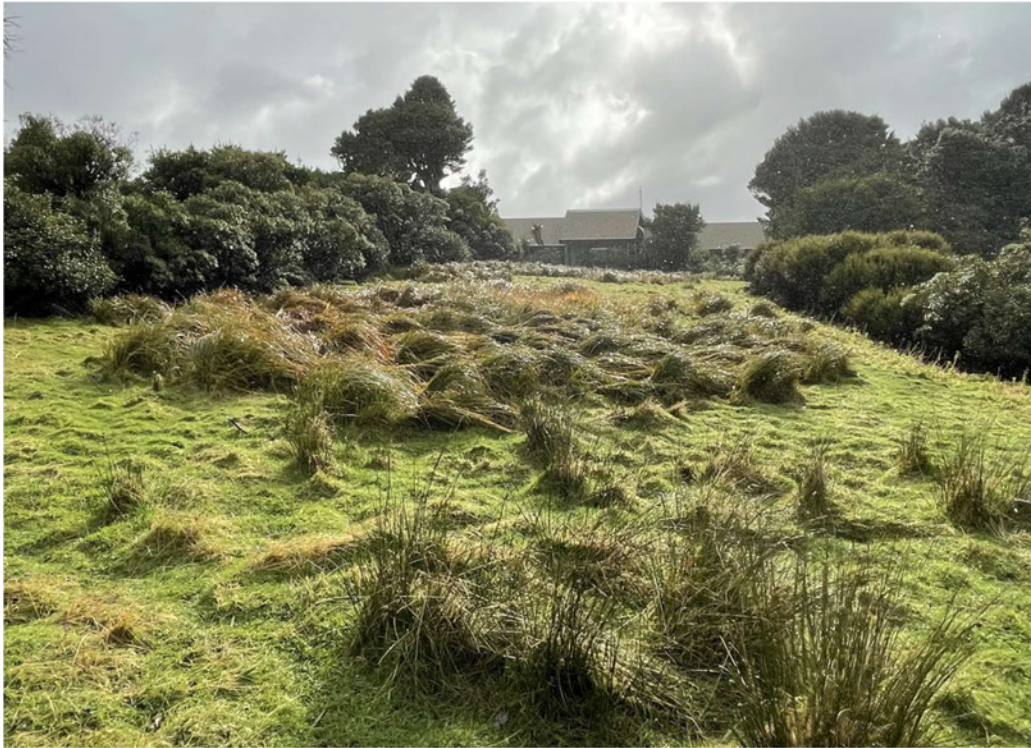
Initial consultation with DoC staff and maintenance staff indicated that the existing system has been operating without known issues. Site observations from BTW field staff observed that vegetation growth (*carex geminata*) is thriving on the surface of the existing wastewater disposal field<sup>1</sup>. These typically indicate saturated hydric soil conditions and likely surface water ponding which are generally unsuitable conditions for effective wastewater disposal. This may indicate the existing system is possibly undersized or underperforming, or stormwater may be ponding on the surface.

**Figure 8: Wetland vegetation feature in the vicinity of the existing wastewater treatment soakage trenches, upslope of the existing building.**

- The proposed visitor centre introduces new activities that will increase wastewater generation and demand on the existing infrastructure.
- Site observations from BTW field staff observed vegetation growth (*carex geminata*), indicating hydric soil conditions and likely surface water ponding which are generally unsuitable for wastewater disposal. This may indicate the existing system is possibly undersized or underperforming, or stormwater may be ponding on the surface.

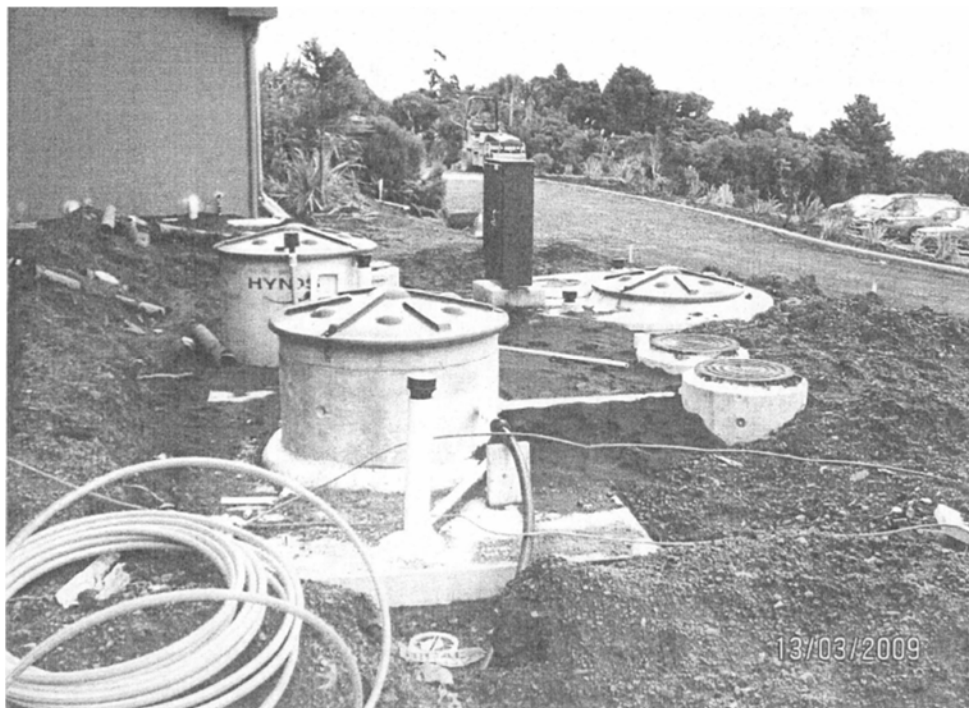
A 100 mm diameter uPVC pipe connects the Camp House sewage to the existing wastewater treatment system, which was installed circa 2009/2010. This pipe along with other existing pipelines may be able to be reused for the redevelopment upon confirmation of condition through a CCTV inspection.

**Figure 9: Hynds SAF wastewater treatment system installed in front of existing visitor centre (photo taken prior to backfill, from 2009 building consent)**

- Staff have advised that the existing Hynds SAF treatment system is a modular treatment system which could be expanded.

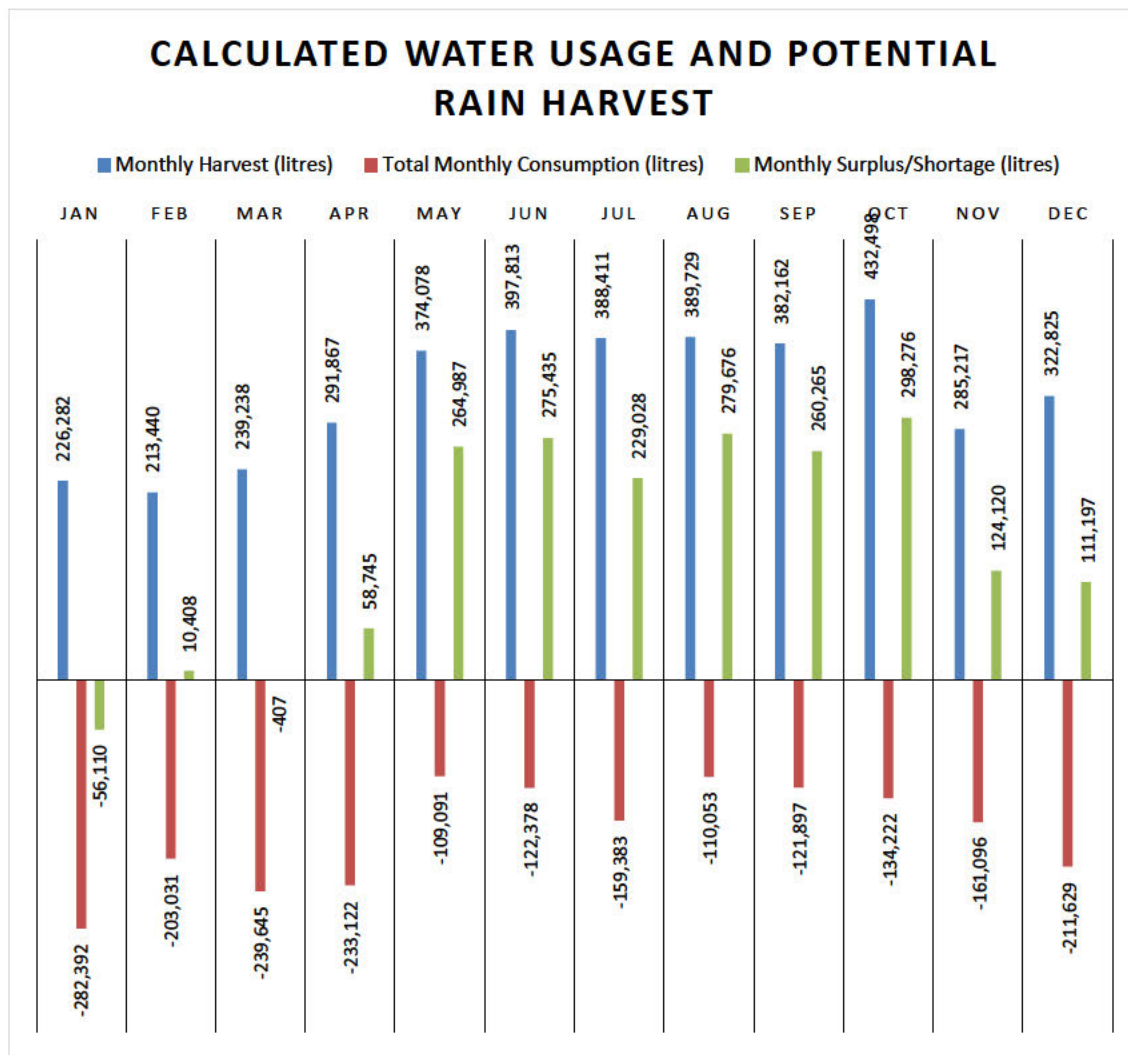
Figure 11: Calculated future water consumption and potential rain harvest and consumption

It is shown that generally throughout the wetter months the total available water supply from rainwater harvesting is significantly greater than the total monthly consumption. During drier months (January - April), water consumption is roughly equivalent and/or exceeds supply.

Additional water supply is also required to meet emergency storage requirements and accommodate the additional visitors during the drier months. A minimum 96 hours' average demand of untreated storage is recommended by Taumata Arowai within their Drinking Water Acceptable Solution for Roof Water Supplies.

The water balance results presented utilise historical rainfall records and existing visitor centre numbers. The effects of climate change are expected to result in longer dry periods between rainfall events. The anticipated number of visitors and users to the visitor centre is also likely to increase. To avoid possible future water shortages, it is recommended that water reduction measures are considered within the detailed design.

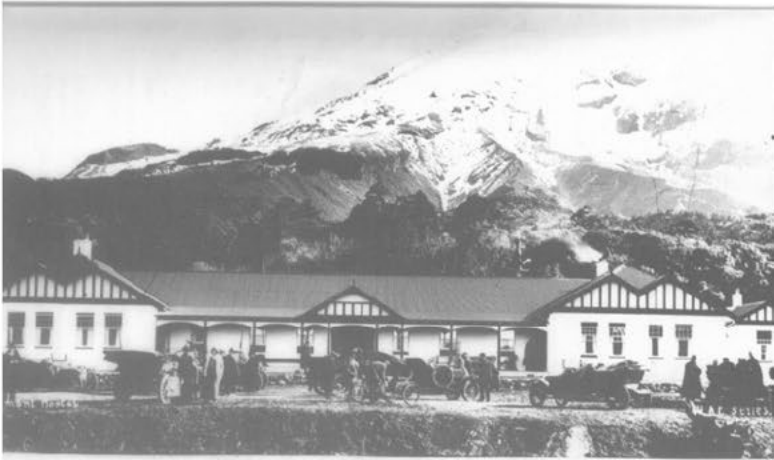
<p style="text-align: center;">NORTH EGMONT CHALET 1912</p>

Date, Source	Description	Image
<p>Scanlan, A.B. 1980 "History in place names." In: Egmont National Park Handbook, pp. 14-15</p> <p>Pages supplied by RCP</p>	<p>Excerpt from book. First construction on the site occurred in 1891.</p>	<p><b>North Egmont Chalet:</b> At the 936-metre level is near the end of the road from Egmont Road. Was officially opened by the Governor, Lord Islington, in 1912. The building was enlarged and improved in 1929.</p> <p><b>Old House (North Egmont):</b> Close to North Egmont Chalet, was the first camphouse constructed on Mount Egmont, being officially opened on 28 January, 1892. It was built of material from the military barracks erected on Marsland Hill, New Plymouth, in 1855, and sledged to the site in 1891.</p>
<p>1912 Provided by RCP</p>	<p>Photo of historic chalet on lower carpark. Large amount of vegetation clearance apparent.</p>

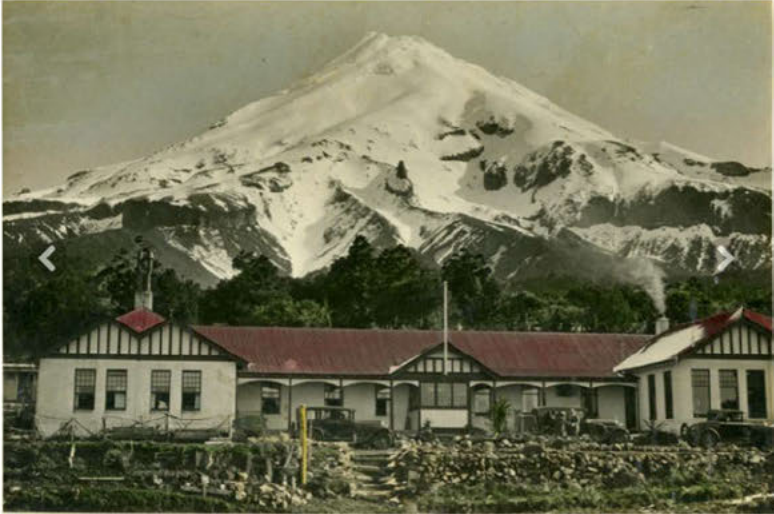
<p>1930s Puke Ariki</p>	<p>Historic chalet still present.</p> <p>Minor building additions, steps appear to have been added between the upper and lower areas.</p>

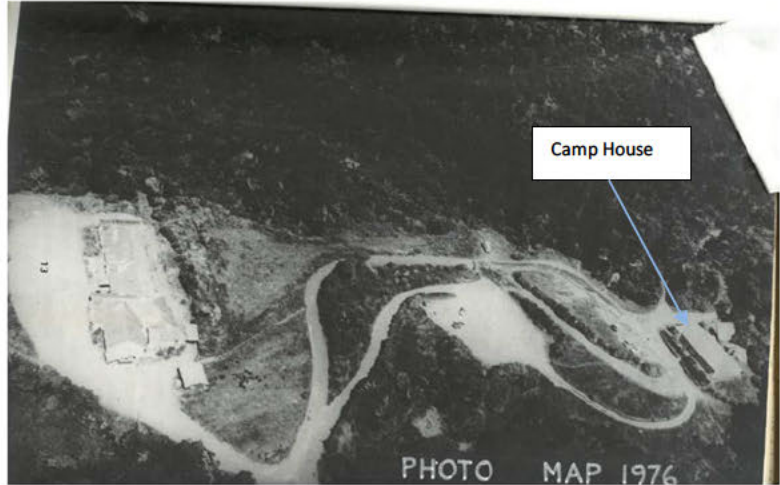
<p><a href="https://files.interpret.co.nz/Retrolens/Imagery/SN1889/Crown_1889_5074_7/med.jpg">https://files.interpret.co.nz/Retrolens/Imagery/SN1889/Crown_1889_5074_7/med.jpg</a></p>
<p>1976 Supplied by RCP</p>	<p>Approximate current clearing visible.</p> <p>Additional roadways to upper carpark and historic chalet present.</p>

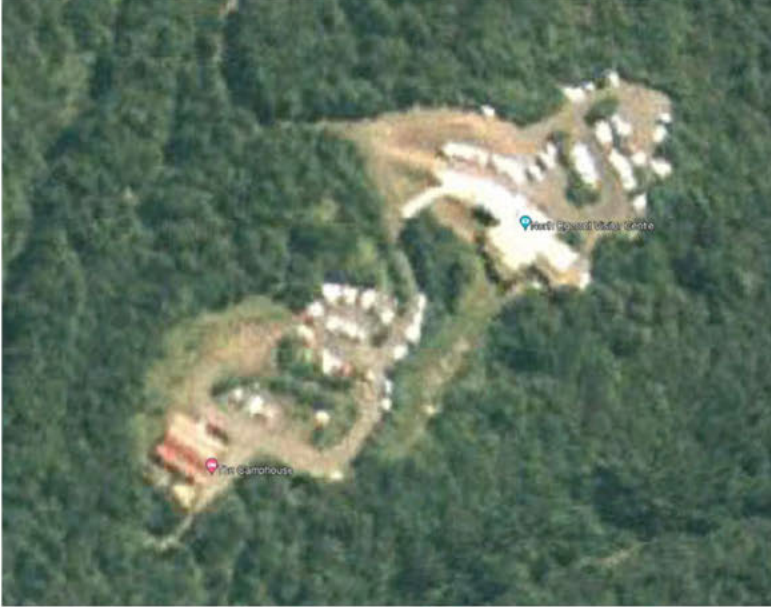
<p><a href="https://files.interpret.co.nz/Retrolens/Imagery/SN8003/Crown_8003_E_1/Med.jpg">https://files.interpret.co.nz/Retrolens/Imagery/SN8003/Crown_8003_E_1/Med.jpg</a></p>
<p>01/04/2001 Google Earth Pro</p>	<p>Existing visitor centre building shown, footprint larger than present-day</p> <p>Possible earthworks/vegetation removal being undertaken in lower carpark area?</p>

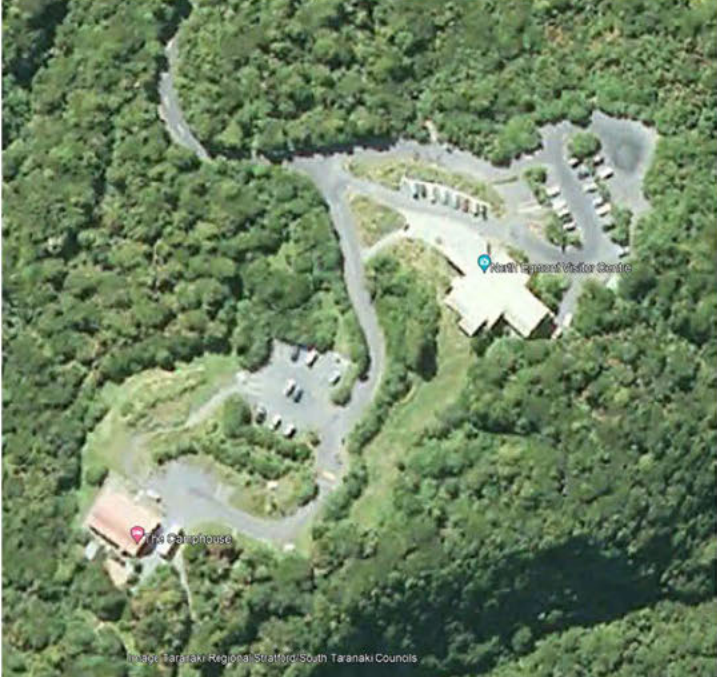
<p>09/02/2005 Google Earth Pro</p>	<p>Similar to 2007</p>

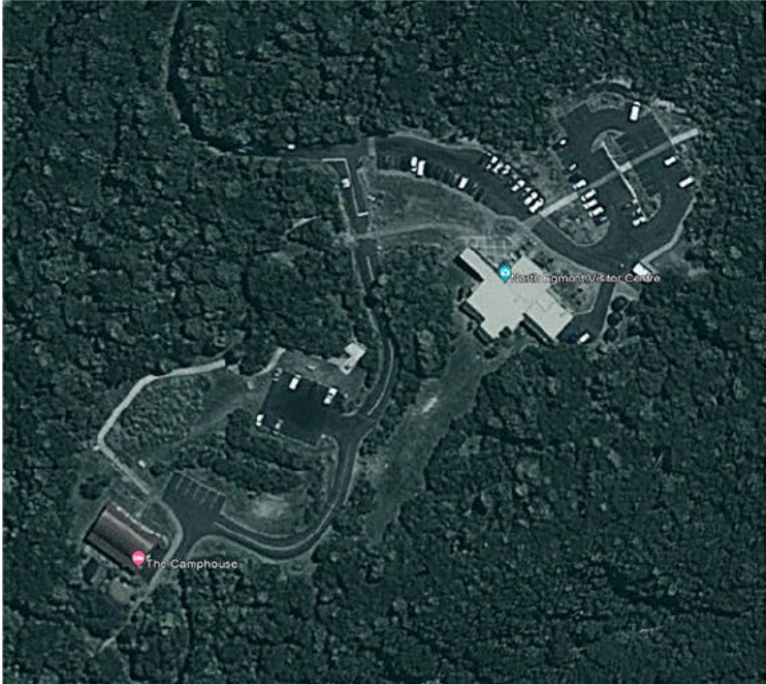
Date, Source	Description	Image
08/03/2012 Google Earth Pro	First aerial image of present-day layout.

An aerial satellite image of a campus, likely taken in 2012. The image shows a large, irregularly shaped building complex situated on a hillside. A prominent feature is a large, multi-level parking area with several rows of cars. The surrounding area is densely wooded. Labels for 'The Camphouse' and 'State of Missouri Visitor Centre' are visible on the image.
09/03/2018 Google Earth Pro	Aerial image showing significant amount of illegal parking within lower carpark (circled in red)	  An aerial satellite image of the same campus, taken in 2018. This image shows a significant increase in the number of cars parked in the lower carpark area. Several areas of illegal parking are highlighted with red circles. The labels for 'The Camphouse' and 'State of Missouri Visitor Centre' are still present. A copyright notice 'Image © 2018, CNES / Airbus' is visible at the bottom of the image.
