19 April 2022

LICENCE/LEASE CONCESSION OLD TAUPŌ NURSERY – TE PAE O WAIMIHIA

On 15 May 2019 [REDACTED] from Cheal Consultants Ltd, accompanied by Anita Porima, conducted a site inspection of two (2) houses at 153 Centennial Drive, Taupo (formally known as The Native Plant Nursery) to assess their structural integrity and note any structural items requiring further assessment or remediation. It should be noted that **no major structural issues were noted for either structure**. The inspection and assessment also picked up obvious non-structural issues which require some attention. As such, a further assessment by an architect is not deemed to be required at this time. However, a general inspection by a qualified builder/electrician, if not completed already, would be recommended to determine any potential code of compliance issues which are beyond Cheal's scope (fire protection, power circuitry/RCDs, plumbing, wood fire compliance, etc.). In addition, Cheal has not attempted to determine the presence of asbestos within either structure as this will be assessed by others.

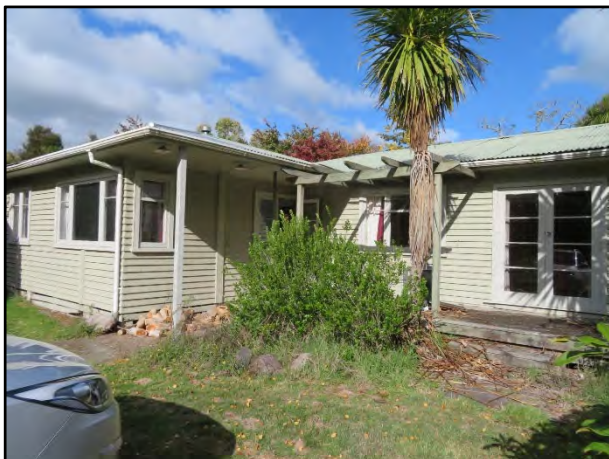
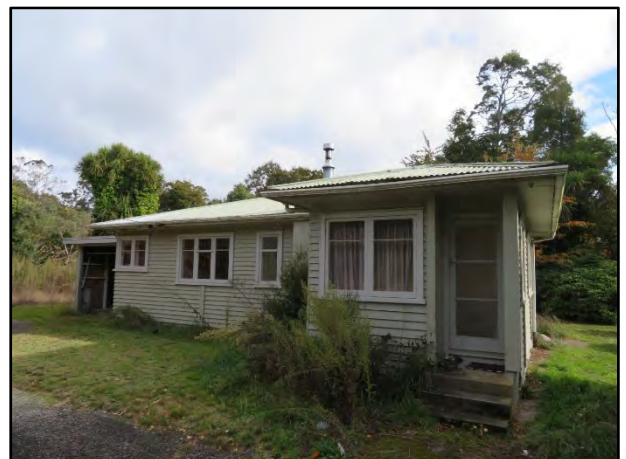
1. Sub-floor structure consists of timber bearers and joists supported on concrete piles. Some decay was note on the external base boards.

- Replace decayed external base boards
- Paint back of garage (external)
- Roof/Ceiling
 - Repair soffit lining where required
 - Re-fix roofing where required
 - Re-position ceiling insulation as required
 - Note – though not immediately imminent, roofing iron probably in need of replacement/maintenance in relatively near future (2-3 years)
- Repair/replace guttering and downpipes as required
- Repair minor damaged areas of internal wall lining
- Repair water damaged area of ceiling lining (porch and lounge)
- Replace timber decking and assess deck framing
- Wood fire to be assessed by specialist.

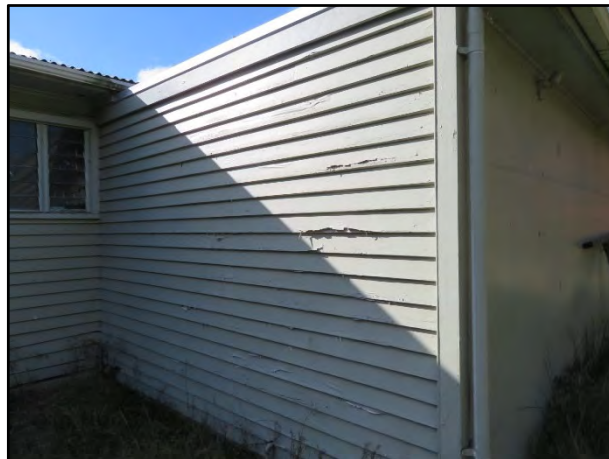
2. Walls consist of timber studs with weather board cladding on exterior. Paint on back of garage is peeling and requires painting.

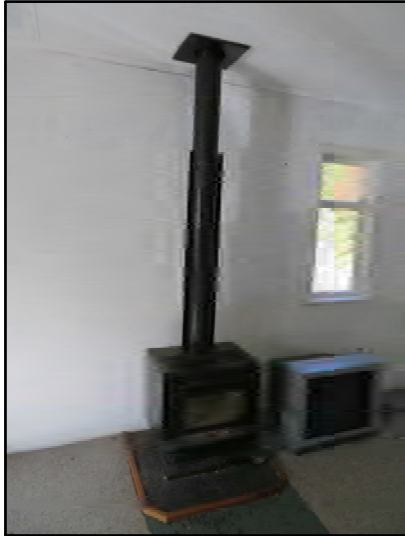
8. There is an enclosed wood burner fire in the lounge with flue through the ceiling and roof cavity. This has not been assessed by Cheal as this requires assessment by a specialist. Wood burner has been placed in front of an original open fire which has been blocked off and chimney removed, although the original concrete breast is still in place.

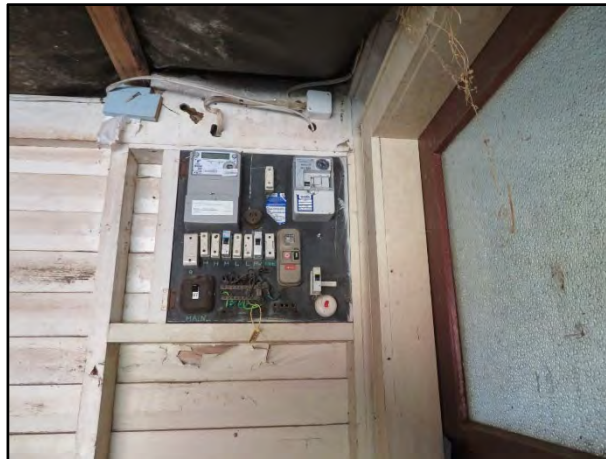
9. There is an old-style electrical switch board in the garage. This was not assessed and should be inspected by a registered electrician.

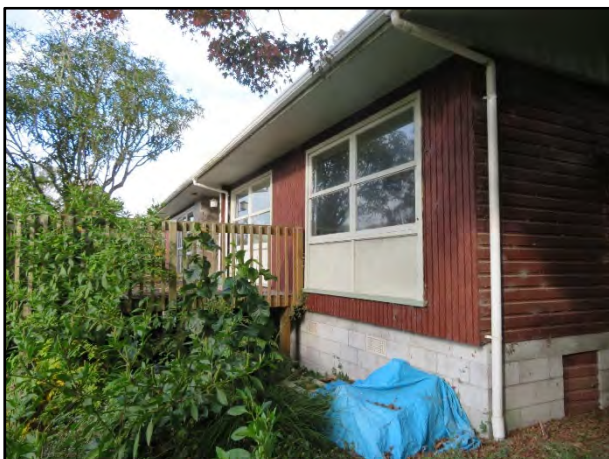
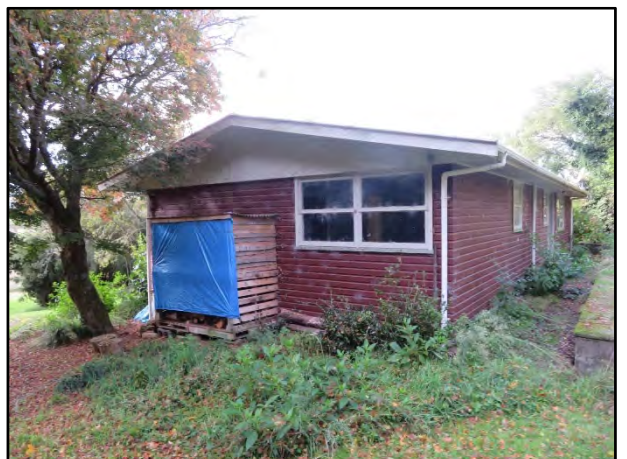
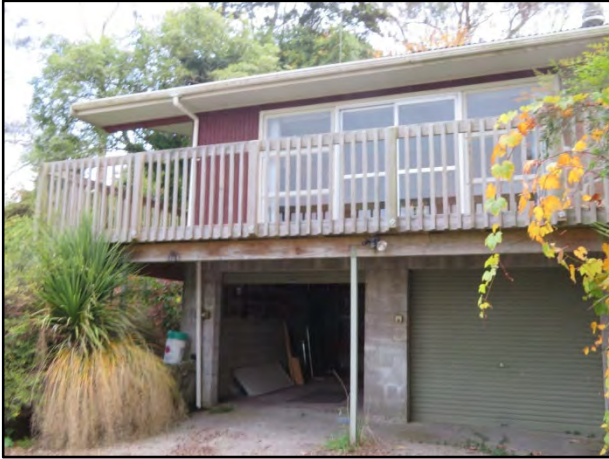
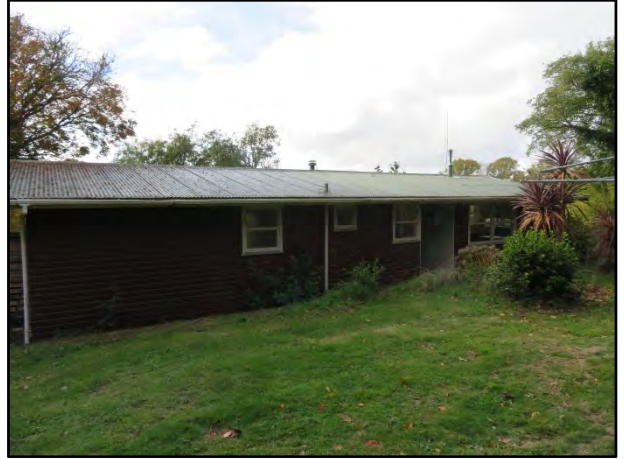
1. There is a line of effervescence along the bottom course of the block wall. A possible cause could be that the floor to wall joint is not sealed properly and rising damp has seeped through the joint. However, this is mainly cosmetic and is not considered to be a serious structural issue. It is also located in a non-living area and so does not pose a health and safety risk. If, however, you wish to pursue the problem further, we recommend seeking expert advice.

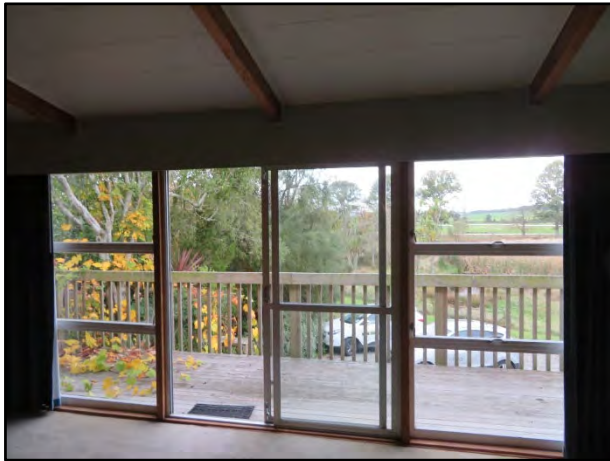
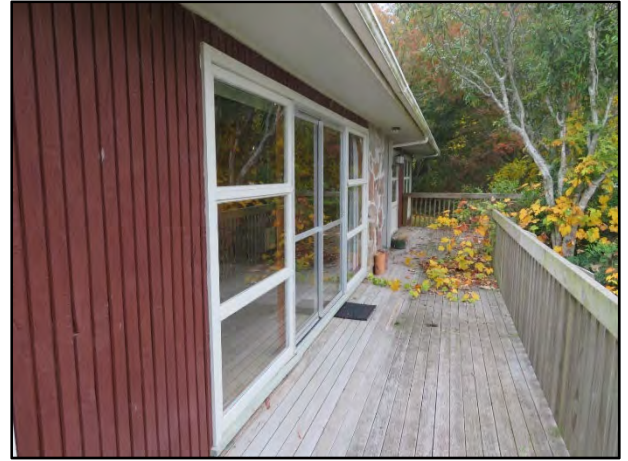
3. Exterior walls consist of timber stud framing with a mix of timber vertical board and batten cladding (possibly plywood) and timber horizontal ship lap.
4. Internal linings are a mix of plywood feature walls, gib board lining and seratone linings to the wet areas.
5. Windows and doors consist of aluminium joinery. All are in good order except for the sliding door in the lounge which is very flimsy and quite ill-fitting in the frame.

- Replace lounge sliding door
- Reposition ceiling insulation as required
- Consult exterminator for rodent infestation within ceiling
- Re-fix front edge of roofing iron
- Replace flue and flashings for fireplace (consult with a specialist for fireplaces)
- Re-fix guttering where required
- Remediate deck handrail fixings with proprietary brackets
- Install anti-slip covering on stair treads and/or trim vegetation

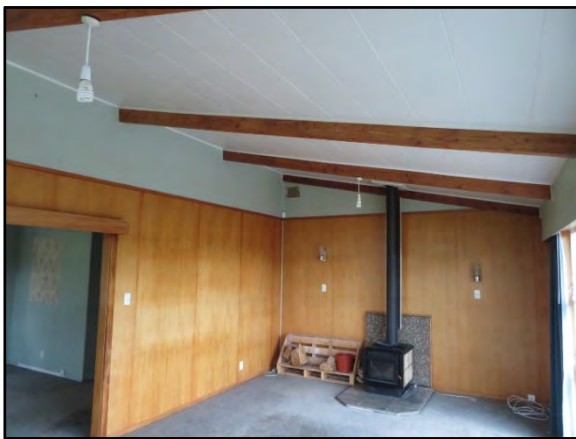
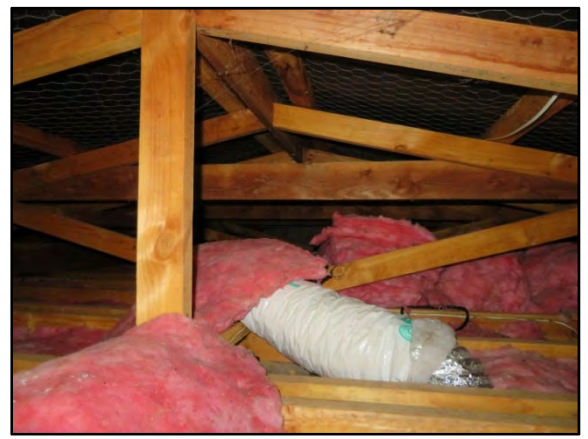
6. The roof structure over the lounge and kitchen areas is a skillion timber frame with exposed rafters and lined with Pinex soft board ceiling (no ceiling cavity). The remainder of the house has a close-coupled timber roof supported on under purlins. All structure appears sound.

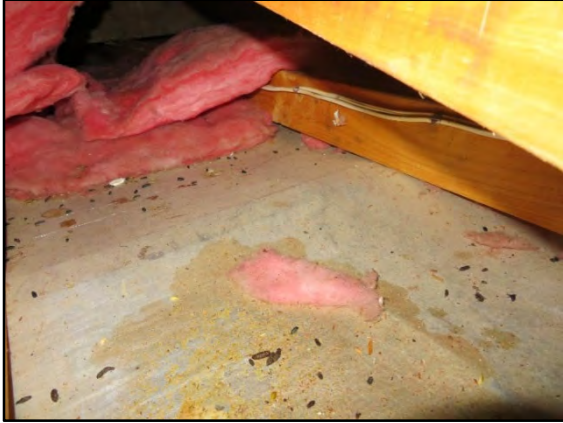
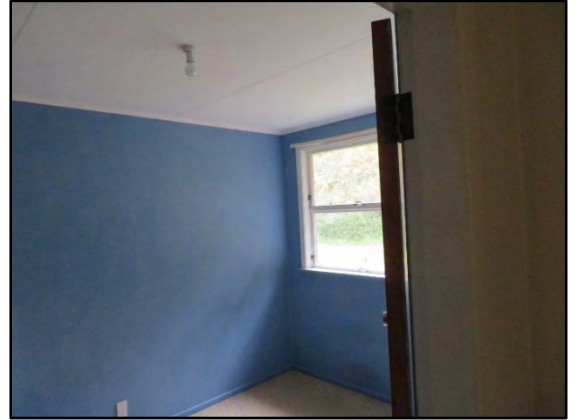
7. The ceiling is clad with a mix of softboard tiles to the skillion roof and soft board flat sheets to the remaining areas. It is insulated with pink batts which need to be repositioned to cover the exposed ceiling material. There is also a heat transfer system fitted in the ceiling cavity. Evidence of rodent infestation was noted within ceiling.

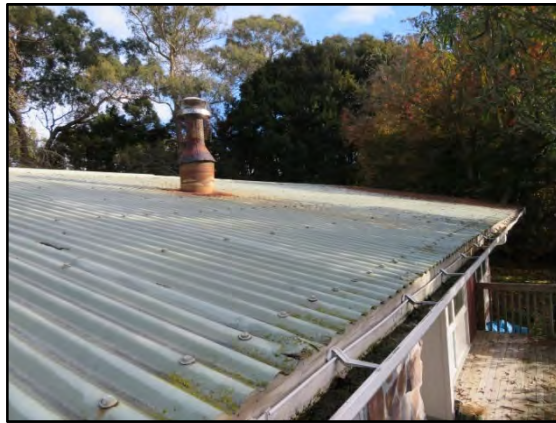
8. Roof cladding consists of corrugated iron on building paper. This needs to be re-nailed along the front edge to secure against driving rain. The flashings and flue for the fireplace are badly rusted and need to be replaced. Guttering is insecure in places and requires re fixing.

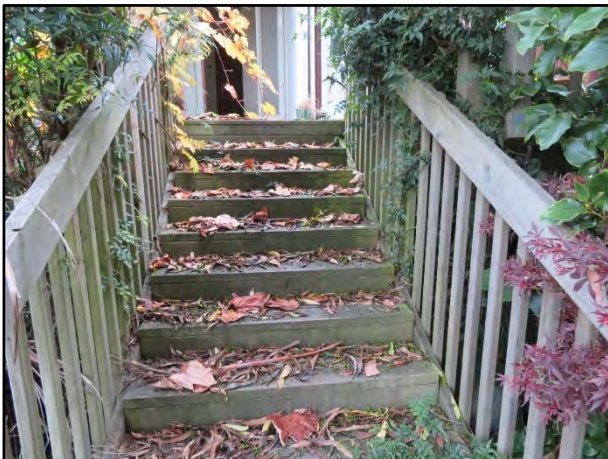
9. The timber deck joists are fixed to stringers on house wall and steel support posts along exterior edge, with galvanised joist hangers. These all appear sound and adequate. However, the handrail is inadequately fixed and has noticeable movement. This requires remediation and the fitting of propriety fixing brackets to the underside of the deck at handrail stanchions.
10. Entrance steps are supported on stringers and are shaded by shrubbery along the sides causing the treads to remain damp and hence slippery. Installing an anti-slip covering on the treads will alleviate this concern. Some trimming of vegetation would also assist in keeping treads dry.

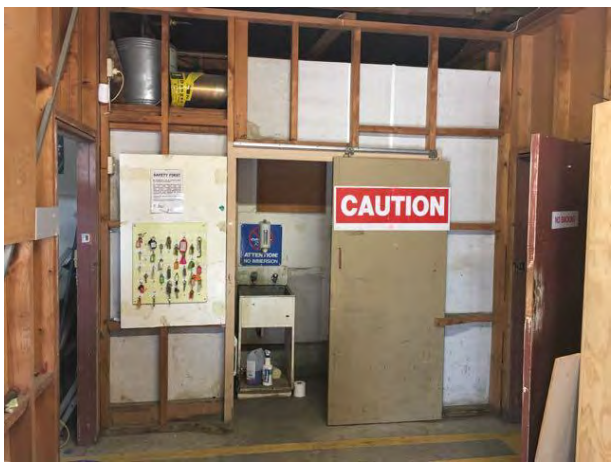
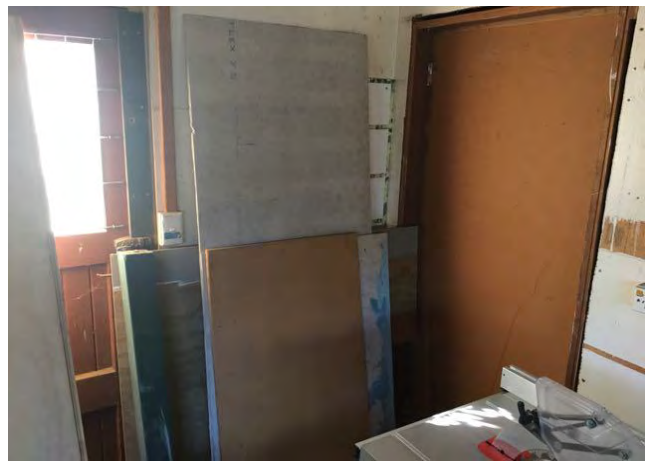
Building:	155 Centennial Drive, Taupo	Floor:	Ground Floor
Location ID:	002	Location:	Workshop
Sample Number	S004	Approx Extent	15 m ²
Item / Position	Toilet wall linings/loose boards	Material:	Cement Product

Product Type	N/A	N/A	Condition	N/A	N/A
Surface Treatment	N/A	N/A	Asbestos Type	NAD	N/A
Material Score	N/A			Risk	N/A

Recommendation:	No action required
Comments:

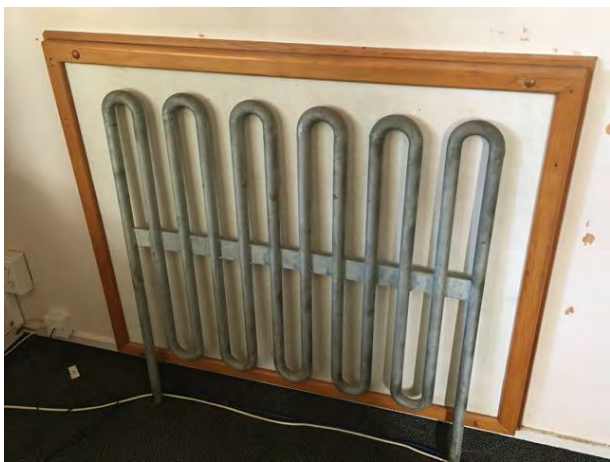
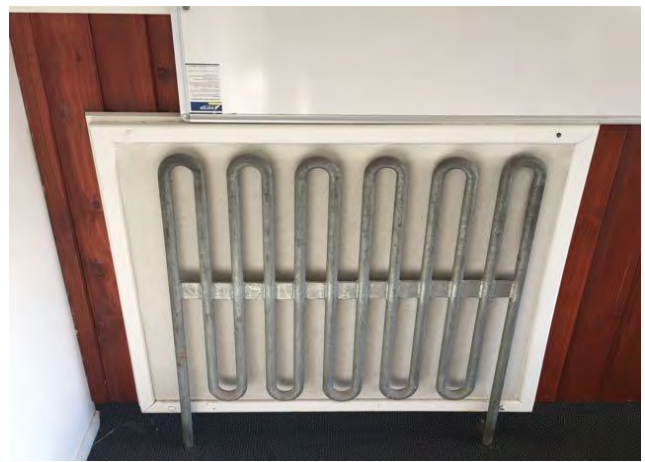
Product Type	Asbestos reinforced composites etc.	1	Condition	Low damage	1
Surface Treatment	Sealed	1	Asbestos Type	Amosite	2
Material Score	5		Risk	Low

Occupant Activity	Main Type of Activity	1	1	Likelihood of Disturbance	Location	2	2
	Secondary Activities	1			Accessibility	1	
				Extent/amount	1		
Human Exposure Potential	No of Occupants	1	2	Maintenance Activity	Type	0	1
	Frequency of Use	3			Frequency	1	
	Average time in Use	1					
Priority Score	6		Risk	Low

RISK ASSESSMENT

11 / 24

Recommendation: Label and maintain

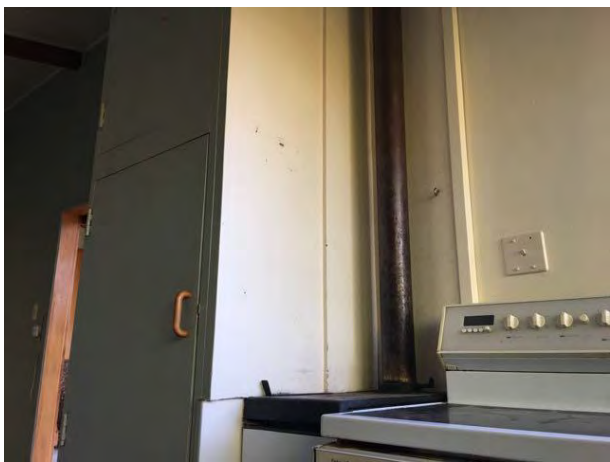
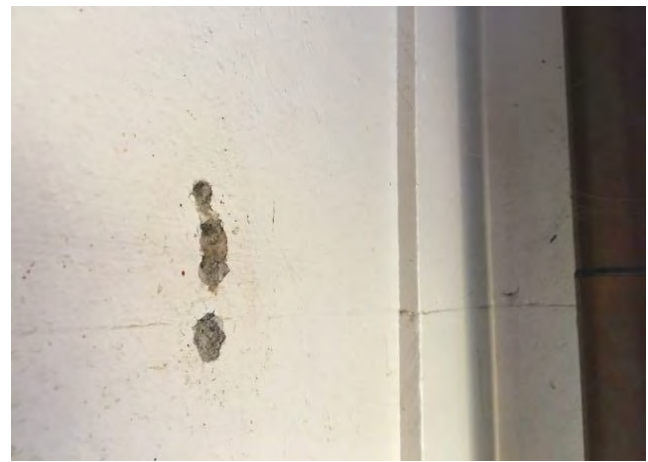
Product Type	N/A	N/A	Condition	N/A	N/A
Surface Treatment	N/A	N/A	Asbestos Type	NAD	N/A
Material Score	N/A			Risk	N/A

RISK ASSESSMENT	N/A	N/A
------------------------	-----	-----

Recommendation:	No action required
Comments:

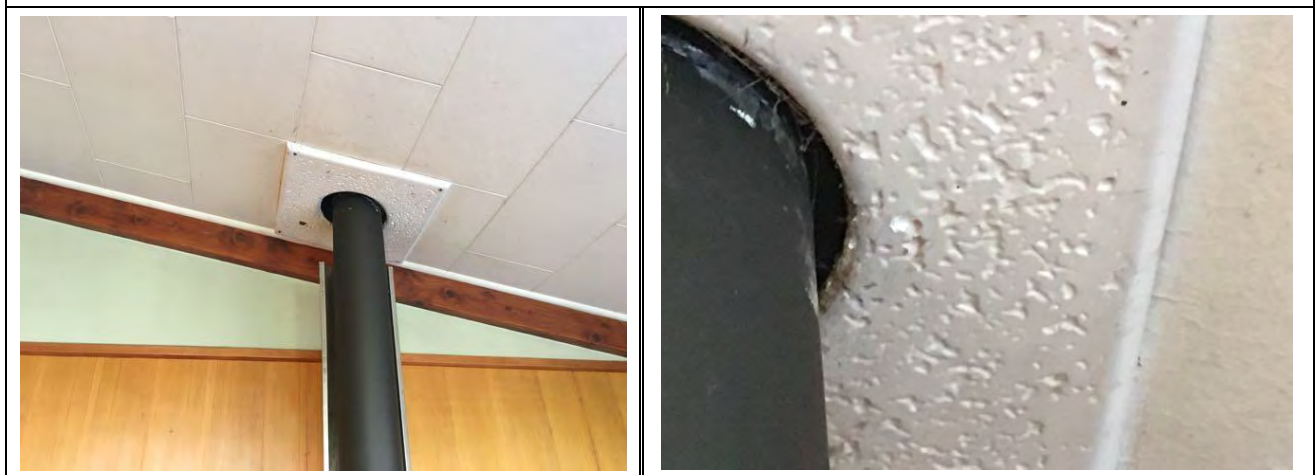
Product Type	N/A	N/A	Condition	N/A	N/A
Surface Treatment	N/A	N/A	Asbestos Type	NAD	N/A
Material Score	N/A		Risk	N/A

RISK ASSESSMENT	N/A	N/A
------------------------	-----	-----

Recommendation:	No action required
Comments:

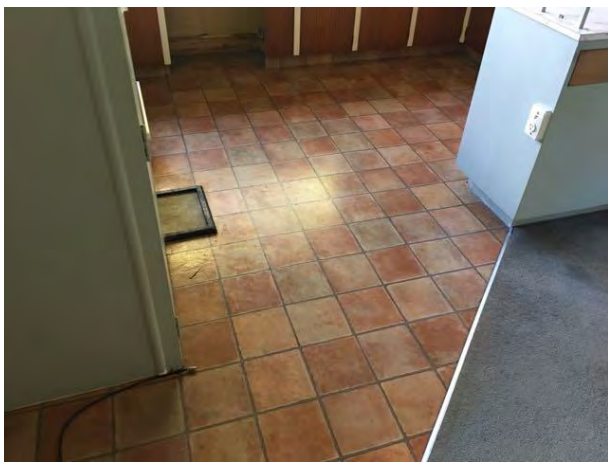
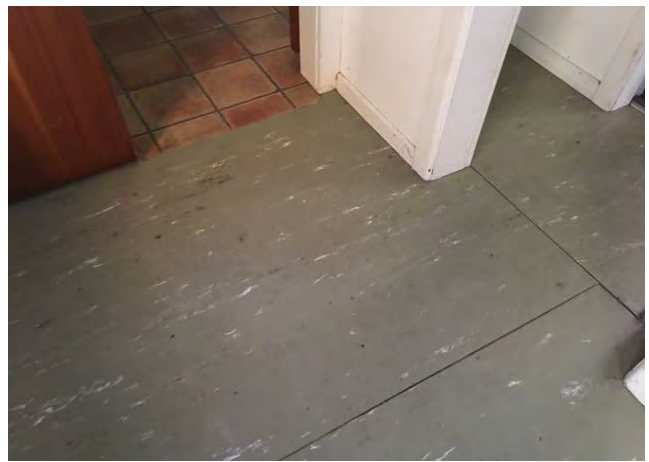
Product Type	N/A	N/A	Condition	N/A	N/A
Surface Treatment	N/A	N/A	Asbestos Type	NAD	N/A
Material Score	N/A			Risk	N/A

RISK ASSESSMENT	N/A	N/A
------------------------	-----	-----

Recommendation:	No action required
Comments:

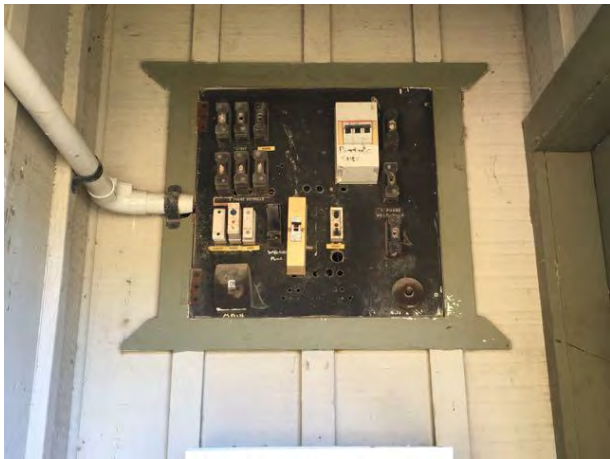
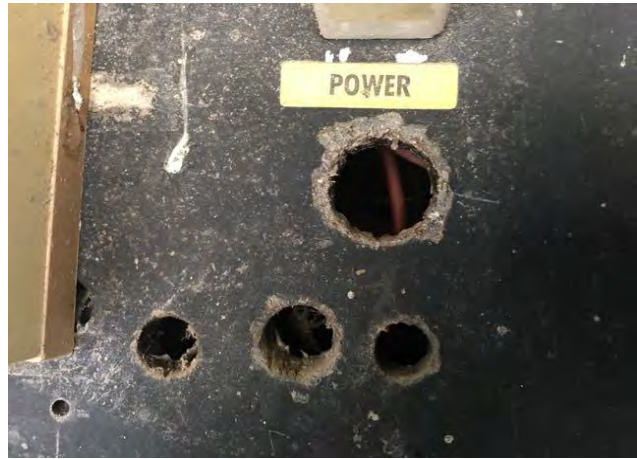
Product Type	Asbestos reinforced composites etc.	1	Condition	Low damage	1
Surface Treatment	Self-Sealed	0	Asbestos Type	Crocidolite	3
Material Score	5		Risk	Low

Occupant Activity	Main Type of Activity	0	0	Likelihood of Disturbance	Location	0	
	Secondary Activities	0			Accessibility	1	
Human Exposure Potential	No of Occupants	1	2	Maintenance Activity	Type	0	
	Frequency of Use	3			Frequency	1	
	Average time in Use	0					
Priority Score	4		Risk	Very Low

RISK ASSESSMENT	9 / 24	LOW
------------------------	--------	------------

Recommendation:	Do not disturb
Comments:

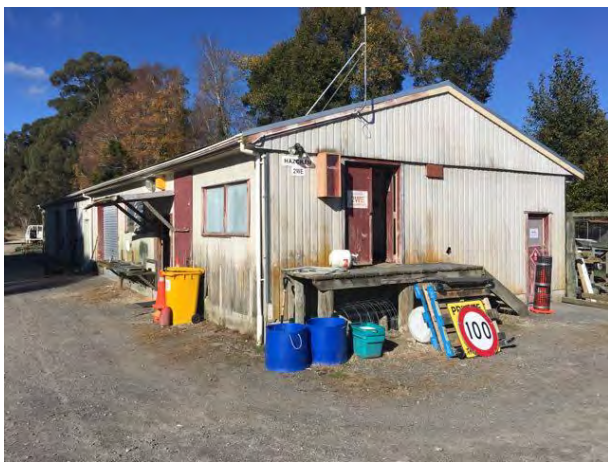
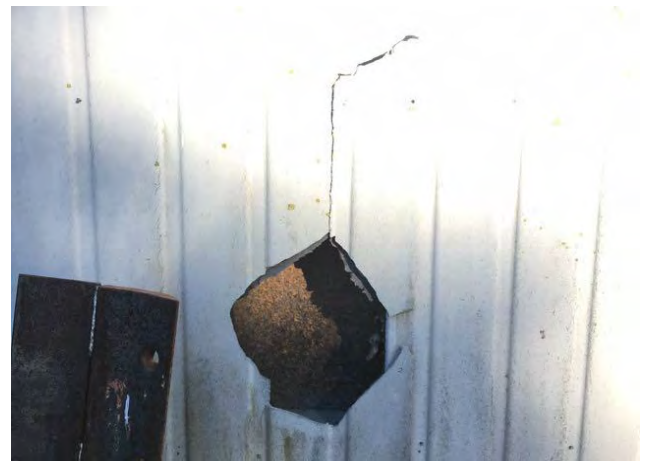
Product Type	Asbestos reinforced composites etc.	1	Condition	High damage	3
Surface Treatment	Sealed	1	Asbestos Type	Amosite	2
Material Score	7		Risk	Medium

Occupant Activity	Main Type of Activity	1	1	Likelihood of Disturbance	Location	0	2
	Secondary Activities	1			Accessibility	1	
				Extent/amount	3		
Human Exposure Potential	No of Occupants	2	3	Maintenance Activity	Type	1	1
	Frequency of Use	3			Frequency	1	
	Average time in Use	2					
Priority Score	7		Risk	Medium

RISK ASSESSMENT

14 / 24

Recommendation: Repair and seal

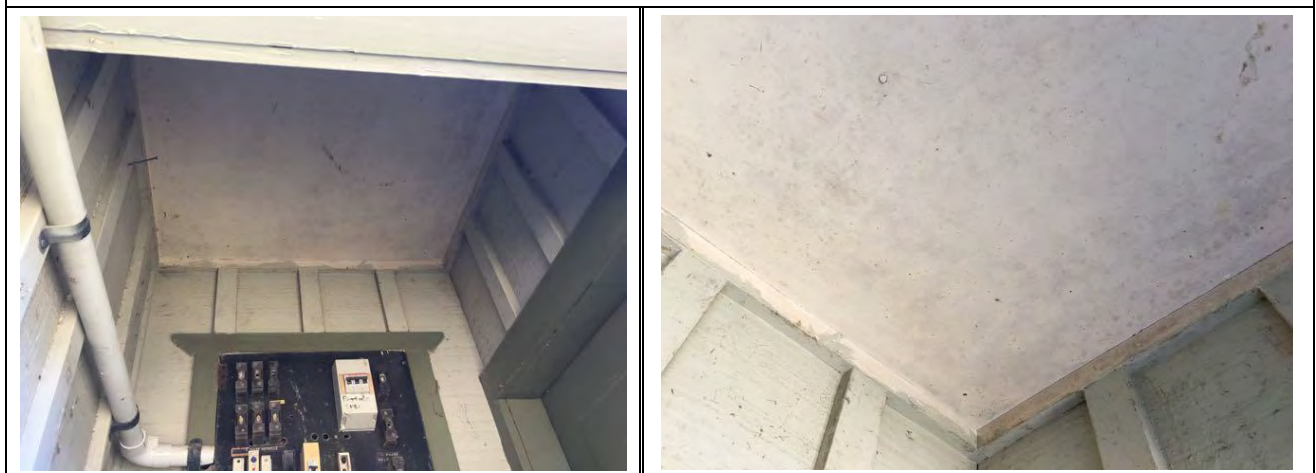
Product Type	Asbestos reinforced composites etc.	1	Condition	Low damage	1
Surface Treatment	Sealed	1	Asbestos Type	Amosite	2
Material Score	5		Risk	Low

Occupant Activity	Main Type of Activity	0	0	Likelihood of Disturbance	Location	0	
	Secondary Activities	0			Accessibility	0	0
Human Exposure Potential	No of Occupants	2	2	Maintenance Activity	Type	0	
	Frequency of Use	3			Frequency	1	1
	Average time in Use	0					
Priority Score	3		Risk	Very Low

RISK ASSESSMENT
8 / 24
VERY LOW

Recommendation: Label and maintain

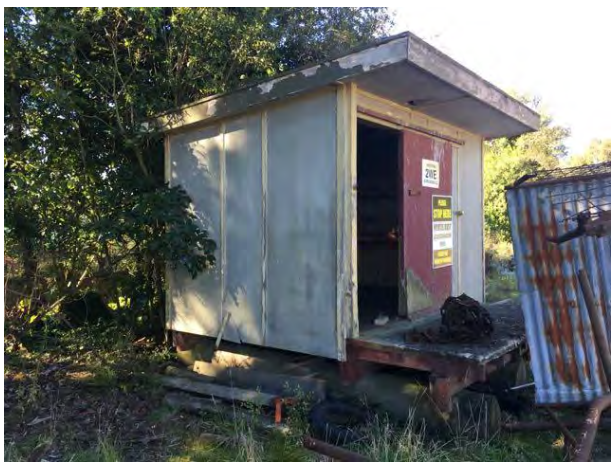
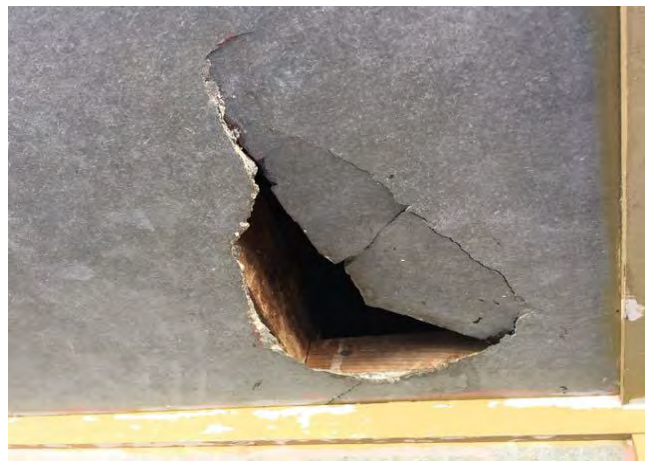
Product Type	Asbestos reinforced composites etc.	1	Condition	Medium damage	2
Surface Treatment	Sealed	1	Asbestos Type	Crocidolite	3
Material Score	7		Risk	Medium

Occupant Activity	Main Type of Activity	0	0	Likelihood of Disturbance	Location	0		
	Secondary Activities	0			Accessibility	1		1
					Extent/amount	2		
Human Exposure Potential	No of Occupants	1	1	Maintenance Activity	Type	0	1	
	Frequency of Use	2			Frequency	1		
	Average time in Use	0						
Priority Score	3		Risk	Very Low

RISK ASSESSMENT	10 / 24	LOW
------------------------	---------	------------

Recommendation:	Repair and seal
Comments:

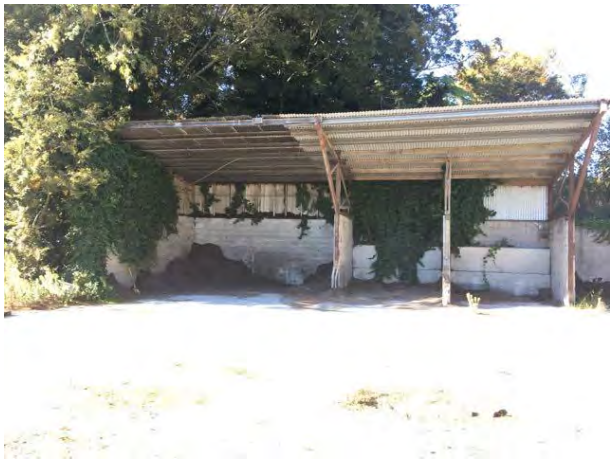
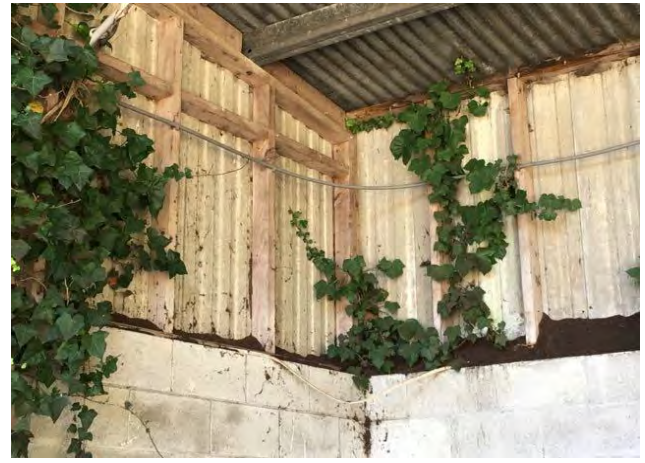
Product Type	Asbestos reinforced composites etc.	1	Condition	Low damage	1
Surface Treatment	Sealed	1	Asbestos Type	Amosite	2
Material Score	5		Risk	Low

Occupant Activity	Main Type of Activity	0	0	Likelihood of Disturbance	Location	0		
	Secondary Activities	0			Accessibility	0		1
					Extent/amount	2		
Human Exposure Potential	No of Occupants	1	1	Maintenance Activity	Type	0	1	
	Frequency of Use	2			Frequency	1		
	Average time in Use	0						
Priority Score	3			Risk	Very Low

RISK ASSESSMENT	8 / 24	VERY LOW
------------------------	--------	-----------------

Recommendation:	Label and maintain
Comments:

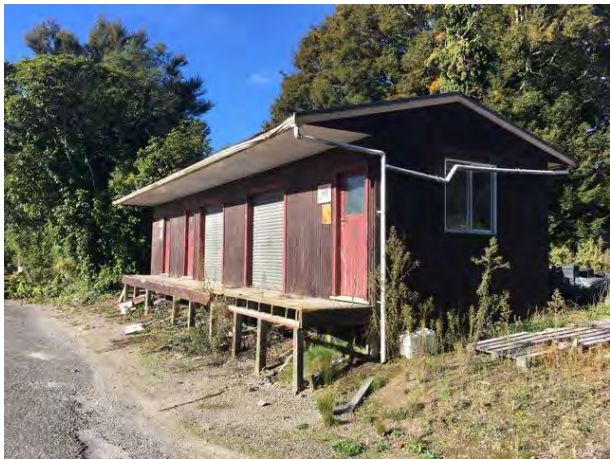
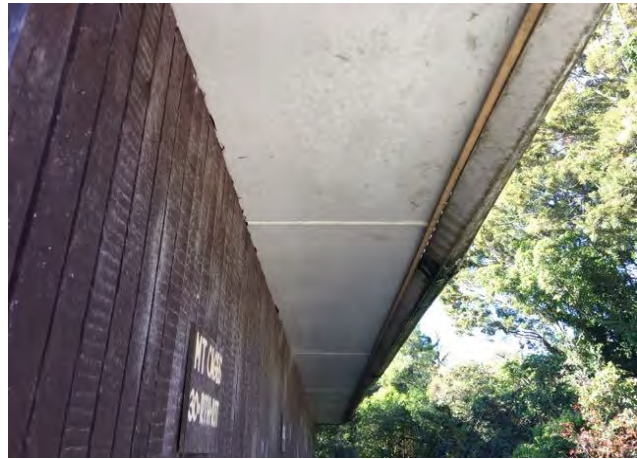
Product Type	Asbestos reinforced composites etc.	1	Condition	Low damage	1
Surface Treatment	Sealed	1	Asbestos Type	Chrysotile	1
Material Score	4		Risk	Very Low

Occupant Activity	Main Type of Activity	0	0	Likelihood of Disturbance	Location	0	
	Secondary Activities	0			Accessibility	0	1
Human Exposure Potential	No of Occupants	1	1	Maintenance Activity	Type	0	
	Frequency of Use	2			Frequency	1	1
	Average time in Use	0					
Priority Score	3		Risk	Very Low

RISK ASSESSMENT	7 / 24	VERY LOW
------------------------	---------------	-----------------

Recommendation:	Label and maintain
Comments:

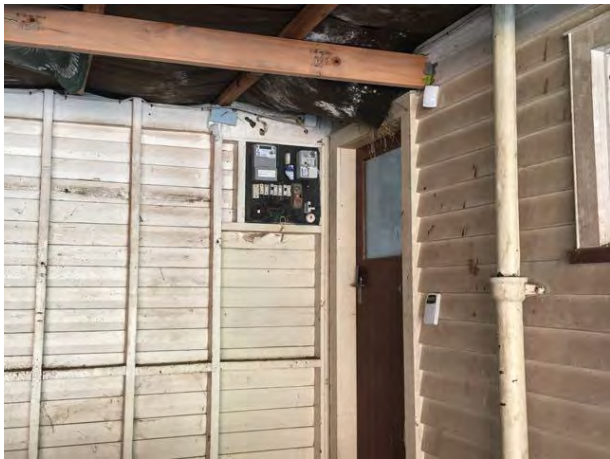
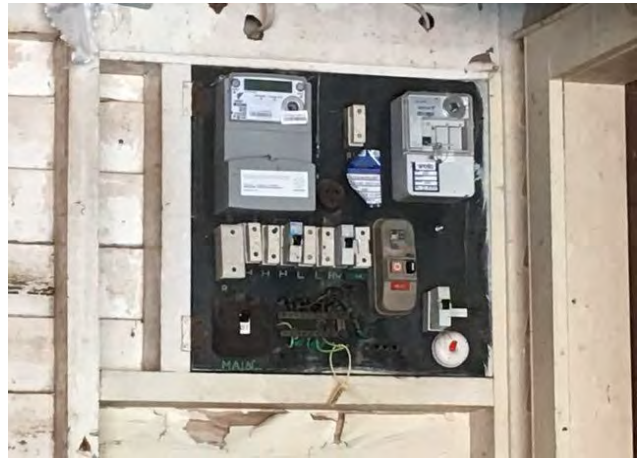
Product Type	Asbestos reinforced composites etc.	1	Condition	Low damage	1
Surface Treatment	Self-Sealed	0	Asbestos Type	Crocidolite	3
Material Score	5		Risk	Low

Occupant Activity	Main Type of Activity	0	0	Likelihood of Disturbance	Location	0	
	Secondary Activities	0			Accessibility	1	
Human Exposure Potential	No of Occupants	1	2	Maintenance Activity	Type	0	1
	Frequency of Use	3			Frequency	1	
	Average time in Use	0					
Priority Score	4		Risk	Very Low

RISK ASSESSMENT	9 / 24	LOW
------------------------	--------	------------

Recommendation:	Do not disturb
Comments:

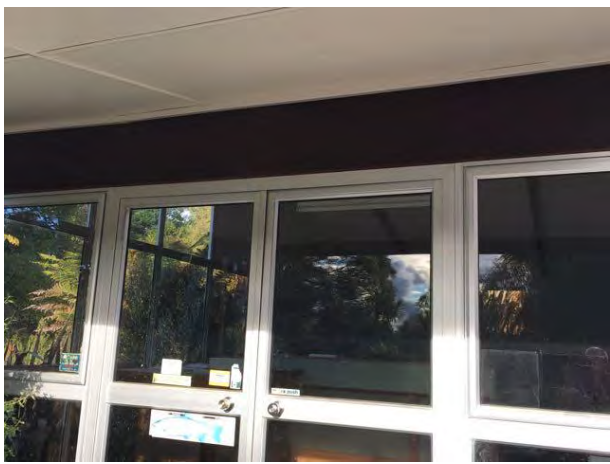
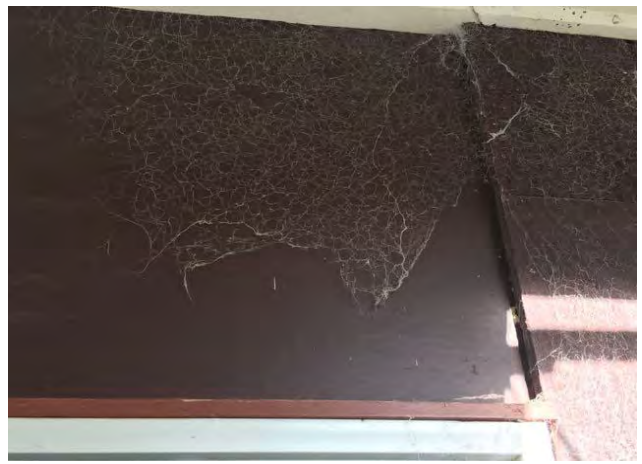
Product Type	N/A	N/A	Condition	N/A	N/A
Surface Treatment	N/A	N/A	Asbestos Type	NAD	N/A
Material Score	N/A			Risk	N/A

RISK ASSESSMENT	N/A	N/A
------------------------	-----	-----

Recommendation:	No action required
Comments:

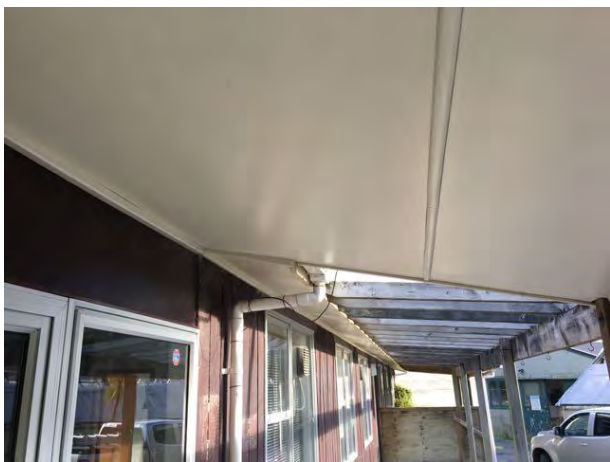
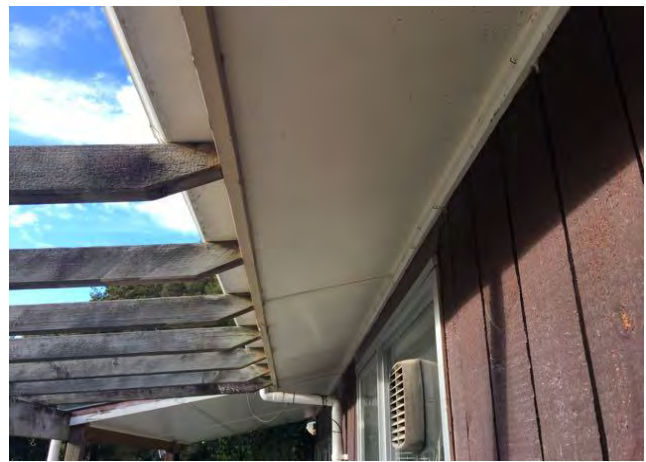
Product Type	Asbestos reinforced composites etc.	1	Condition	Low damage	1
Surface Treatment	Sealed	1	Asbestos Type	Crocidolite	3
Material Score	6		Risk	Low

Occupant Activity	Main Type of Activity	1	1	Likelihood of Disturbance	Location	0	
	Secondary Activities	1			Accessibility	1	
Human Exposure Potential	No of Occupants	1	2		Extent/amount	2	
	Frequency of Use	3		Maintenance Activity	Type	0	1
	Average time in Use	0			Frequency	1	
Priority Score	5			Risk	Low

RISK ASSESSMENT 11 / 24 LOW

Recommendation: Label and maintain

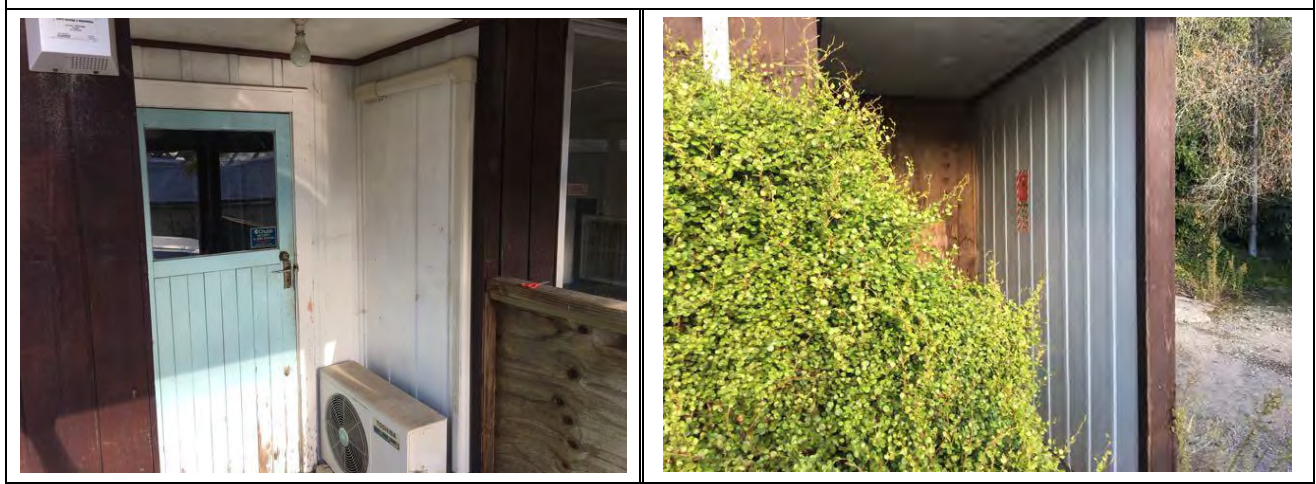
Product Type	Asbestos reinforced composites etc.	1	Condition	Low damage	1
Surface Treatment	Sealed	1	Asbestos Type	Amosite	2
Material Score	5		Risk	Low

Occupant Activity	Main Type of Activity	1	1	Likelihood of Disturbance	Location	0	
	Secondary Activities	1			Accessibility	1	
Human Exposure Potential	No of Occupants	1	2		Maintenance Activity	Type	
	Frequency of Use	3		Frequency		1	
	Average time in Use	0		Priority Score	5		Risk

RISK ASSESSMENT 10 / 24 LOW

Recommendation: Label and maintain

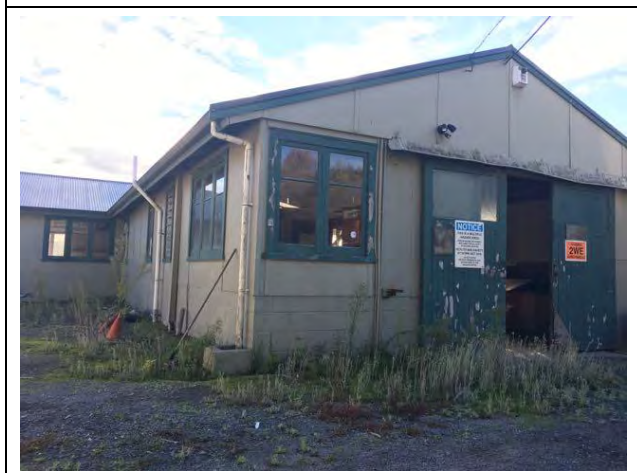
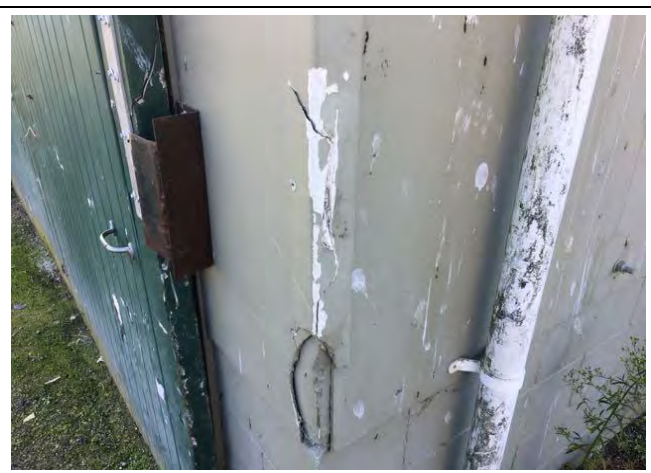
Product Type	Asbestos reinforced composites etc.	1	Condition	Medium damage	2
Surface Treatment	Sealed	1	Asbestos Type	Amosite	2
Material Score	6		Risk	Low

Occupant Activity	Main Type of Activity	1	1	Likelihood of Disturbance	Location	0	
	Secondary Activities	1			Accessibility	1	2
			Extent/amount		3		
Human Exposure Potential	No of Occupants	1	2	Maintenance Activity	Type	0	
	Frequency of Use	3			Frequency	1	1
	Average time in Use	1					
Priority Score	6		Risk	Low

RISK ASSESSMENT 12 / 24 LOW

Recommendation: Label and maintain

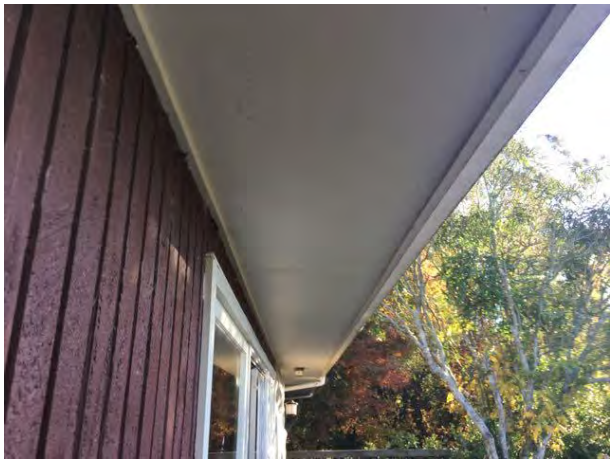
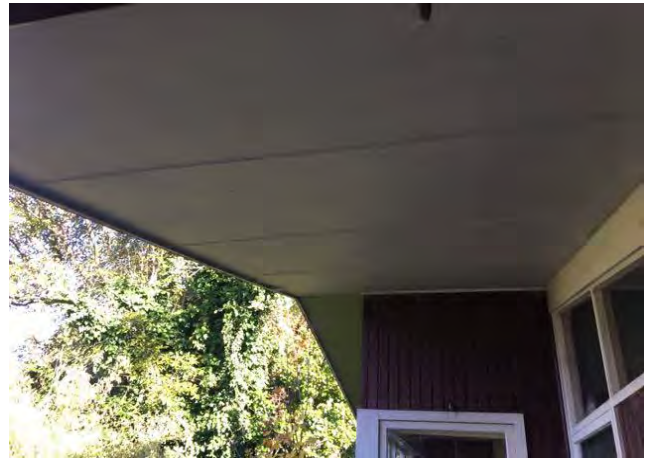
Product Type	Asbestos reinforced composites etc.	1	Condition	Low damage	1
Surface Treatment	Sealed	1	Asbestos Type	Chrysotile	1
Material Score	4		Risk	Very Low

Occupant Activity	Main Type of Activity	1	1	Likelihood of Disturbance	Location	0	
	Secondary Activities	1			Accessibility	1	2
			Extent/amount		3		
Human Exposure Potential	No of Occupants	1	2	Maintenance Activity	Type	0	
	Frequency of Use	3			Frequency	1	1
	Average time in Use	0					
Priority Score	6		Risk	Low

RISK ASSESSMENT	10 / 24	LOW
------------------------	---------	------------

Recommendation:	Label and maintain
Comments:

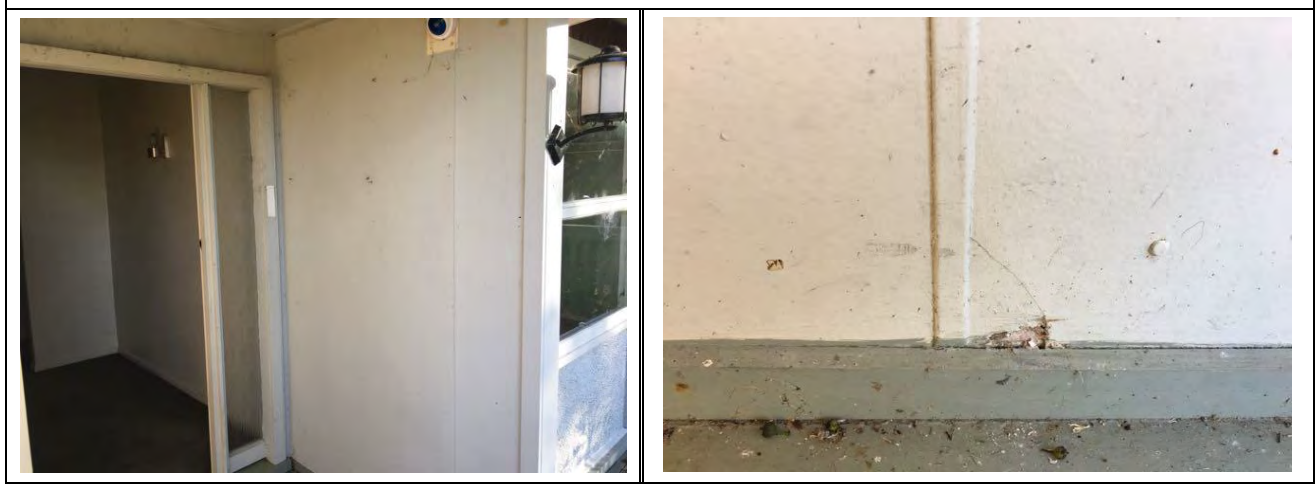
Product Type	Asbestos reinforced composites etc.	1	Condition	Low damage	1
Surface Treatment	Sealed	1	Asbestos Type	Chrysotile	1
Material Score	4		Risk	Very Low

Occupant Activity	Main Type of Activity	1	1	Likelihood of Disturbance	Location	0	
	Secondary Activities	1			Accessibility	1	
Human Exposure Potential	No of Occupants	1	2		Maintenance Activity	Type	
	Frequency of Use	3		Frequency		1	
	Average time in Use	0					
Priority Score	5			Risk	Low

RISK ASSESSMENT 9 / 24 **LOW**

Recommendation: Label and maintain

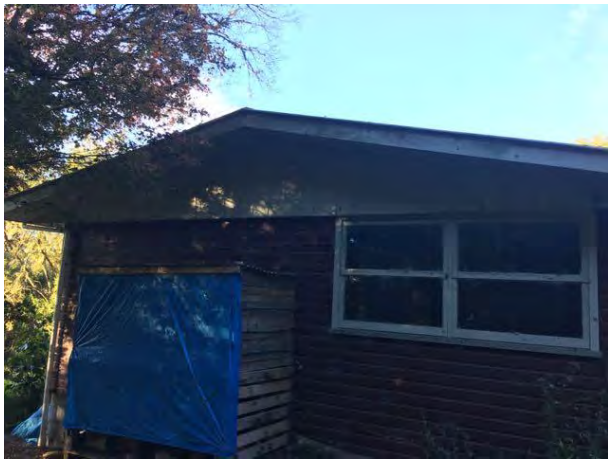
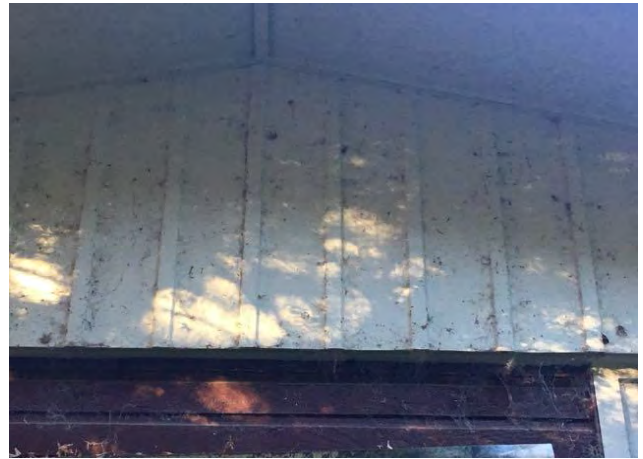
Product Type	Asbestos reinforced composites etc.	1	Condition	Low damage	1
Surface Treatment	Sealed	1	Asbestos Type	Amosite	2
Material Score	5		Risk	Low

Occupant Activity	Main Type of Activity	1	1	Likelihood of Disturbance	Location	0	
	Secondary Activities	1			Accessibility	0	
Human Exposure Potential	No of Occupants	1	2		Extent/amount	2	
	Frequency of Use	3		Maintenance Activity	Type	0	1
	Average time in Use	0			Frequency	1	
Priority Score	5		Risk	Low

RISK ASSESSMENT	10 / 24	LOW
------------------------	---------	------------

Recommendation:	Label and maintain
Comments:

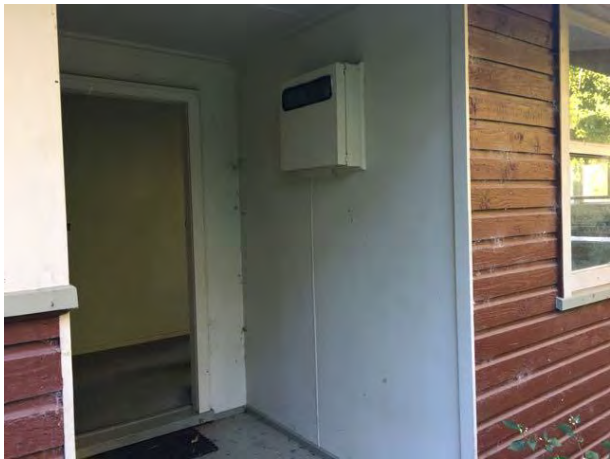
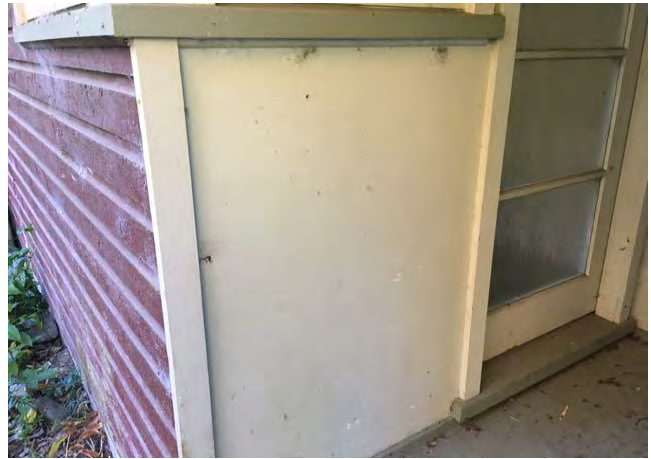
Product Type	Asbestos reinforced composites etc.	1	Condition	Low damage	1
Surface Treatment	Sealed	1	Asbestos Type	Chrysotile	1
Material Score	4		Risk	Very Low

Occupant Activity	Main Type of Activity	1	1	Likelihood of Disturbance	Location	0	
	Secondary Activities	1			Accessibility	1	
Human Exposure Potential	No of Occupants	1	2		Extent/amount	2	
	Frequency of Use	3		Maintenance Activity	Type	0	1
	Average time in Use	0			Frequency	1	
Priority Score	5			Risk	Low

RISK ASSESSMENT 9 / 24 **LOW**

Recommendation: Label and maintain

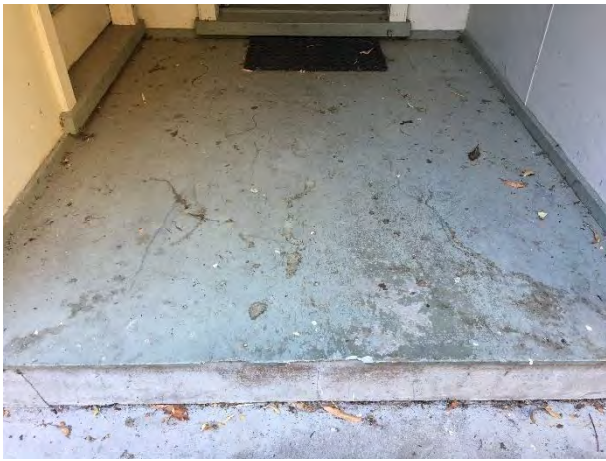
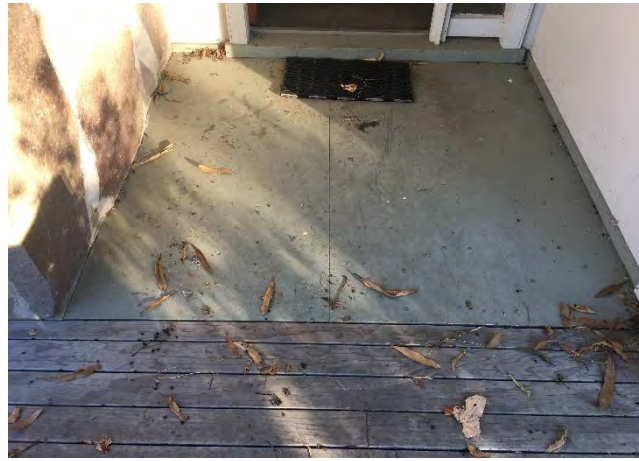
Product Type	Asbestos reinforced composites etc.	1	Condition	Low damage	1
Surface Treatment	Sealed	1	Asbestos Type	Crocidolite	3
Material Score	6		Risk	Low

Occupant Activity	Main Type of Activity	1	1	Likelihood of Disturbance	Location	0	
	Secondary Activities	1			Accessibility	1	
Human Exposure Potential	No of Occupants	1	2		Maintenance Activity	Type	
	Frequency of Use	3		Frequency		1	
	Average time in Use	0					
Priority Score	5			Risk	Low

RISK ASSESSMENT	11 / 24	LOW
------------------------	---------	------------

Recommendation:	Label and maintain
Comments:

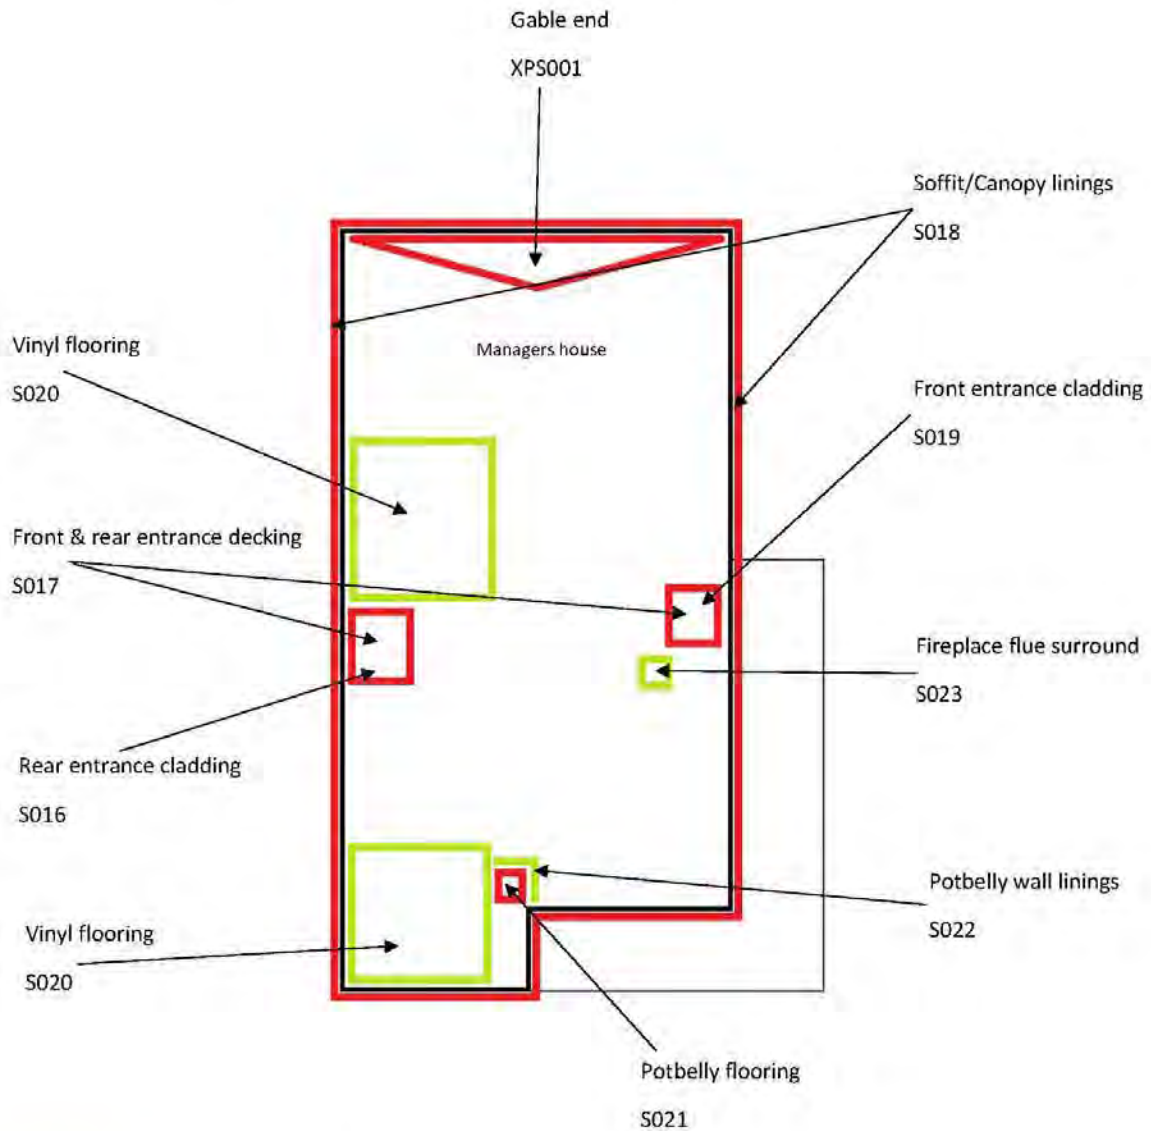
155 CENTENNIAL DRIVE, TAUPO

- Asbestos detected
- No Asbestos detected
- Presumed Asbestos present
