Charming Creek Walkway

Baseline Inspection Report

Jackie Breen and Amy Findlater West Coast *Tai Poutini* Conservancy

A report prepared for the Buller Kawatiri Area Office

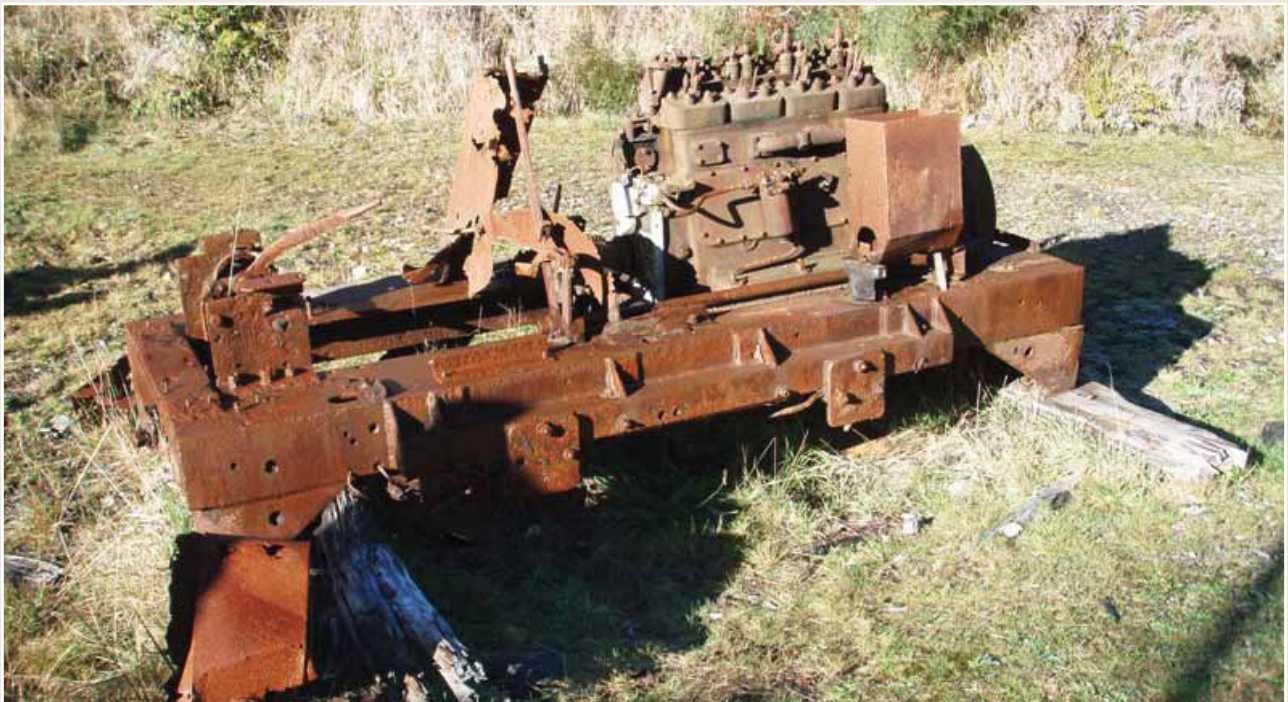
Of the bins, only the parallel concrete foundations are still present. They are a dominant feature at the site. Other remains from the bins include wooden beams, trap doors and four sliding gates (for dropping coal into trucks) now found NE of the bins. The bins were modified during their use (1956 to 1986), mainly to accommodate a transportation change from rail to road..

Photo 5 top: Remains of the bins
Photo 6: Ruston Lokey remains

The remains of a Ruston lokey is also situated to the west of the bins. It originally worked the tram line at the Ngakawau end, but was left here when the tram line was no longer used. Photo 2 shows the lokey in relation to other features at the site, and photo 6 a close up view.⁹

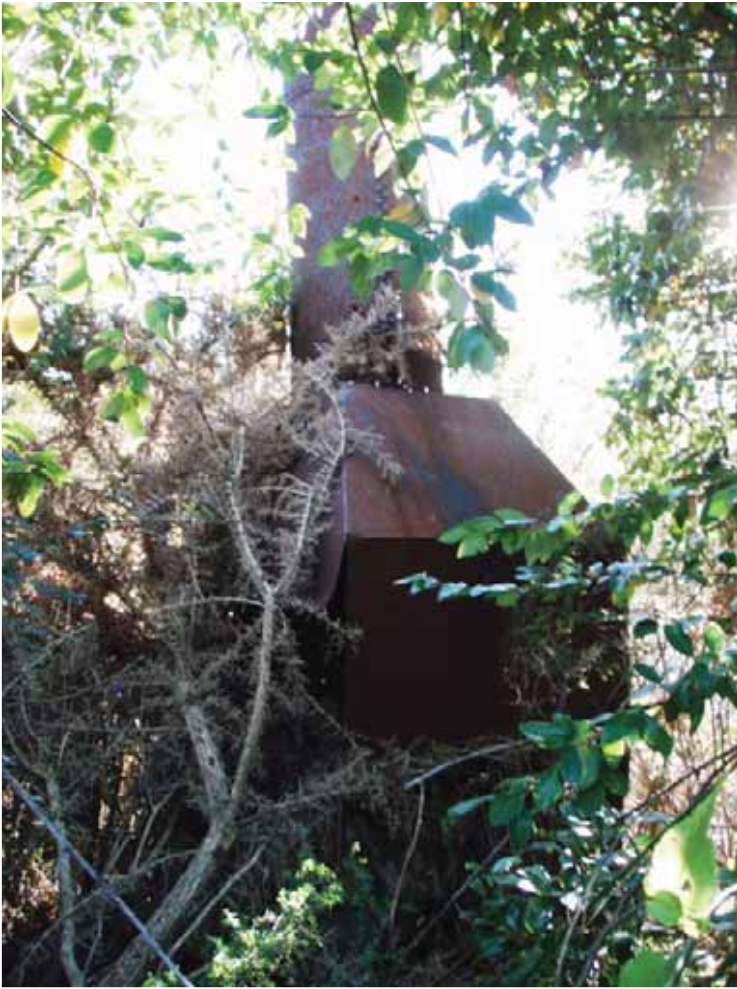
This area was originally the site of the first set of mine buildings built at the second mine portal dating from 1943. Coal tubs ran along an alignment from the mine portal, between the buildings and on to a set of bins. After a fire in 1952 and the installation of hydro-mining and a hydraulic hoist in 1956, this area was not used as much. Later mine works and salvage operations have modified this area, including the original tram alignment from the second portal. Following a heavily overgrown tram alignment, the chimney from the workshop/blacksmith is found (photo 7). There are numerous artefacts (such as a grinding wheel cover) scattered in the undergrowth.

Photo 7: Chimney thought to be from the blacksmith workshop.

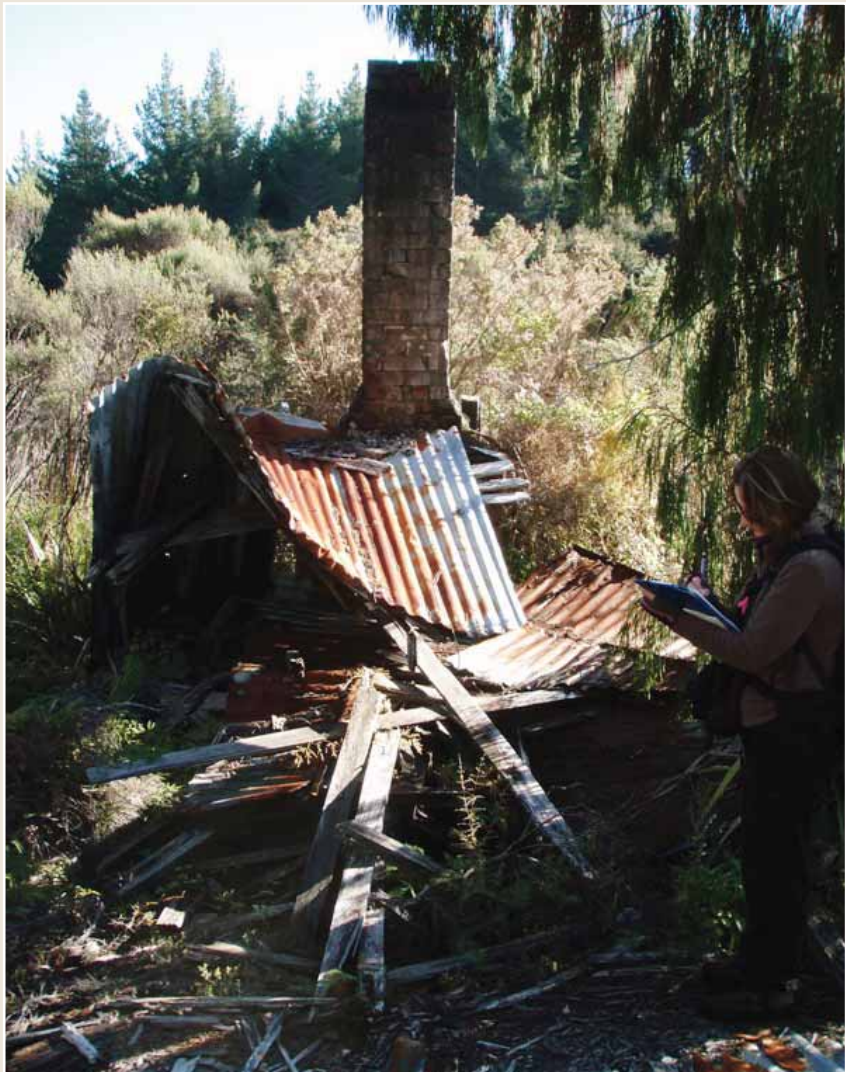
Photo 10: Hut site

Further west there is a hut site (Photo 10). The structure of this 3x4m hut including wooden beams and corrugated iron has now collapsed but the chimney is still standing.

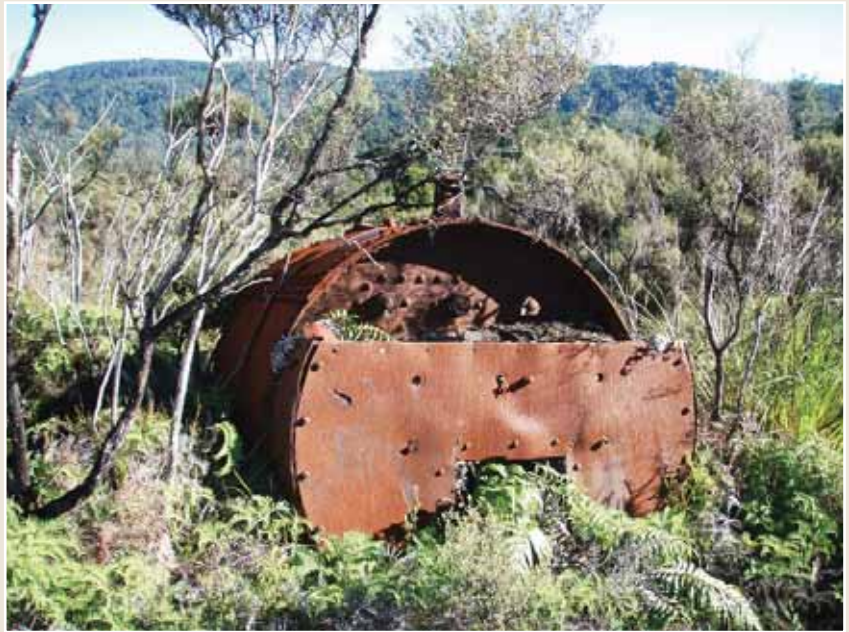
Photo 11: Package boiler

Following the terrace further west, a couple of slips are crossed. Near here there is a package boiler with fire bars scattered around it. It is a short package 'Dryback' boiler with a compact marine type firebox and may have started life on a ship, but there is no makers mark on the boiler indicating who built it (photo 11). It may have been one used in the early period of the second mine (pre-hydro hoist 1943 to 1956) to provide motive power for the winch that hauled tubs out of the mine.¹¹

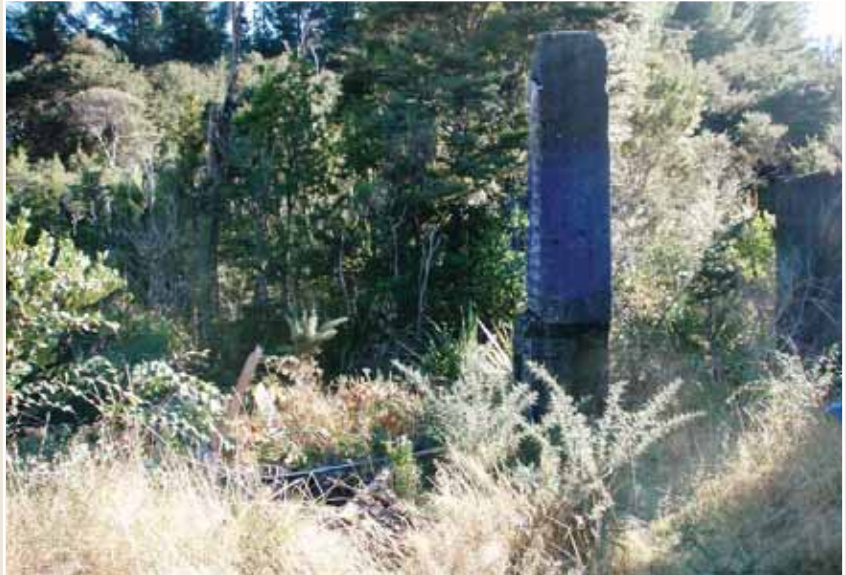
Directly to the west of the bathhouse are the remains of the mine office which was later used as a storeroom. This was a wooden structure but only the chimney now remains (see photo 13).

Photo 13: Chimney on the mine office and storeroom site.

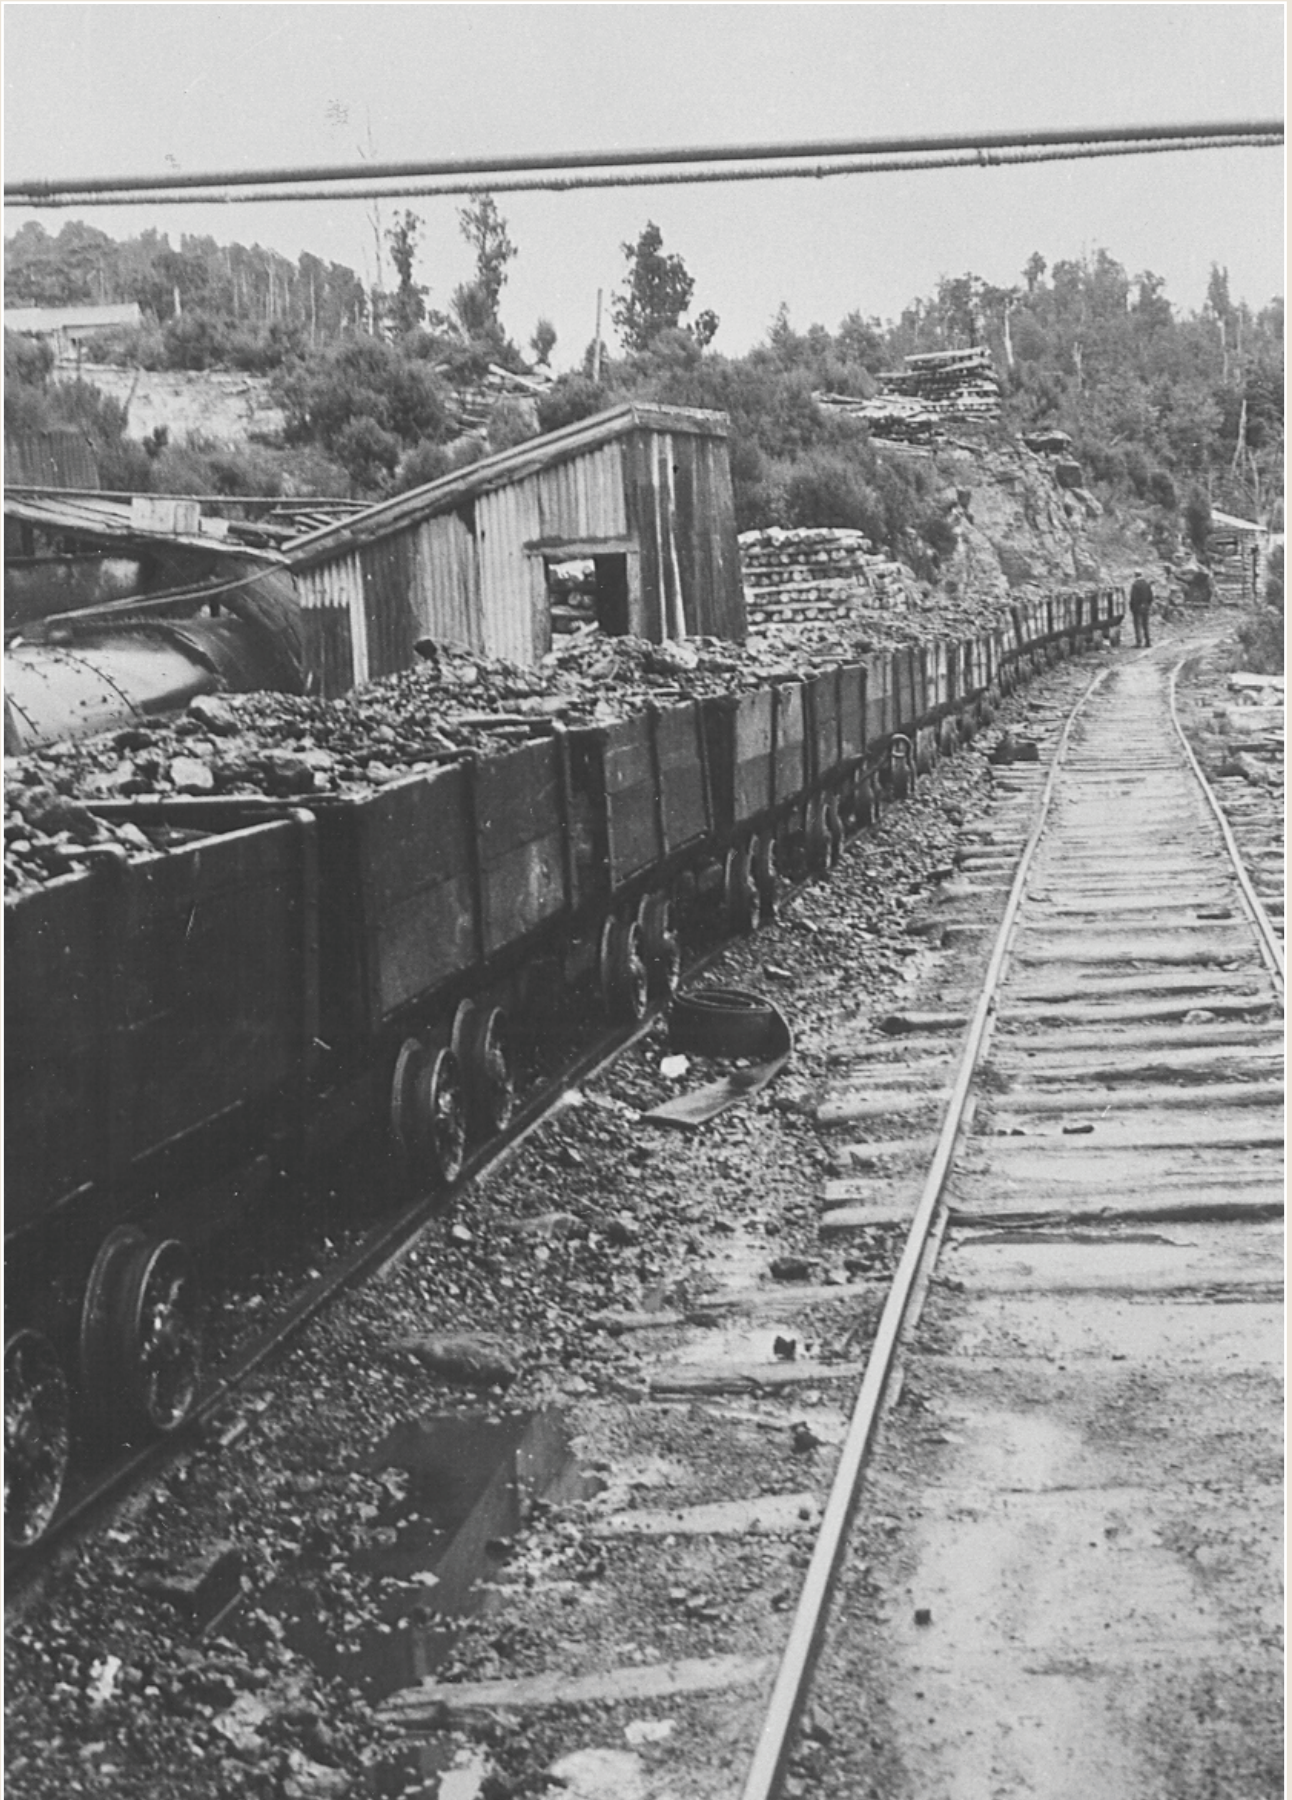
Photo 15: 1940s tramline view. The fanhouse and associated building are seen on the right of the image. Note the double track of tram, with the right hand line being slightly higher than the left.

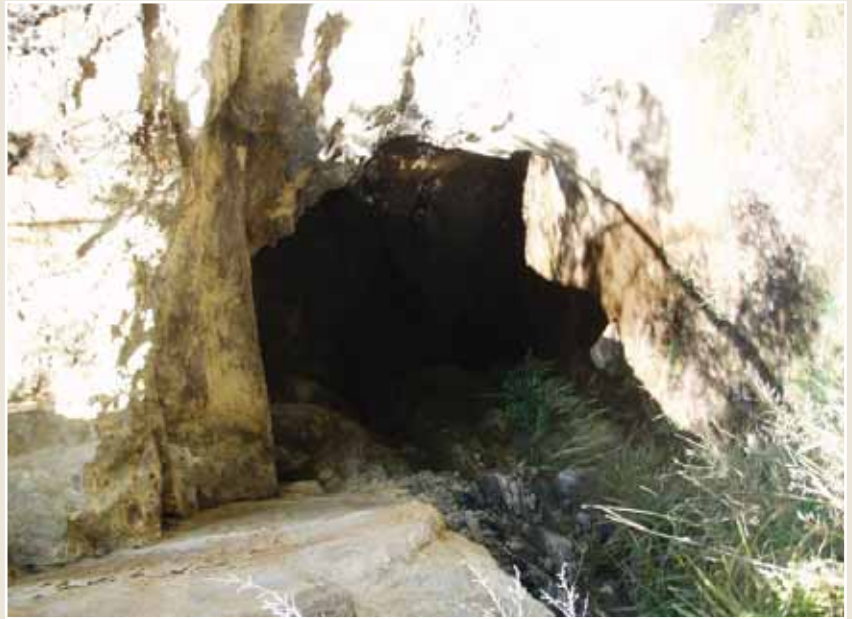
Photo 16: Magazine

Along the walkway, past the fanhouse was the magazine site where explosives were kept (photo 16). All that remains is a hollowed out cavity excavated into the rock at the side of the track.

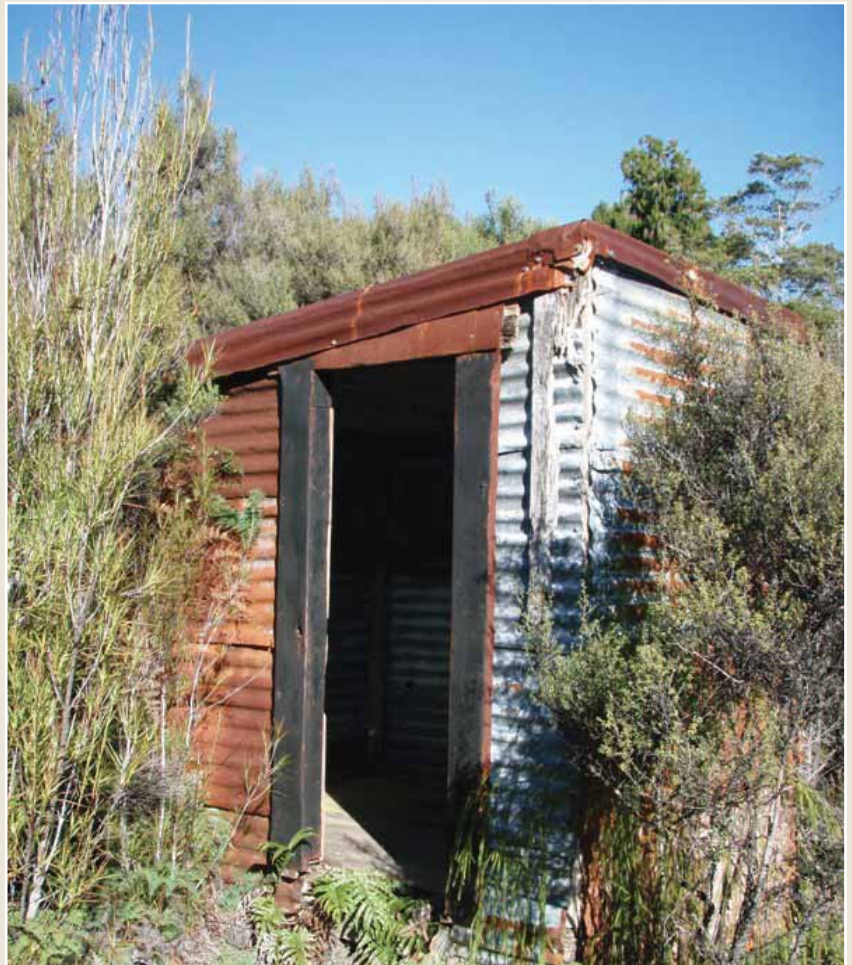
Photo 17: Hut

A small track leaves the tramway here and progresses up the side of the hill to a hut site (photo 17). The hut is about 1.5 x 2.5 m and may have been used to store supplies during mining operations, or it may be the magazine that was reported under construction in 1947.¹²

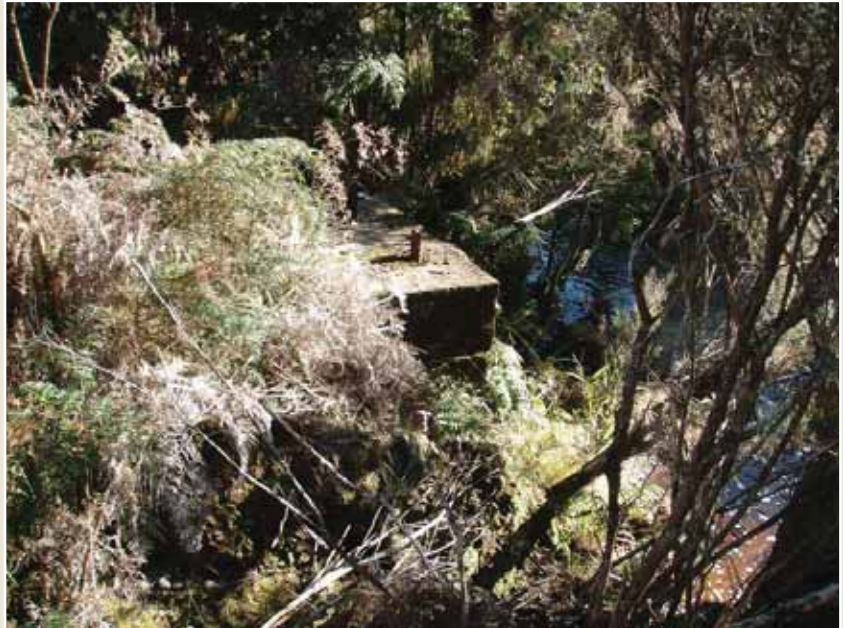
While not associated with the mine, directly adjacent to the tramway (photo 18) the abutments of a NZFS laminated bridge can be seen by the edge of the creek. This bridge marks the junction of a diversion track put in by the NZFS to bypass the mine in 1984 — the beginning of the recreational use of the area. This bridge was destroyed by a flood.

Photo 18: NZFS bridge abutment

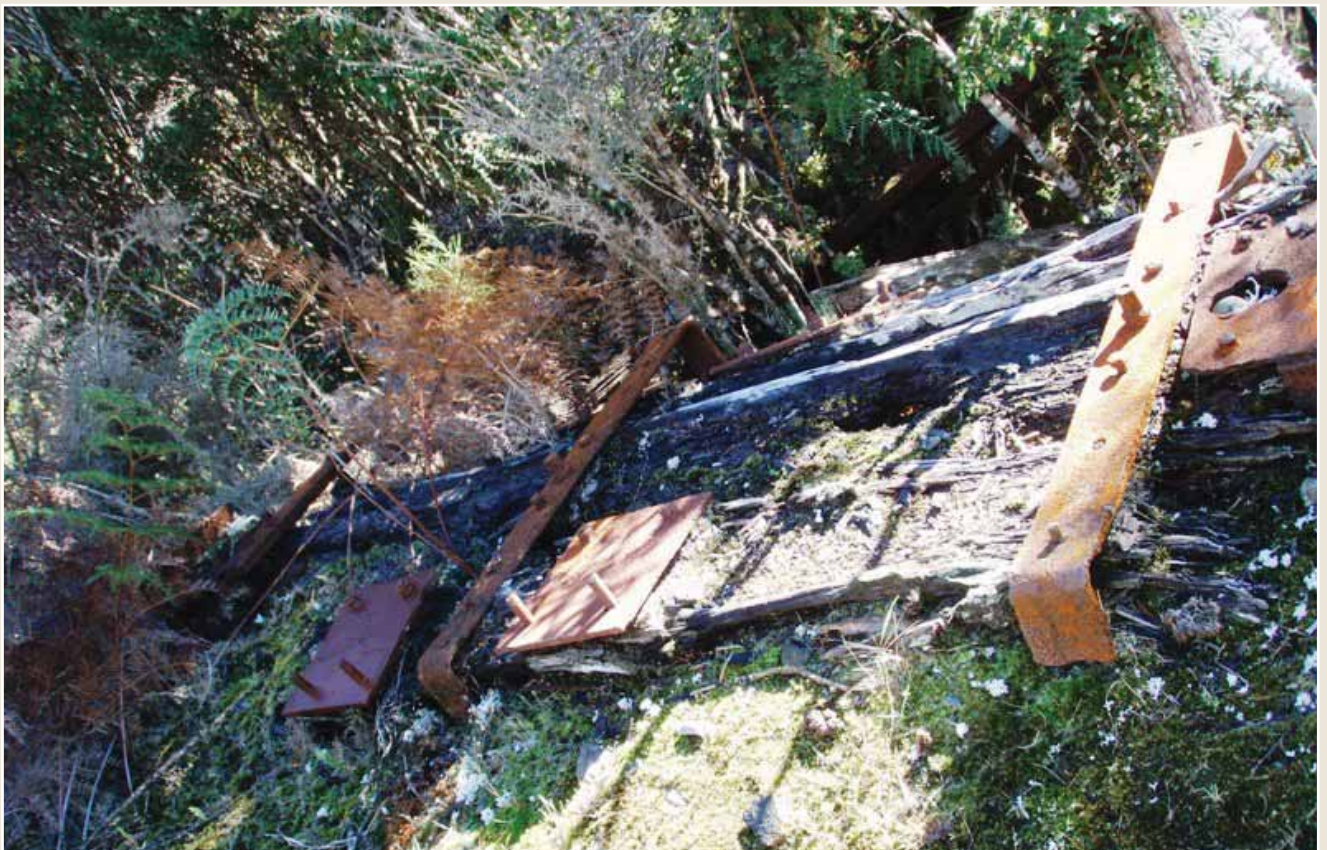
Immediately to the north in this section of walkway are many pieces of historic equipment lying in the scrub, including a 6hp Dispatch boiler, one small winch drum, a docking saw (both probably used in saw mill operations) and 1.7 tonne coal truck chassis (see photo 19).

Photo 19: Remains of a 1.7 tonne coal truck

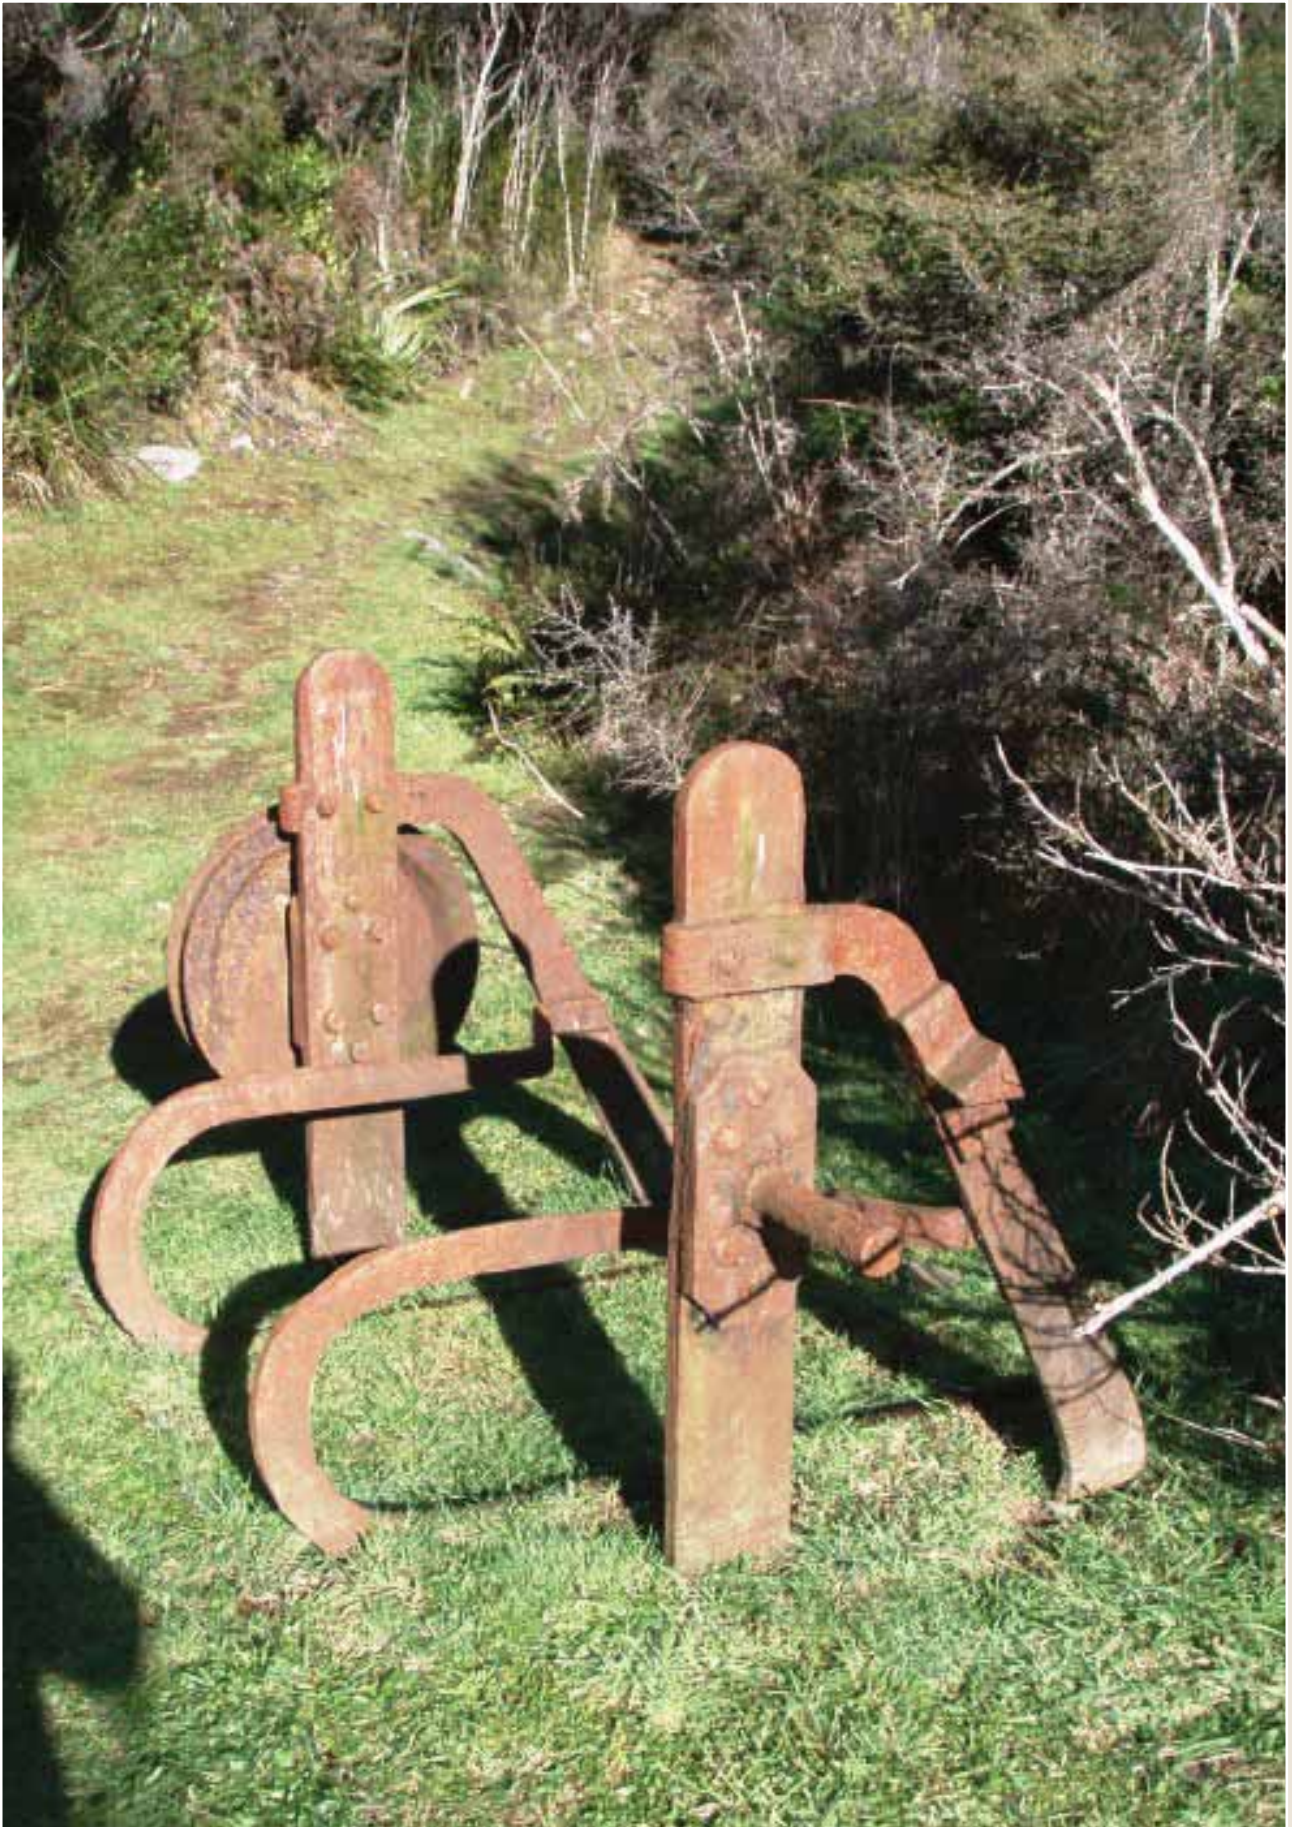
Photo 24: Tub tipper at Cornes Hill Junction

- 1) Any visitor upgrade work at this junction needs to be mindful of potential subsurface remains of the tramway formation where it crosses the walkway. Earthworks should be minimised to preserve the two tramway formations and the embankment profile.
- 2) The tub tipper should be treated with metal preservative and the vegetation kept clear from around it.

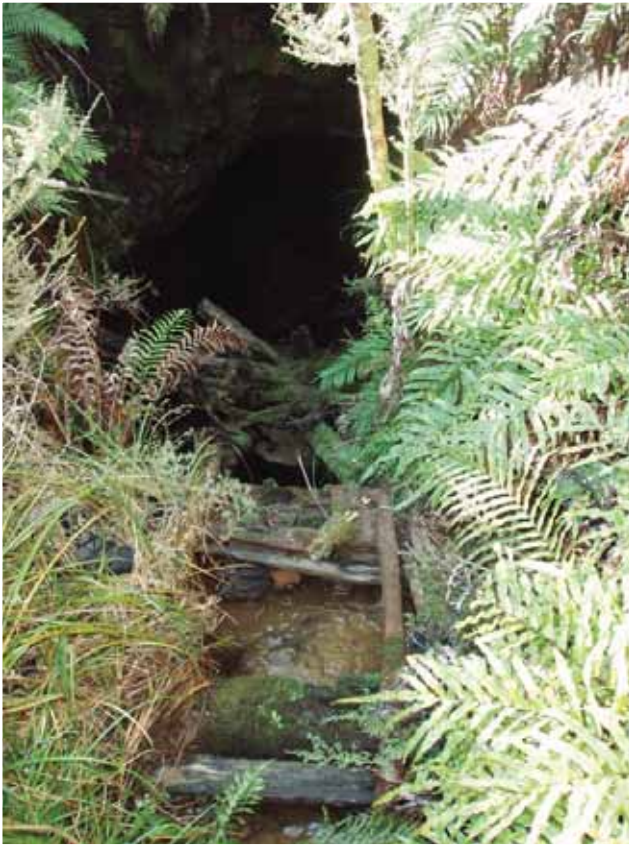
Photo 25: The first mine entrance. Note the rail and sleepers.

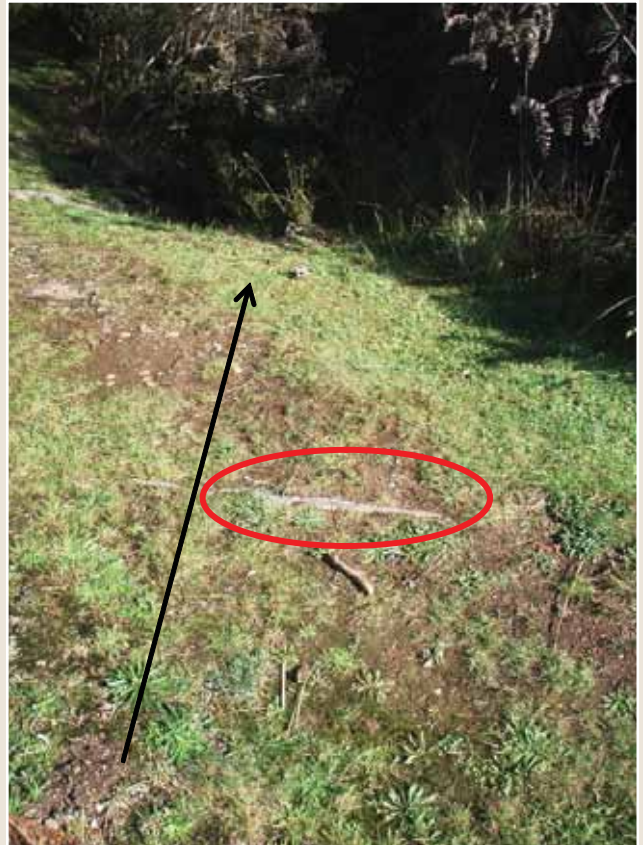
Photo 26: Tramway alignment from mine entrance, where the high level siding intersects with the walkway. The line of the tram is marked by an arrow. A sleeper exposed in the track surface has been circled.

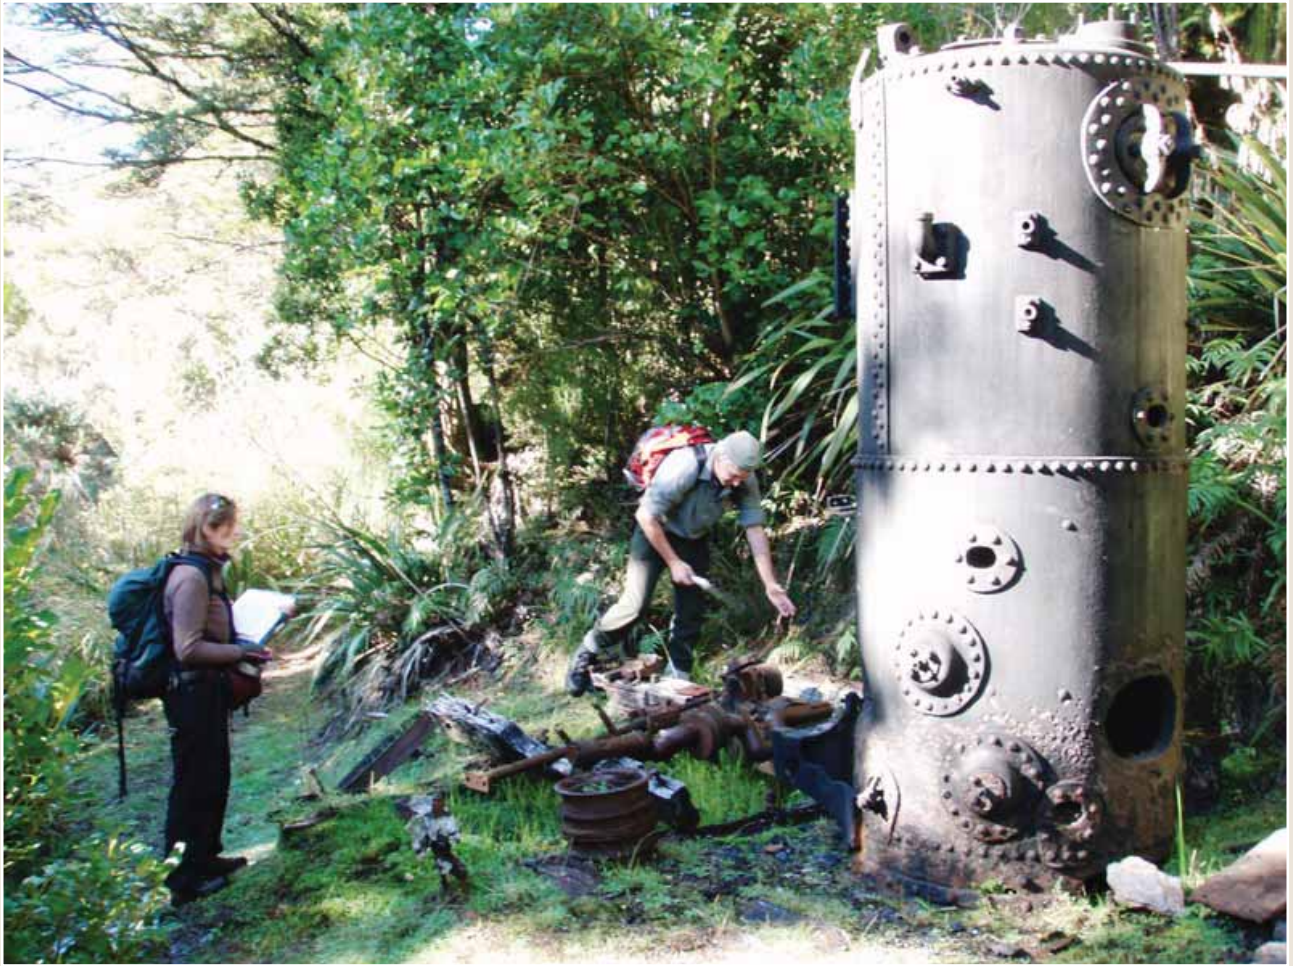
Photo 28: Vertical Boiler (TECH ID 042717)

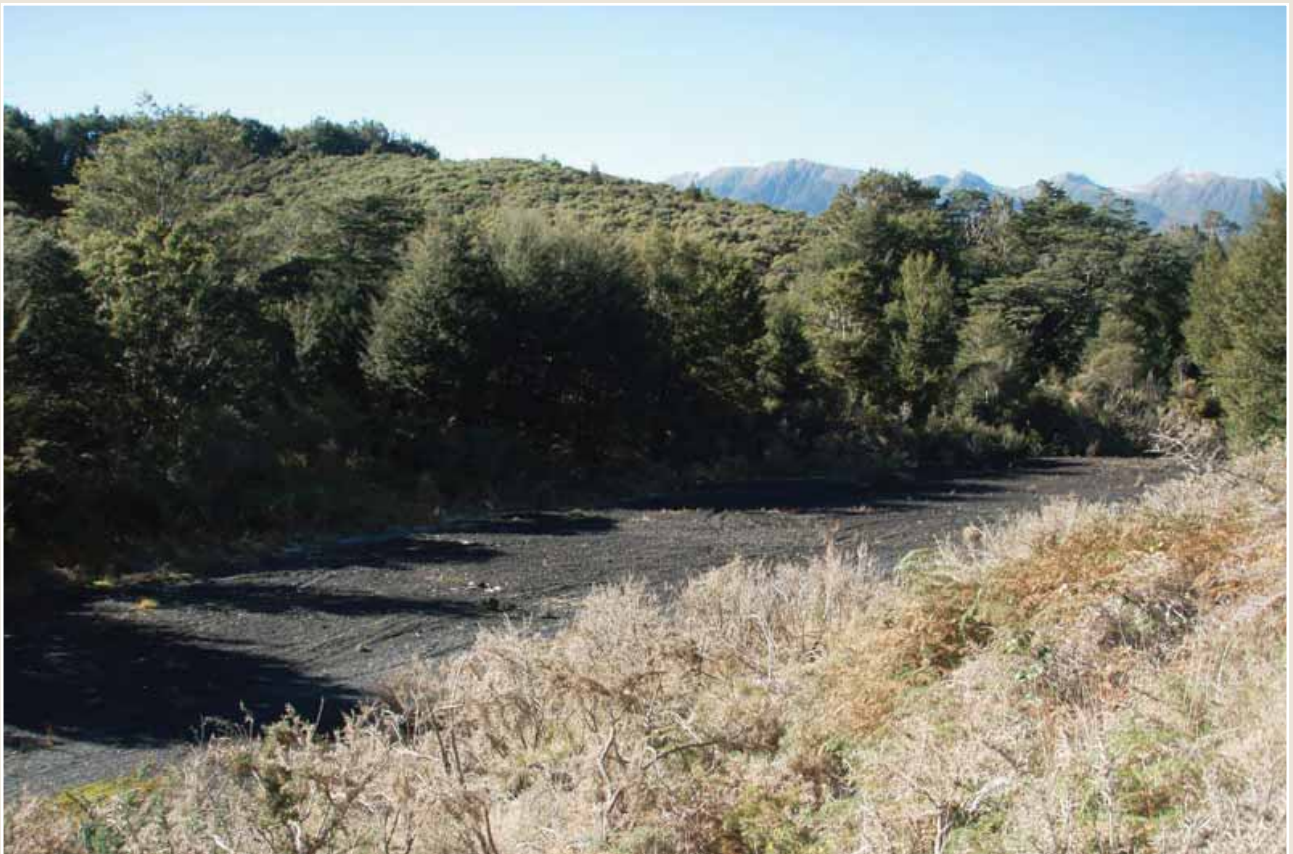
Photo 29: A view of the settling ponds from the walkway.

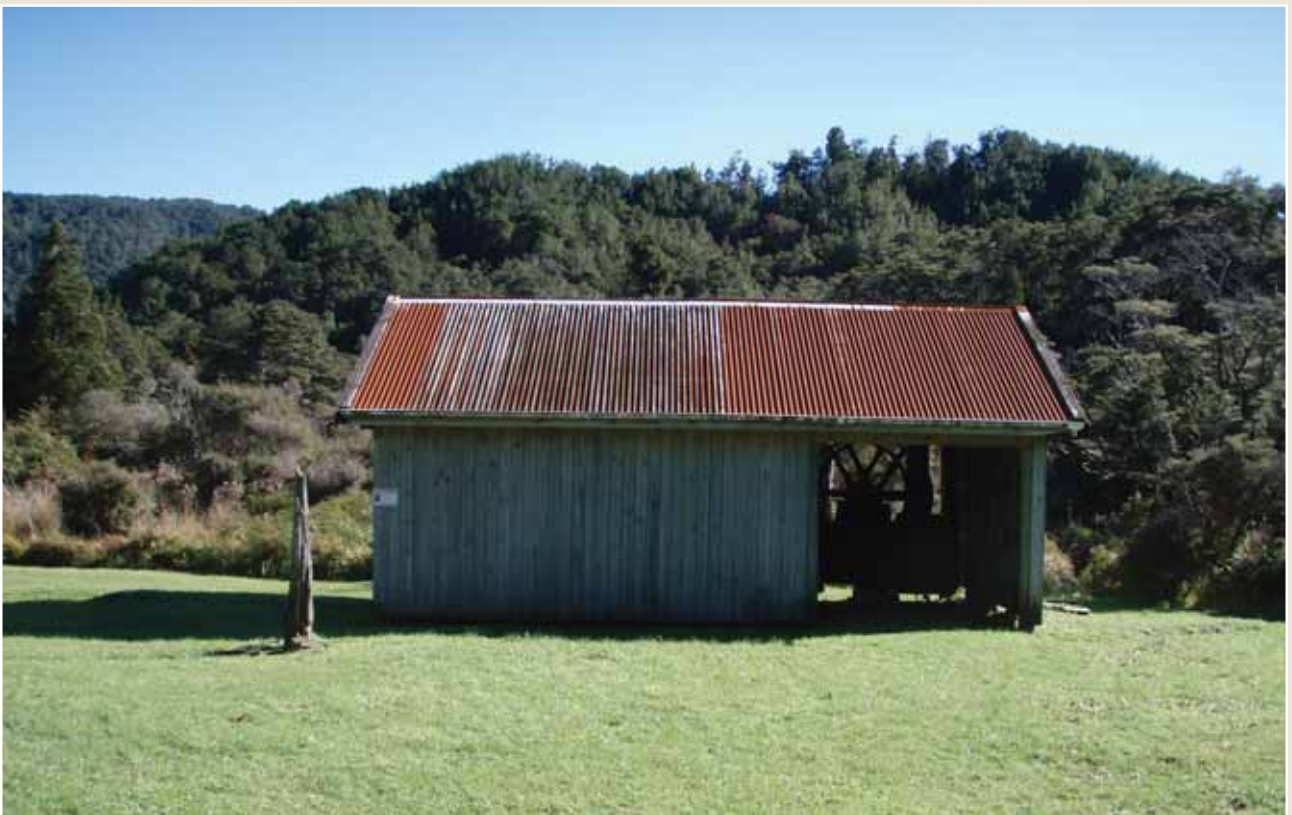
Photo 34: Clearing at Mumm's mill and the shelter that houses the steam plant that drove the mill. Note the remaining upright beam from the original mill building to the left of the shelter.

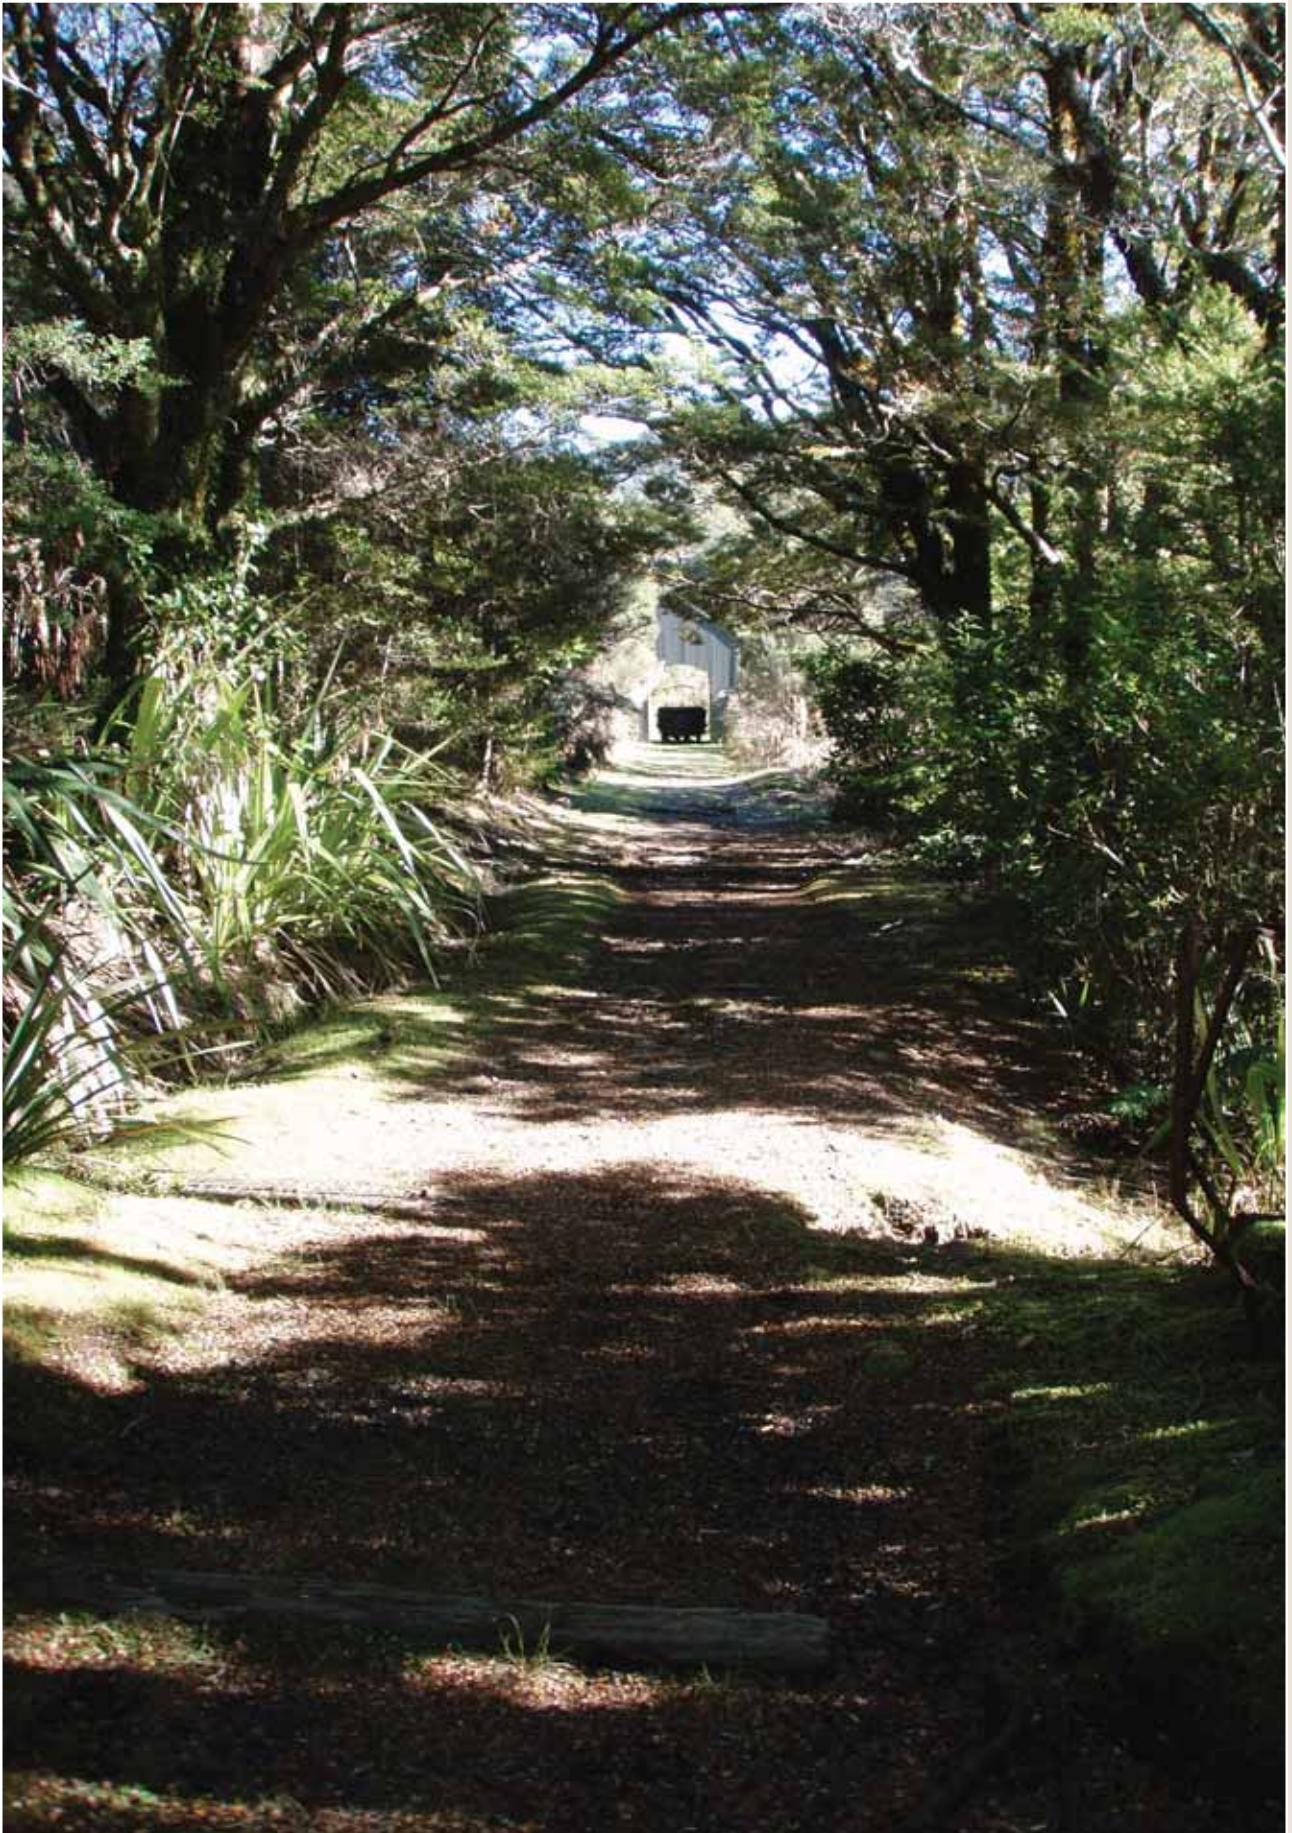
Photo 35: A tram line view with the Union Rail Tractor shelter in the distance..

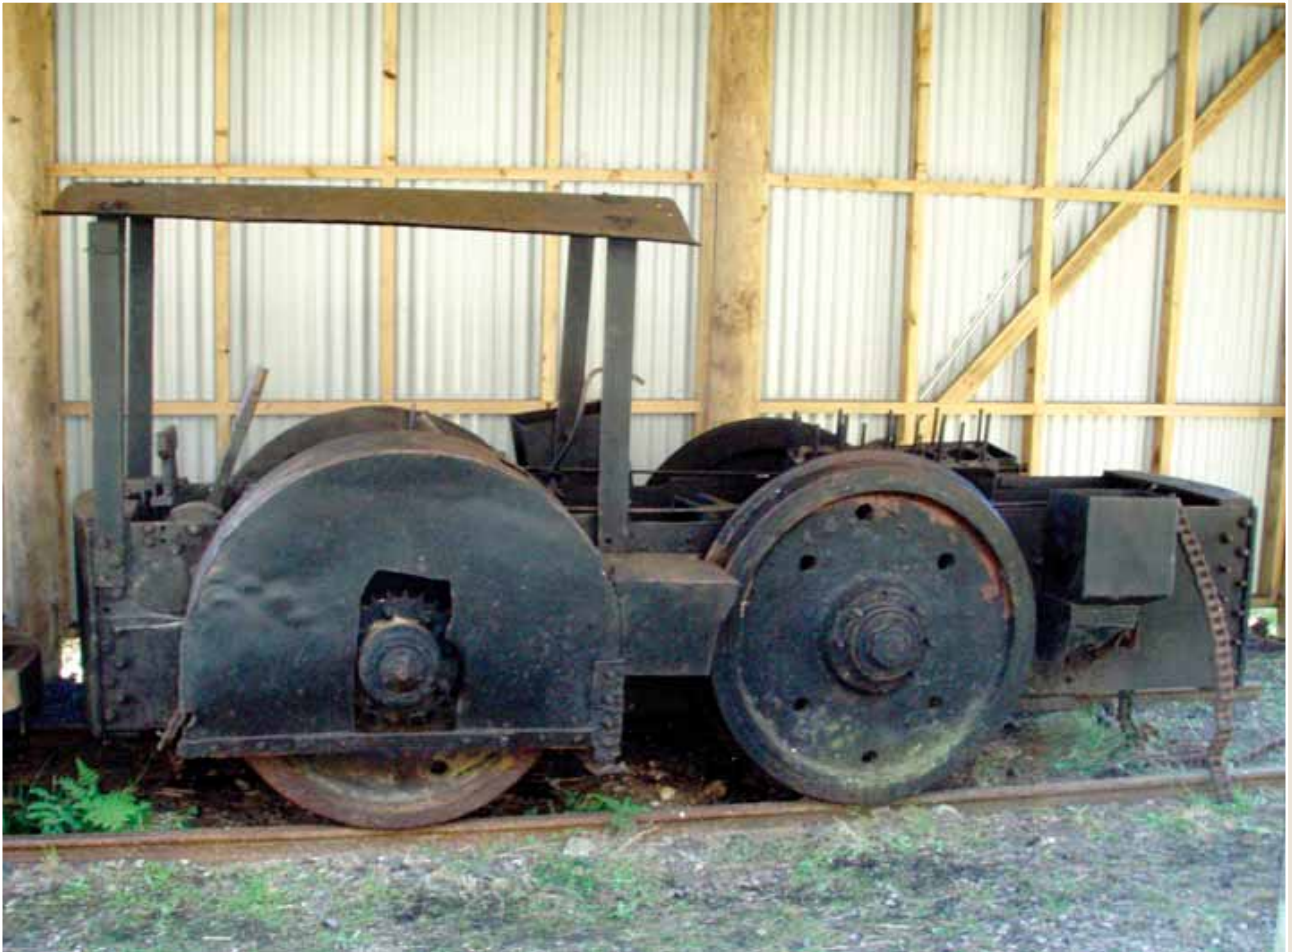
Photo 36: Union Foundries Rail Tractor.

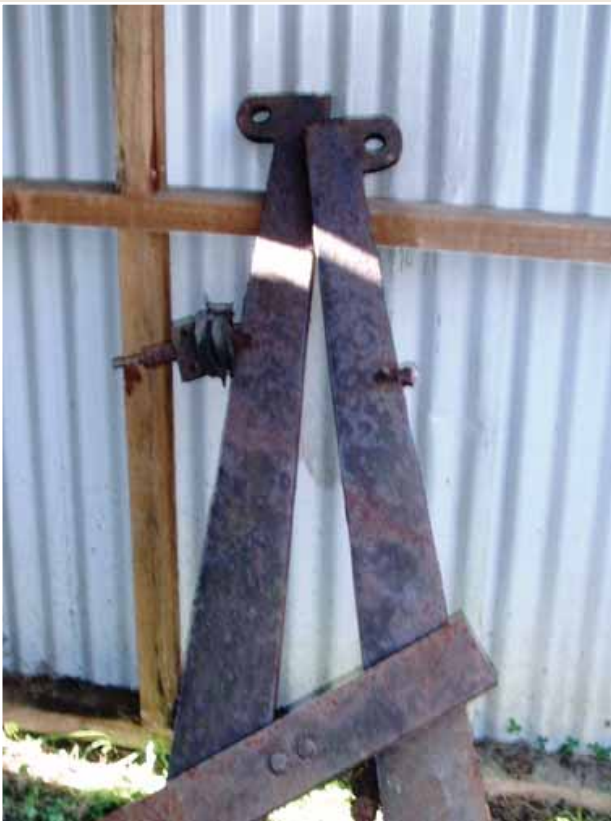
Photo 37: Brake

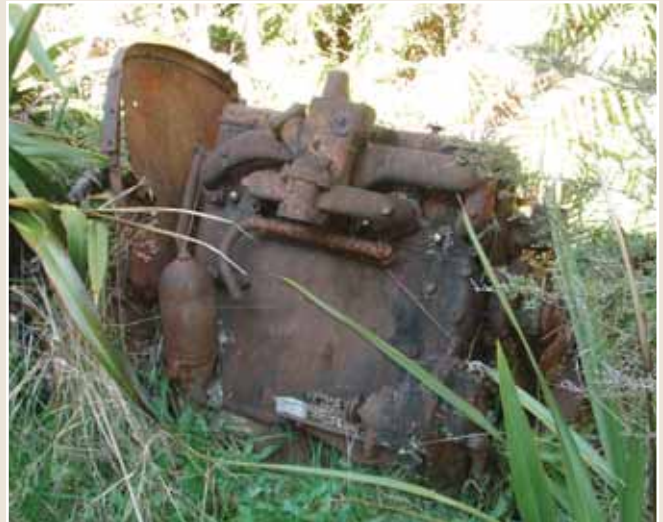
Photo 38: The International 'H' engine.

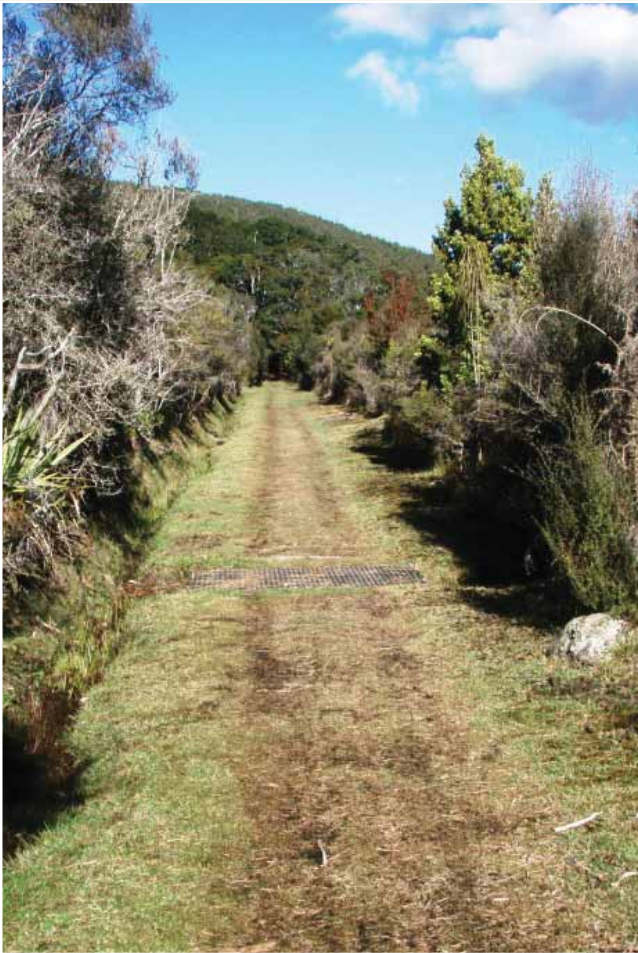
Photo 39: Section of tramway alignment

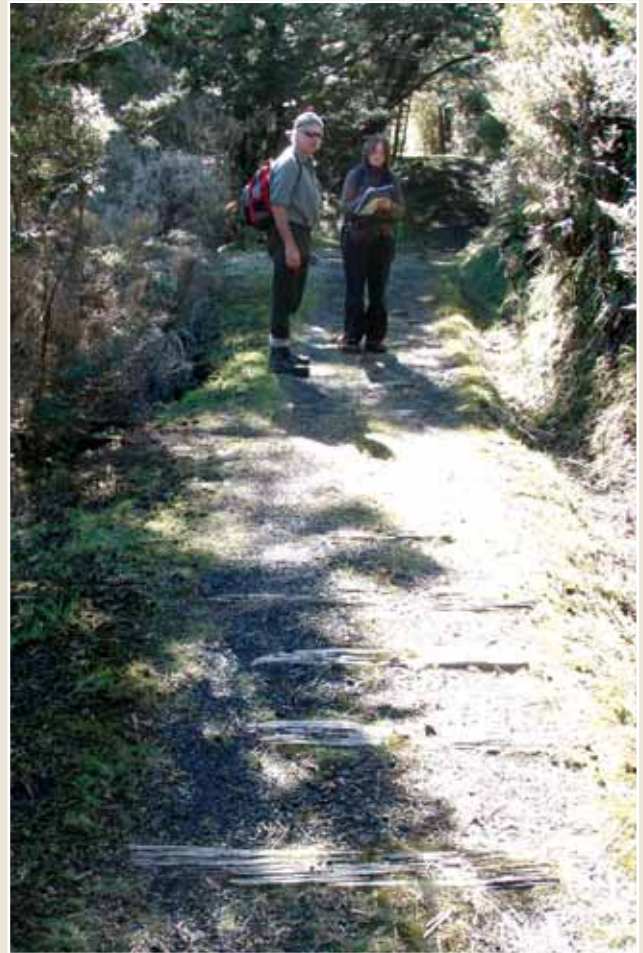
Photo 40: Section of tramway showing sleepers
