Charming Creek Walkway

Baseline Inspection Report

Jackie Breen and Amy Findlater West Coast *Tai Poutini* Conservancy

A report prepared for the Buller Kawatiri Area Office

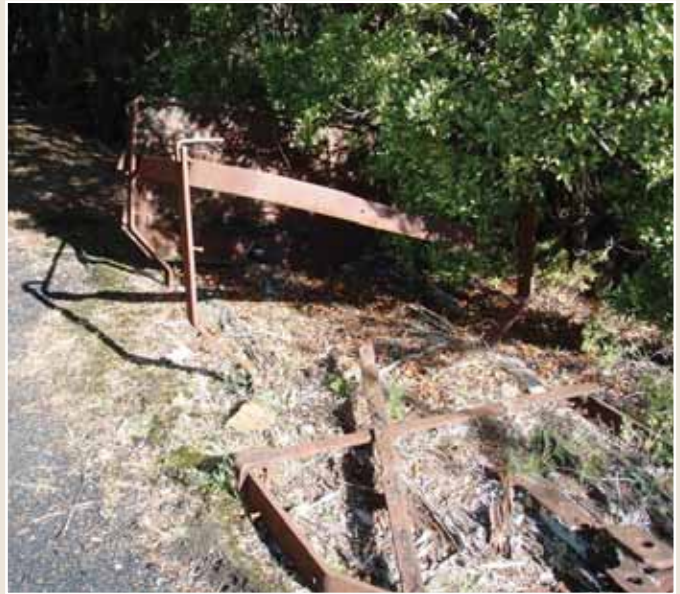
Photo 49: Remains of a log bogie

- 1) Maintain vegetation along the outer edges of the tramway alignment to retain historic profile.
- 2) Vegetation clearance should be addressed especially with regard to the log bogies and trucks. Vegetation should be cleared within a minimum of a 2m radius around standing structures. Plants should not be pulled off structures or earthworks as this can cause damage.
- 3) Vegetation should be monitored around any historic features at appropriate intervals.
- 4) Slip prone areas should be monitored to mitigate further damage to historic fabric. This especially applies to the sections already affected and the benched formation section at GPS ID 106, as this is an excellent example remaining in the slip prone area.
- 5) A solution to the muddy track surface is needed within cutting GPS ID 146. Because this is an excellent example of a cutting, earthwork should be avoided in any upgrades.

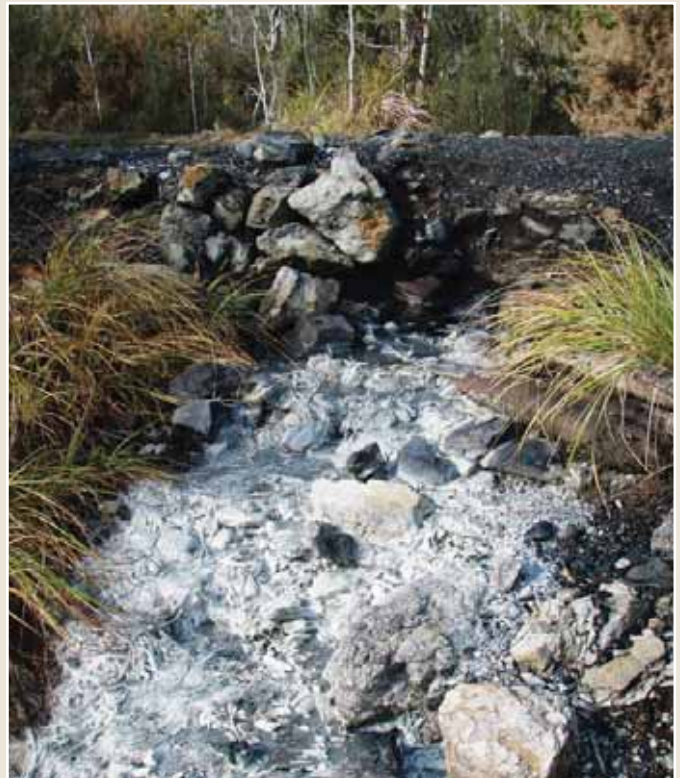
One unique historic feature on this section of the walkway is the sulphur 'stink hole' where seepage from a government prospecting hole can be seen and smelt (photo 50).

Photo 50: Sulphur spring adjacent to the track.

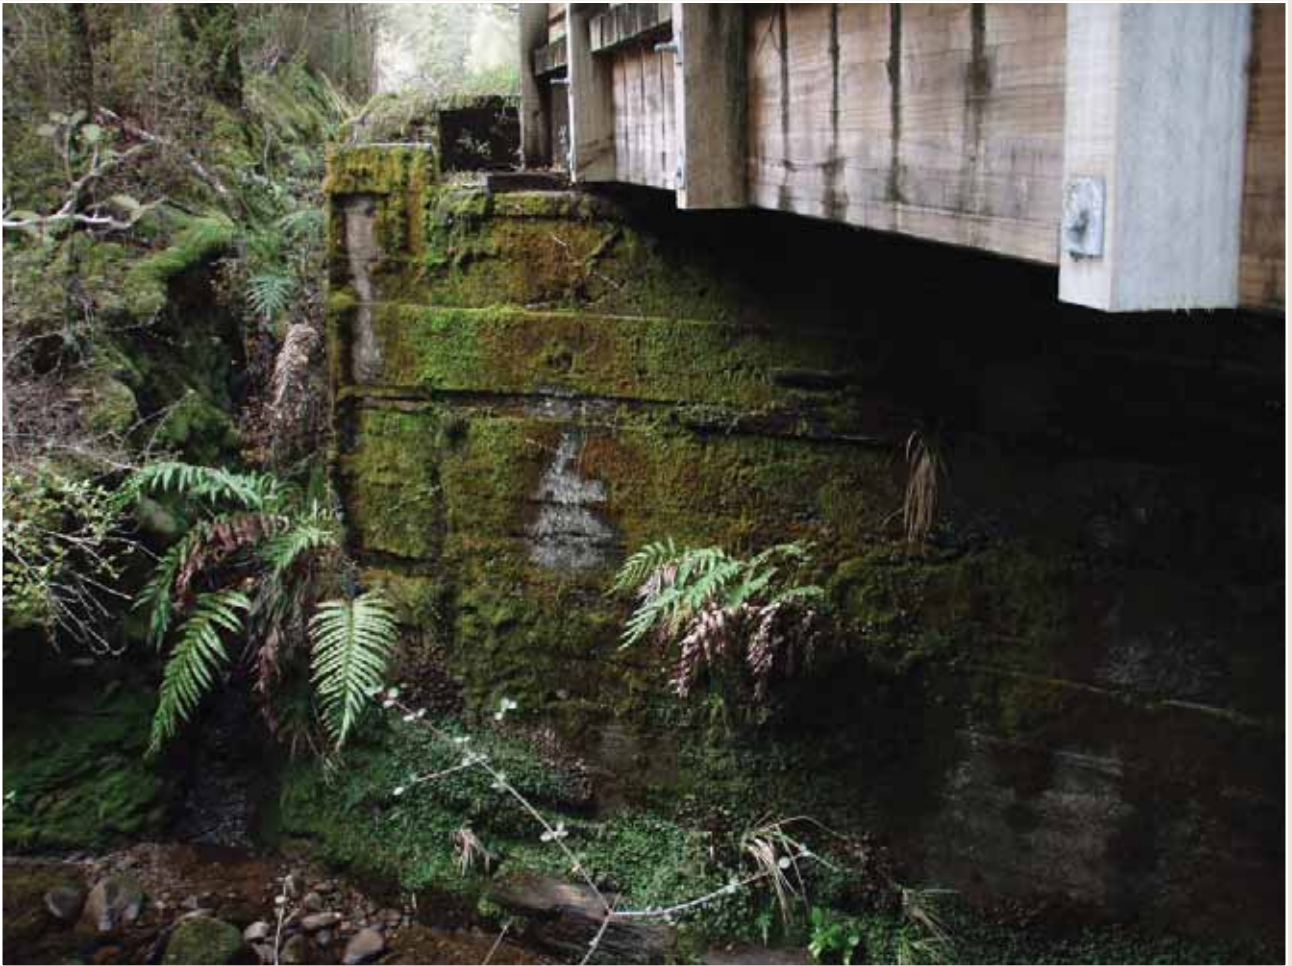
At the Charming Creek Bridge the remains of old bridge timbers are still present here from 12x12 original beams and also one of the anchor blocks is still here. Another bridge (photo 51; GPS ID 154) is a modern bridge sitting on old abutments. Only one bridge in this section appears to still be original.

Photo 51: Modern bridge built on old concrete abutments.

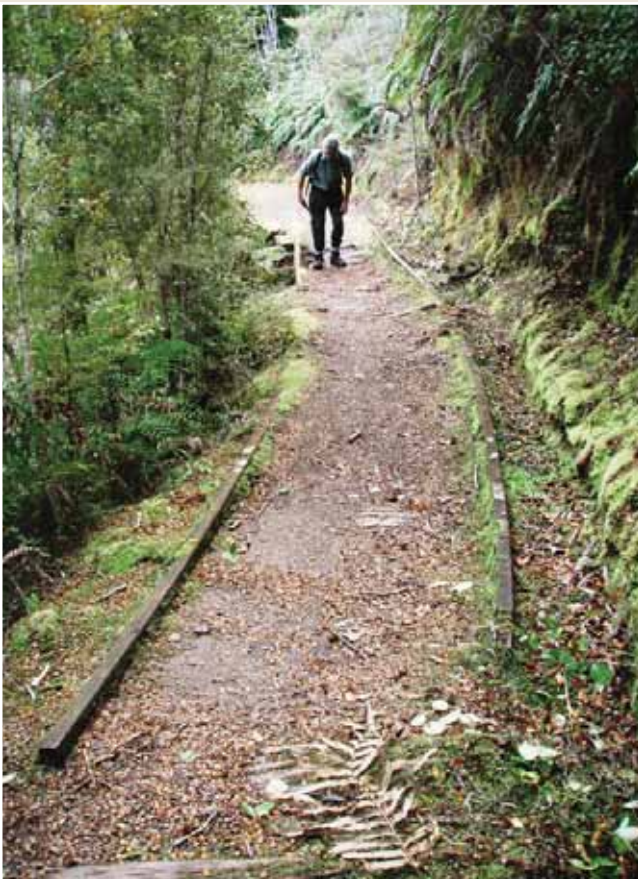
There is evidence of many kinds of tramway formation features in this section including benching. It is in this section of track that the first lengths of in situ rail are found. A good example of benched tram formation with a section with in-situ rail is at GPS ID 159 (see photo 52).

Photo 52: In-situ rail on a side benched formation.

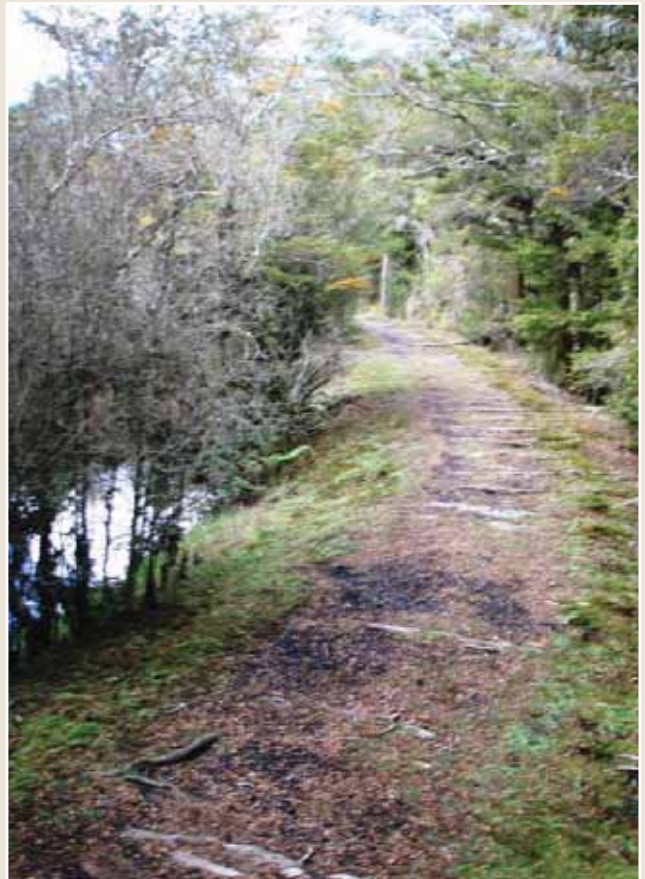
There are some unique historic features on this section of tramway. The first is a post suspected to be a telegraph pole, which is the only post like this known on the walkway. The other is a well defined section of embankment (GPS ID 155). This section is built up within a very boggy area - see photo 53. For the first time on the tramway alignment side drains are visible in places too. One very tall cutting has a side drain on the west side (photo 54).

Photo 53: Embankment formation with sleepers exposed

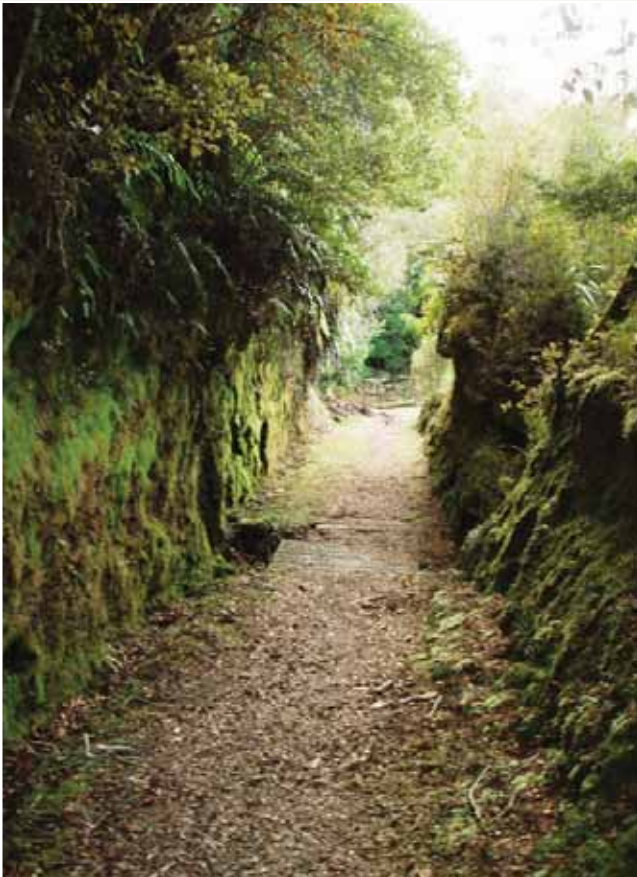
Photo 54: Right - Cutting with side drain.

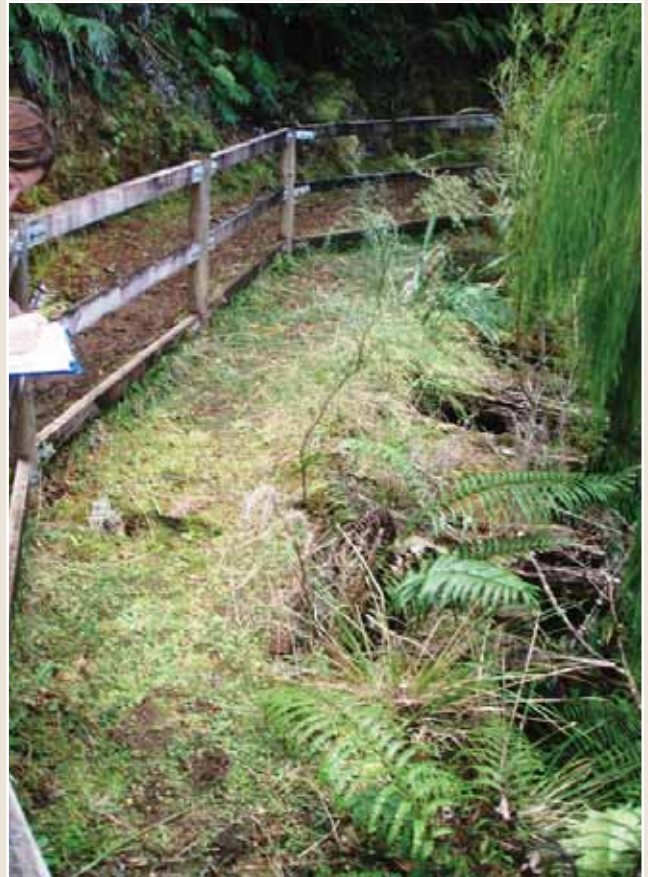
Photo 56: Section of tramway being undermined.

The condition of the tramway formation is very good. There are a few exceptions where the tramway has been subject to slipping on sections closer to the sawmill. In some cases it appears that the rail may still be in-situ under the slips. There is some slumping evident on the north side of the embankment of GPS ID 155. One section of the tramway is being severely undermined and is fenced off (see photo 56).

- 1) Maintain vegetation along the outer edges of the tramway alignment to retain historic profile.
- 2) Historic and visitor upgrade work involving earthworks should be minimised to preserve potential subsurface remains, such as sleepers and rail, and eliminate any further modifications to tramway profiles. Likewise, the width of any tramway formations should be maintained and cuttings not altered.
- 3) Cut outs should be retained and reinstated if possible without damaging original fabric.
- 4) Slip prone areas should be monitored to mitigate further damage to historic fabric. This includes the section of tramway that is currently being undermined.
- 5) Any existing historic side drains along the tram formation should be cleaned out. This will assist with ongoing tram preservation.

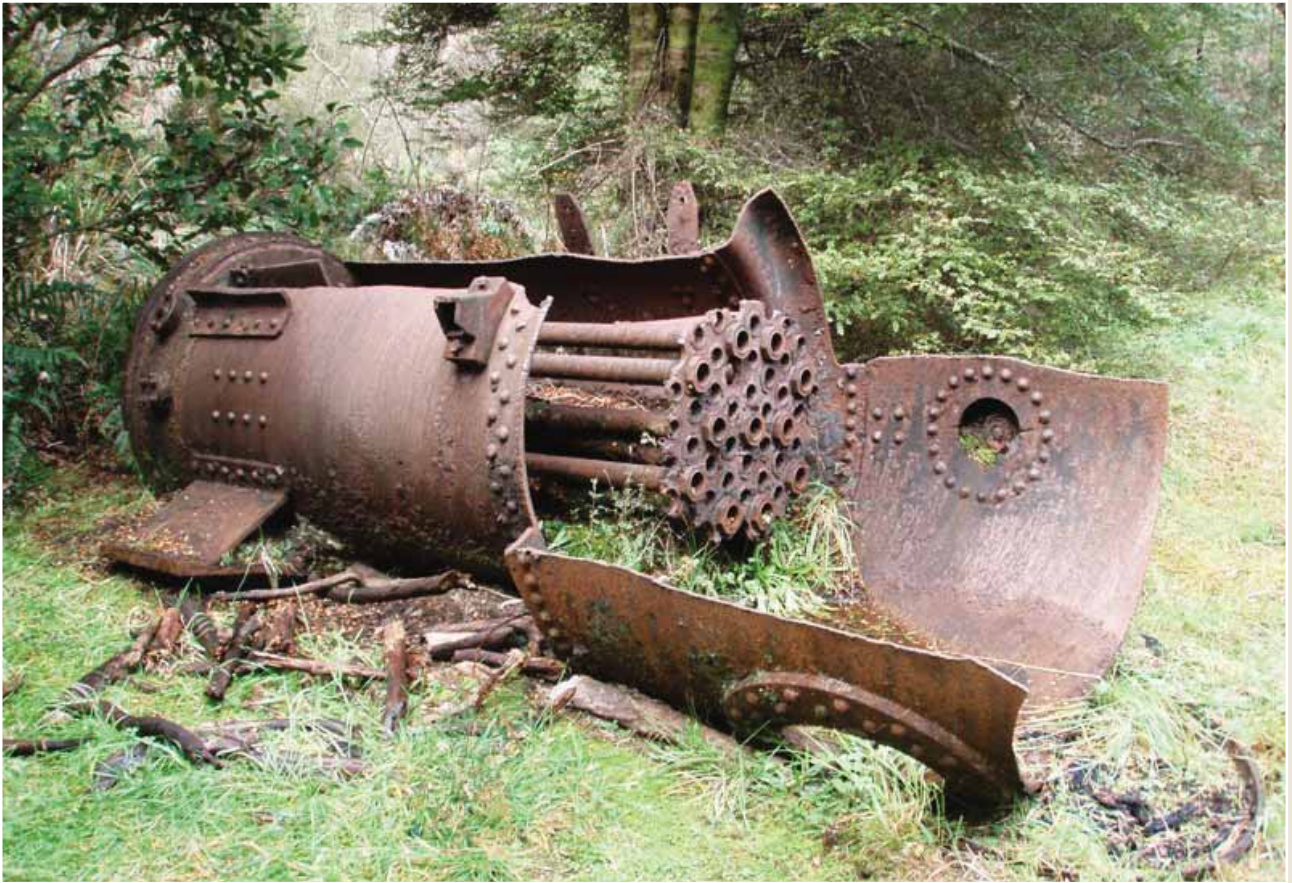
The boiler in photo 57 is a portable boiler, possibly a Marshall. It has a marine fire box (Tech Id asset no. 042713). The second, Photo 58, is an old style stationary boiler with a long fire box which would have been useful for utilising slab wood as fuel (Tech Id asset no.042713).

The boilers are in a fair condition, although a past salvage attempt has left at least one of them incomplete. Neither of the boilers have had any recent preservative treatment, and there is a build up of vegetation and organic matter in and around them.

Photo 57: Boiler

- 6) Establish a vegetation monitoring regime.
- 7) Initiate a metal preservative programme for the two mill boilers. If required update the maintenance specifications written by J. Green in 2002.

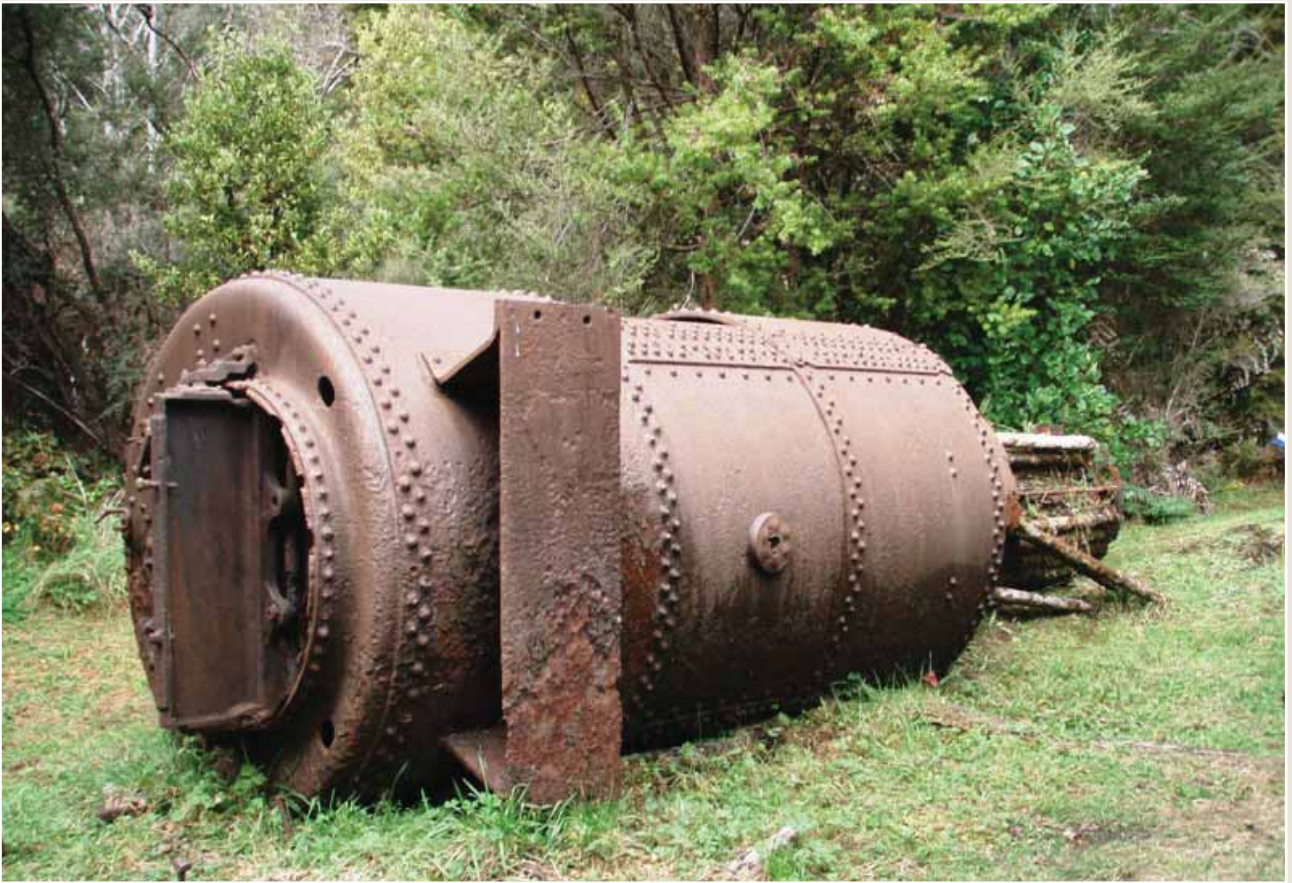
Photo 58: Boiler

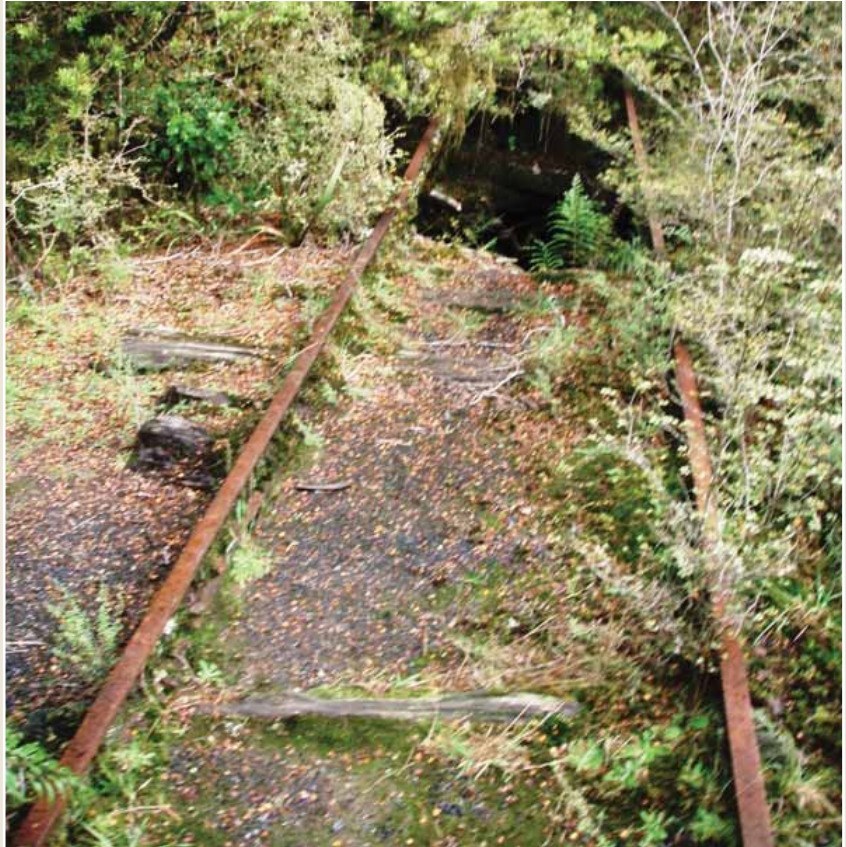
The tramway cannot be followed very far, because at either end where it has crossed the creek, the bridges are now non-existent (see photos 59 and 60). There are rails and sleepers still present on an embankment and through a long, high cutting. There is quite a bit of historic fabric on this section of tram, and sections of rail and sleepers have survived across the creek, a feature not seen on other sections of tram.

Photo 59: Left - Bridge site near Watson's Mill Shelter. The rails hang in mid air as the bridge has been washed away.

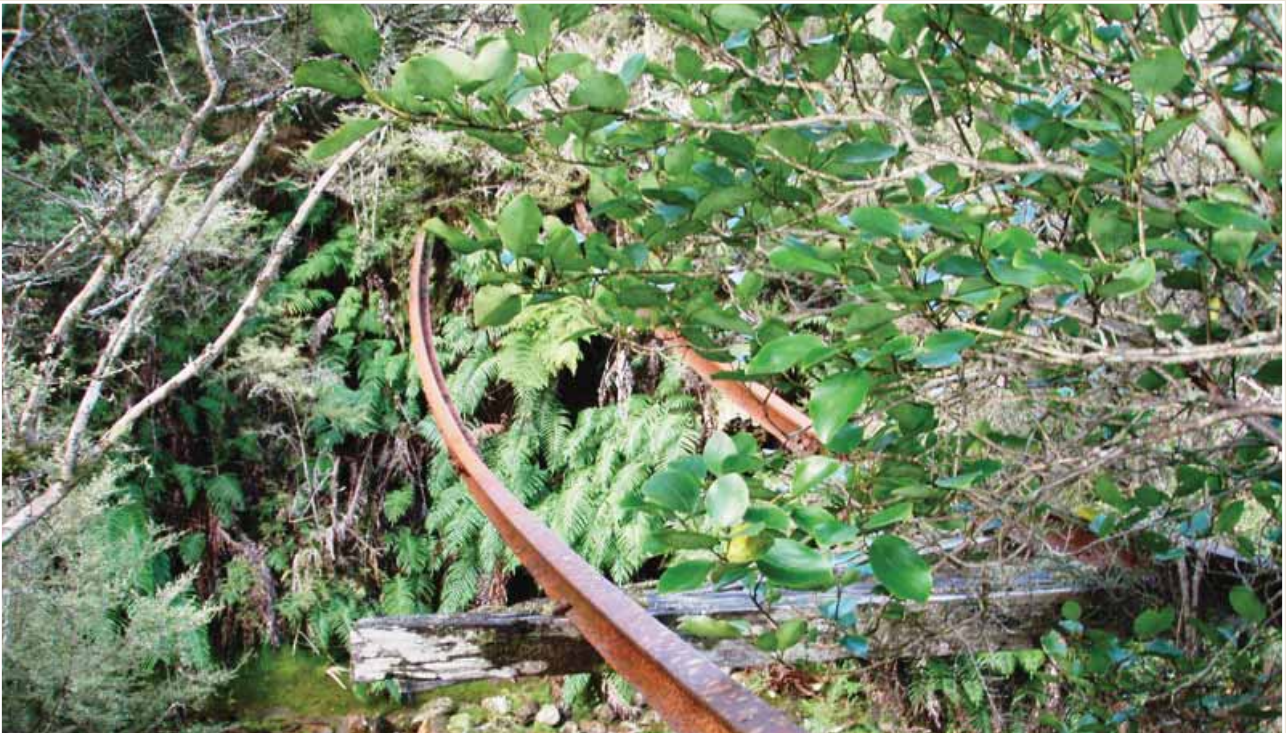
Photo 60: At the other end of the bridge only the rail and a few precarious sleepers remain.

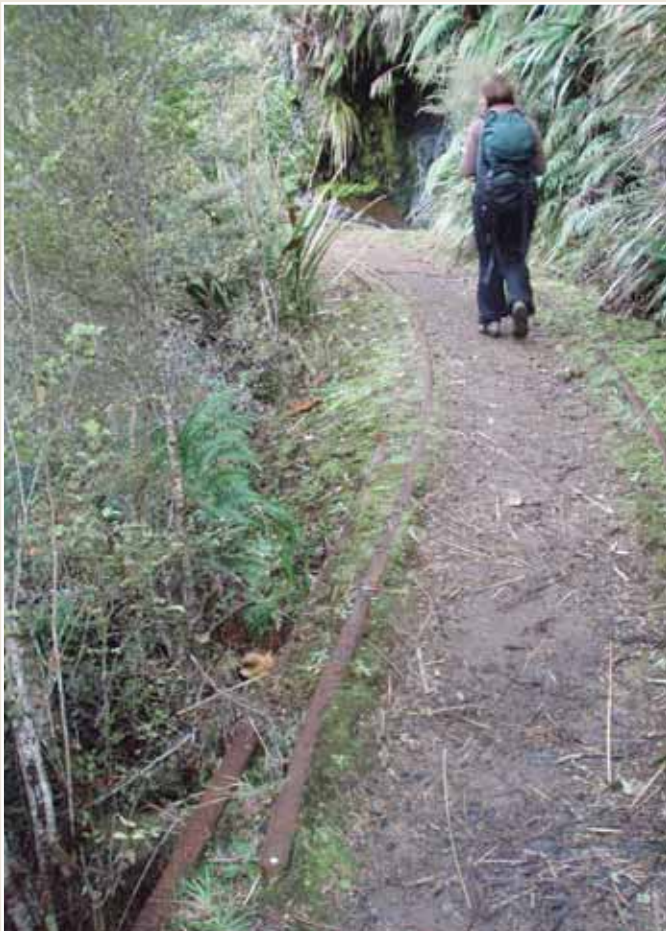
Photo 61: Section of in situ rail. Note the check rail bottom left. An extra safety measure to keep the tram on the rails as it negotiated tight corners.

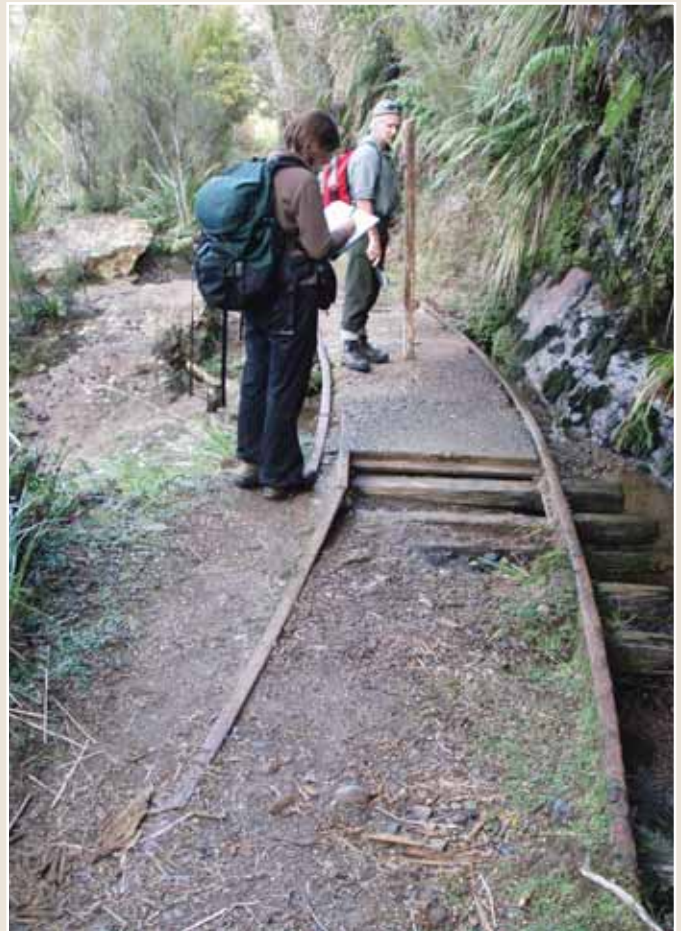
Photo 62: A section of the concrete slab bridge which has been undermined by water.

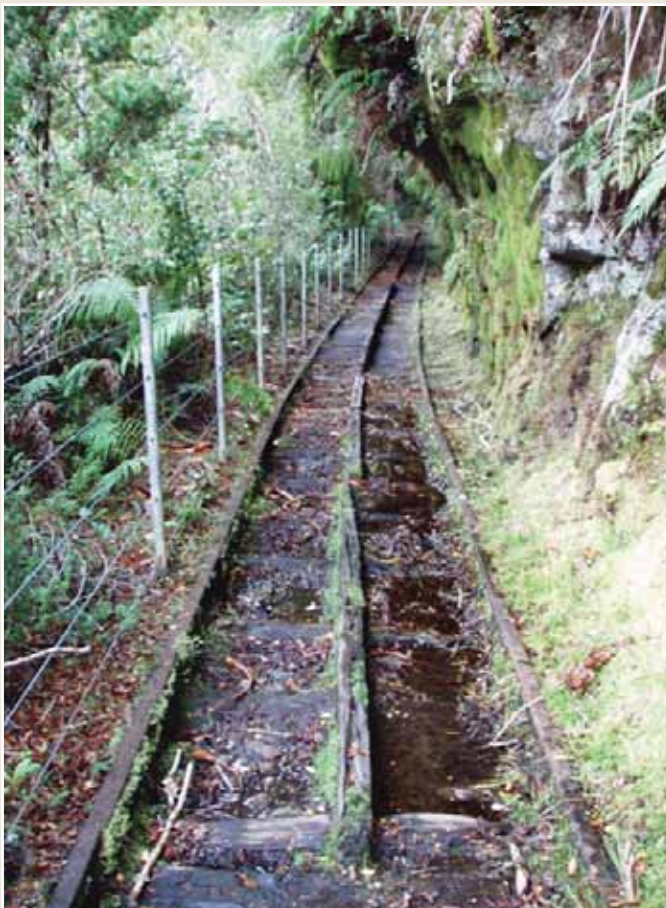
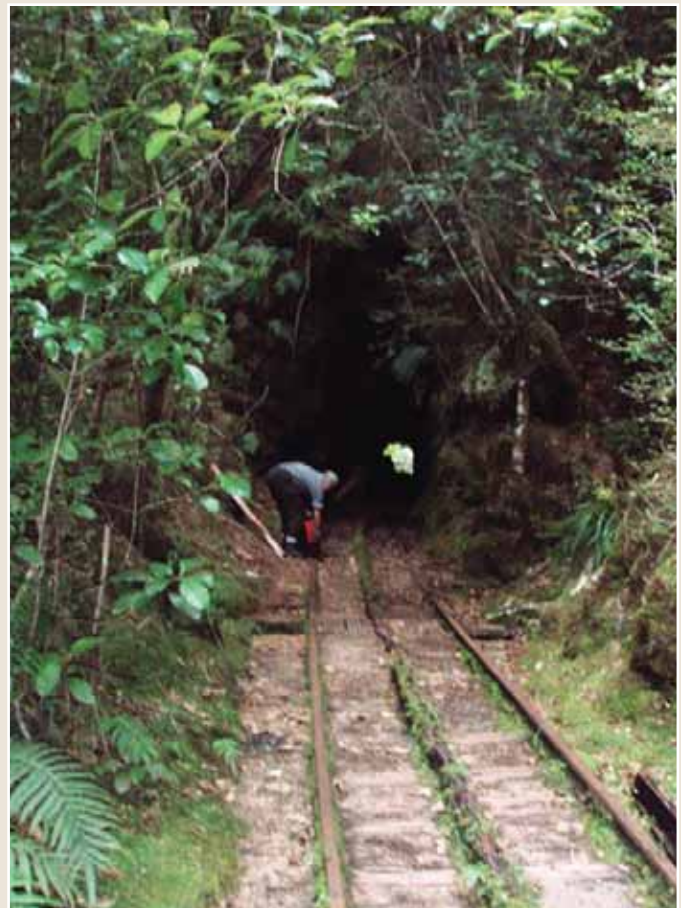
Photos 63 and 64: Centre rail brake at the southern end of The Veranda and the north side of the Mangatini Tunnel.

1. The centre rail brake should be left as it is and not modified. It should be monitored for any signs of deterioration.
2. Slips need to be monitored for safety reasons as well as to mitigate damage to the historic features.
3. Monitor large vegetation growth, especially for roots that may become established and undermine the historic features. Maintain vegetation to retain the tramway profile.
4. Historic and visitor upgrade work involving earthworks should be minimised to preserve historic remains, such as sleepers and rail, and

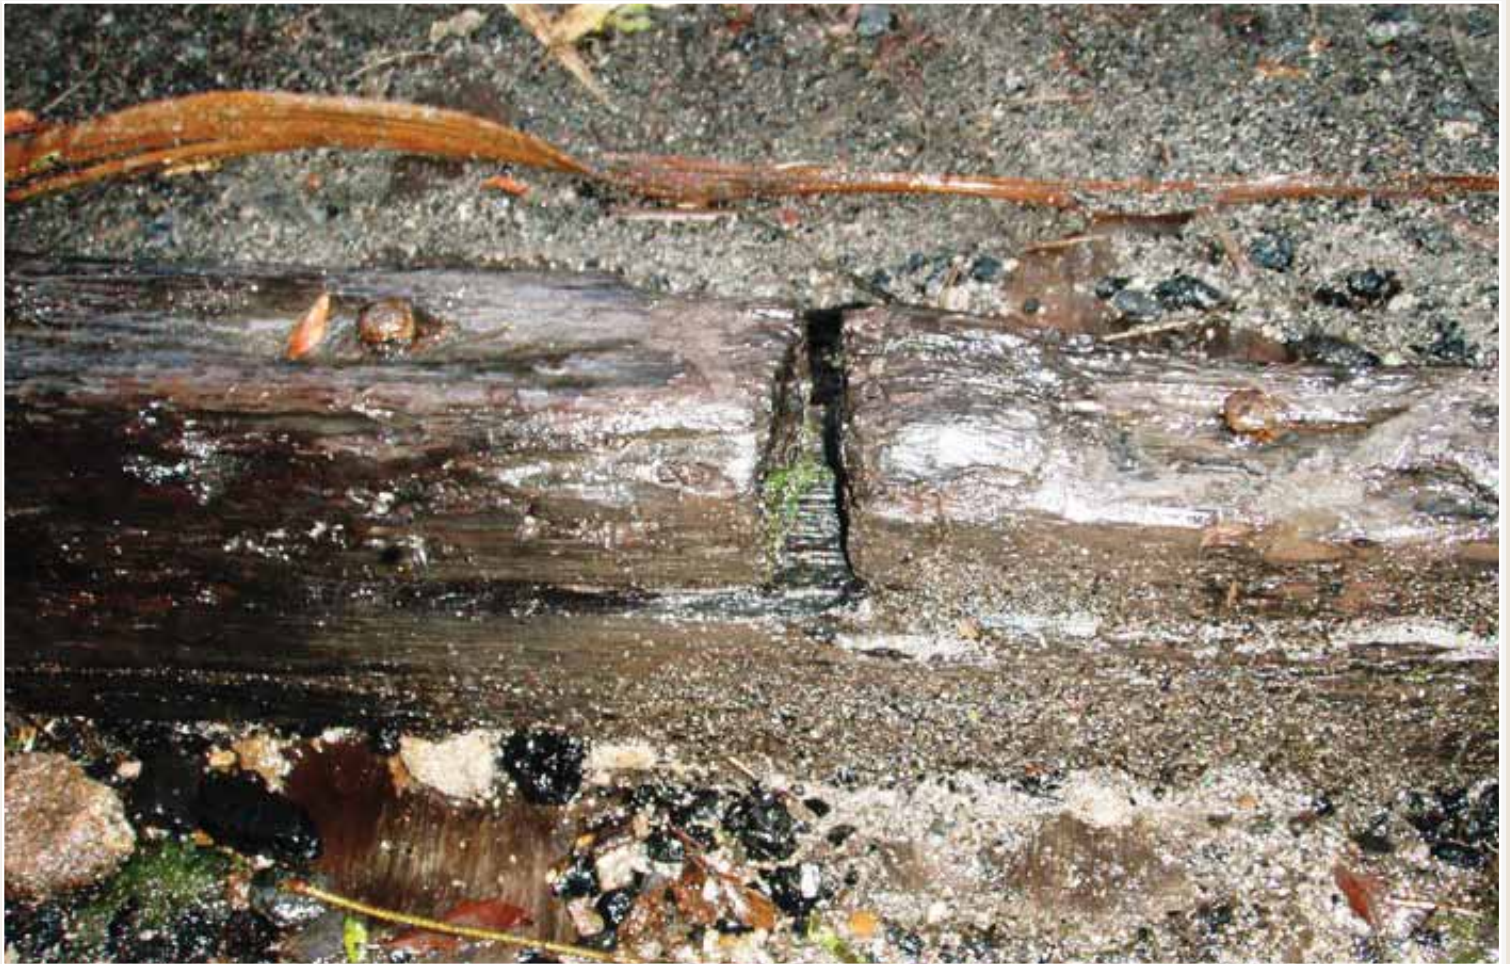
Photo 65: Detail side view of centre rail brake showing the placement of timbers

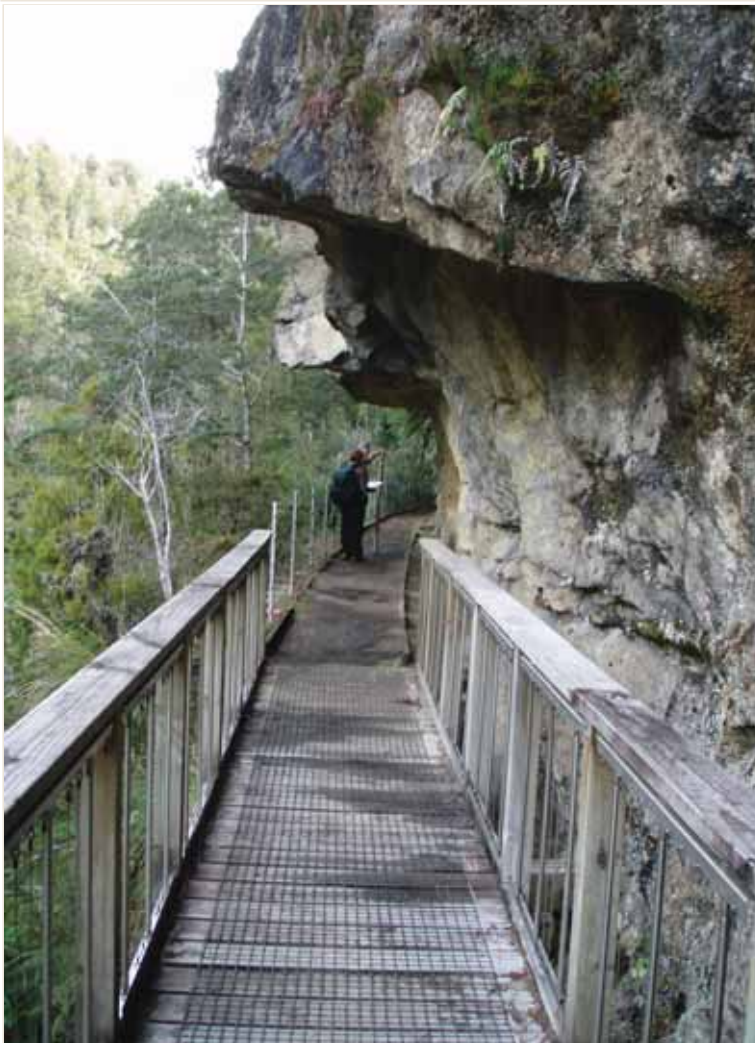
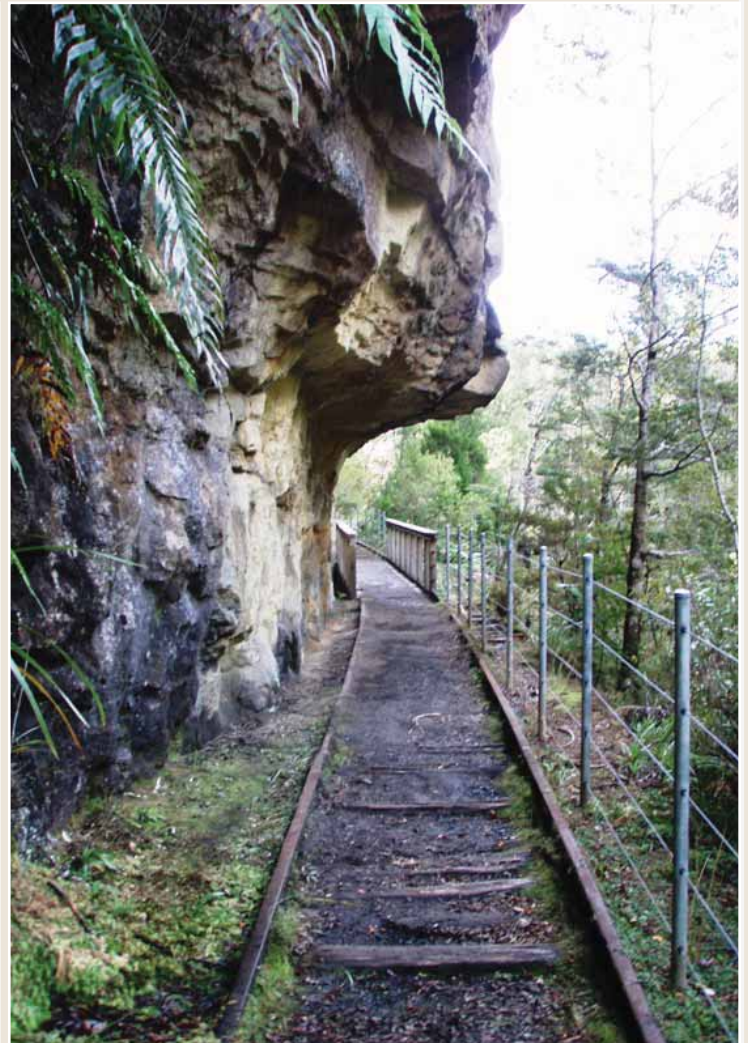
One of the most spectacular features on the walkway is a cutting named The Veranda where the tram negotiates the rocky bluffs of the Ngakawau Gorge. The bench gets extremely narrow in places under The Veranda. A safety barrier now runs along it's the length. It was constructed to be sympathetic to the historic values with posts being carefully placed between sleepers. Beyond the addition of the modern structures, the cutting is as impressive as it was when the tram was initially built. (Photos 66 and 67)

Photos 66 and 67: The Veranda in 2008, from both directions

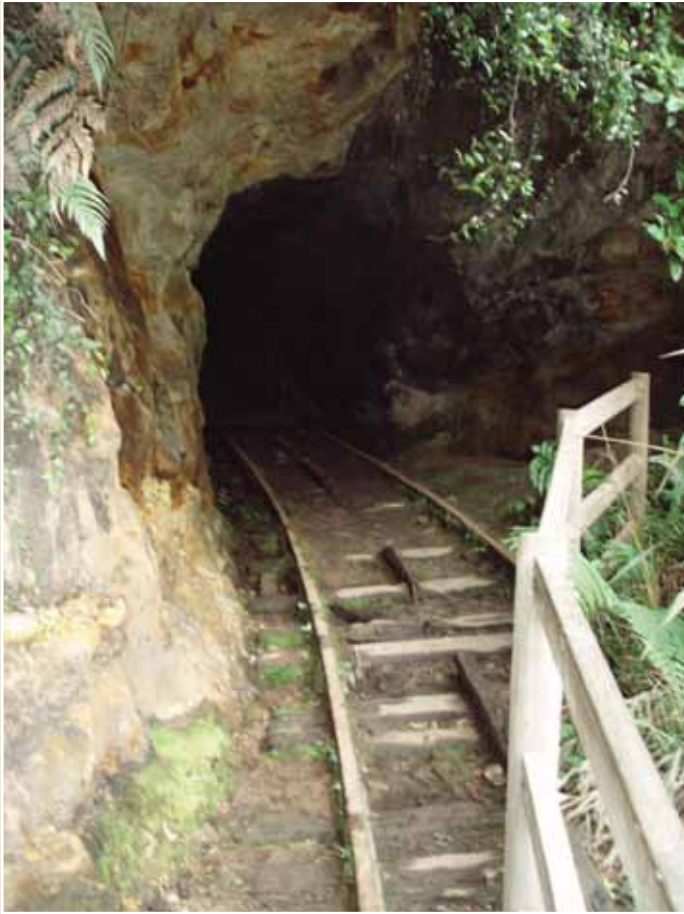
The tram formation immediately outside the western end of the tunnel has been undermined a little by a slip. Potentially this area was always unstable, as the tram has been built out on a series of closely spaced sleepers. A modern safety barrier has been installed to prevent track users straying too near the edge (see photo 68).

Photo 68: Western end of the Mangatini tunnel where it comes out into the Ngakawau gorge.

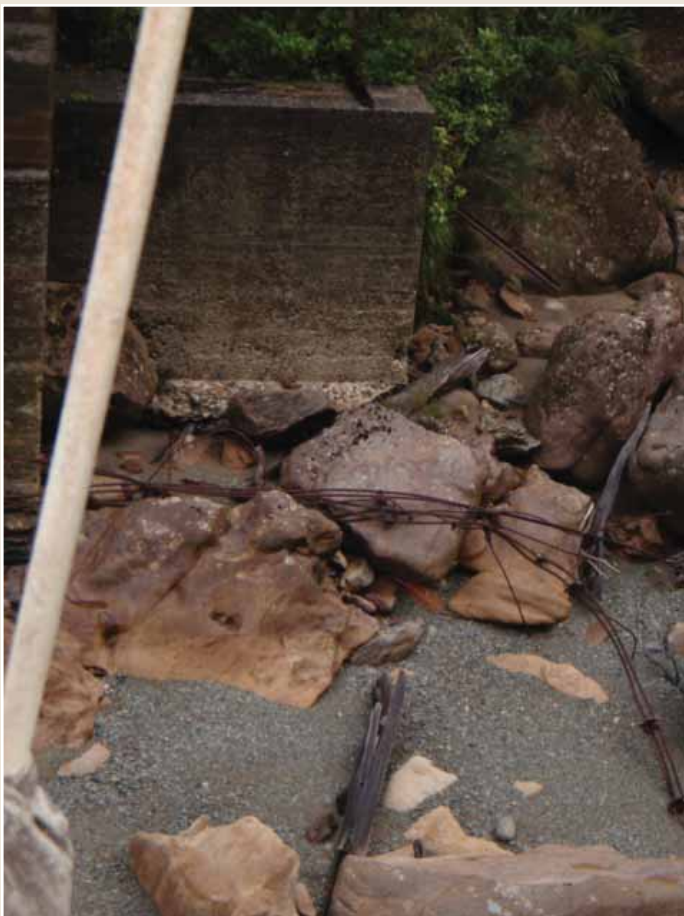
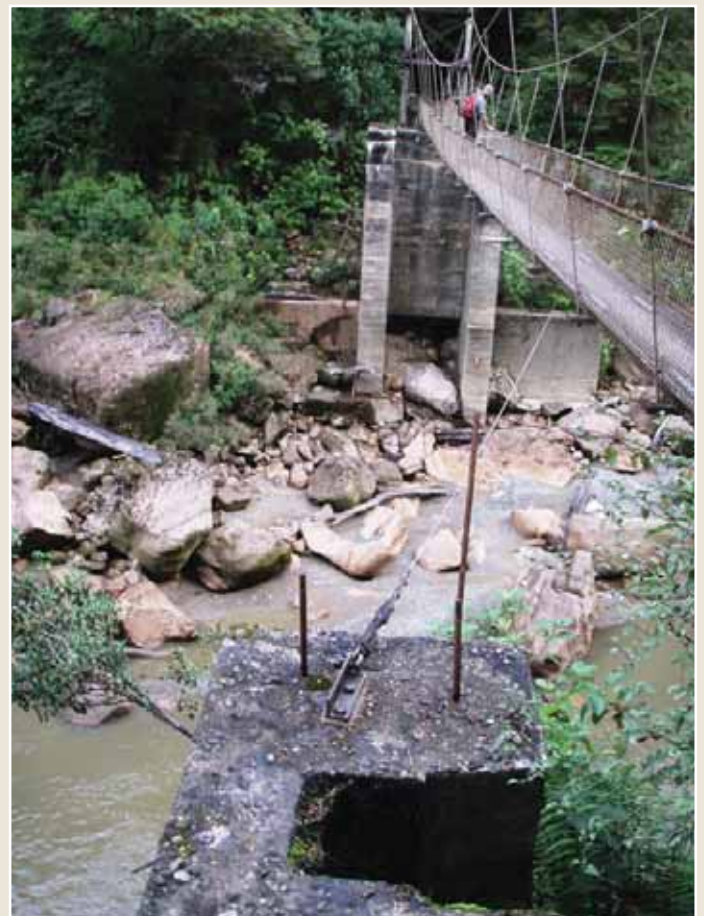
Not far from the western end of the Mangatini Tunnel, the tram crosses the Ngakawau River, passing over a suspension bridge. The Ngakawau Suspension Bridge utilises old concrete anchor blocks and abutments from the previous tram bridge (see photo 69 and 70). Figure 7 shows bridges on this site over the years.

Photos 69 and 70: The Ngakawau Suspension Bridge looking to the true right, and detail of abutments and cables in the river bed below the bridge.

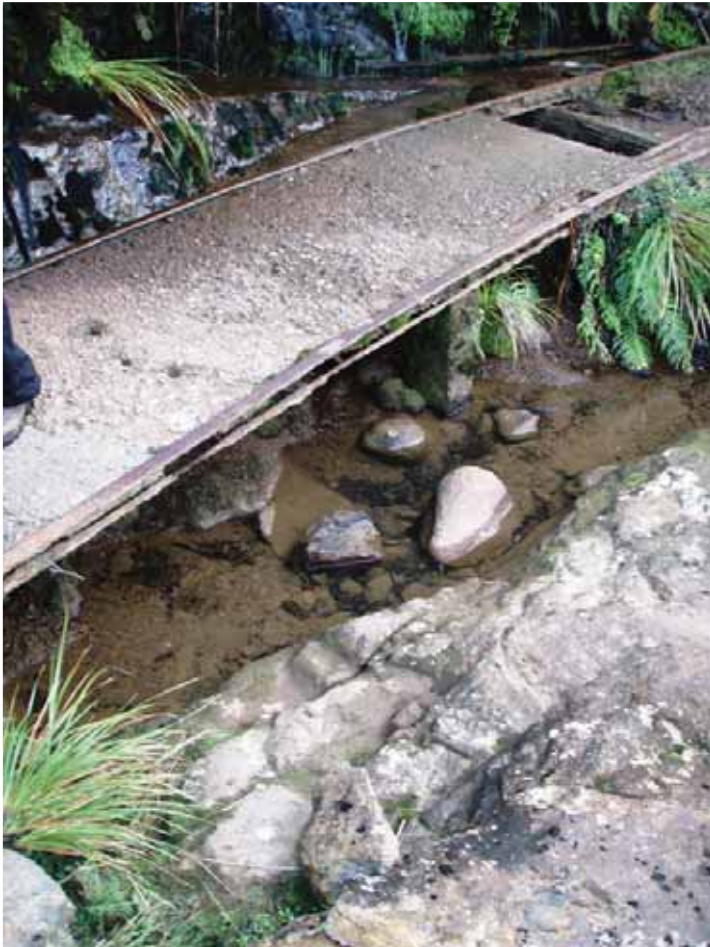
Some parts of the tram in this section are under threat from slips or undermining from water courses. The section of tramway closest to Watson's Mill is much modified due to poor drainage, washouts and water scouring (see photo 71). As noted previously, at the south end of the Mangatini Tunnel, a slip has undermined the edge of the tramway formation. This section has been fenced off from visitors (photo 72).

Photo 71: Waterfall undermining rail formation under concrete slab.

5. The waterfall at GPS ID 196 needs to be redirected to stop the tramway from being undercut further. Seek advice from TSO Historic.
6. Drainage needs to be re-instated on the section of tramway just west of Watson's Mill in a manner consistent with past construction and without altering the historic fabric. This will ensure ongoing stability of the tram formation.

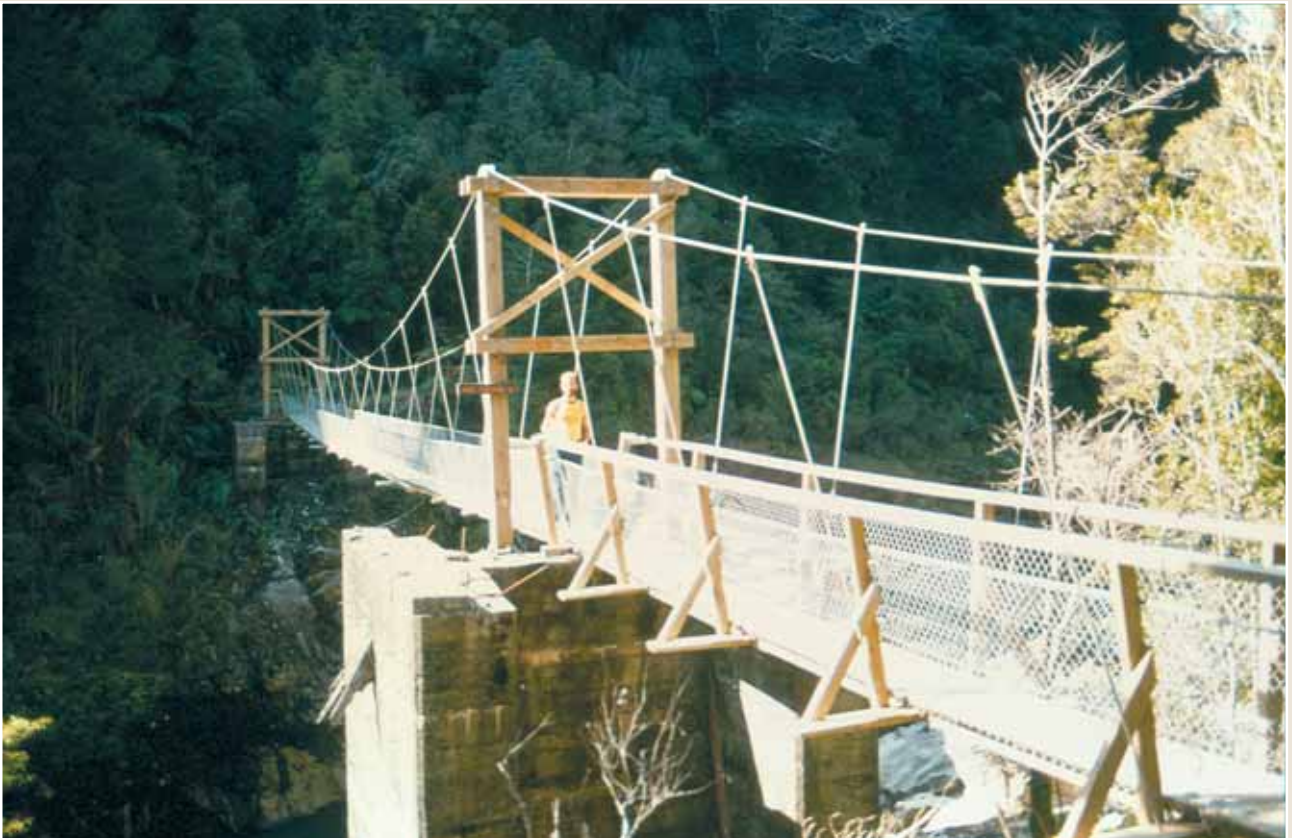
Figure 7: The Ngakawau Suspension Bridge site. The images on the following two pages show four different bridges on the site.
 1) Earliest image during the horse tram era- pre-1914;
 2) Bridge upgraded, probably to take the weight of lokeys ca.1914 - could be later;
 3) View of bridge built in 1935 taken in 1948;

4) The 1935 Bridge in 1975 - note work has been done replacing towers and the tower piers have been concreted in since the 1948 shot;

5) The current pedestrian suspension not long after it was built in 1981 by Fijian NZ Army recruits.

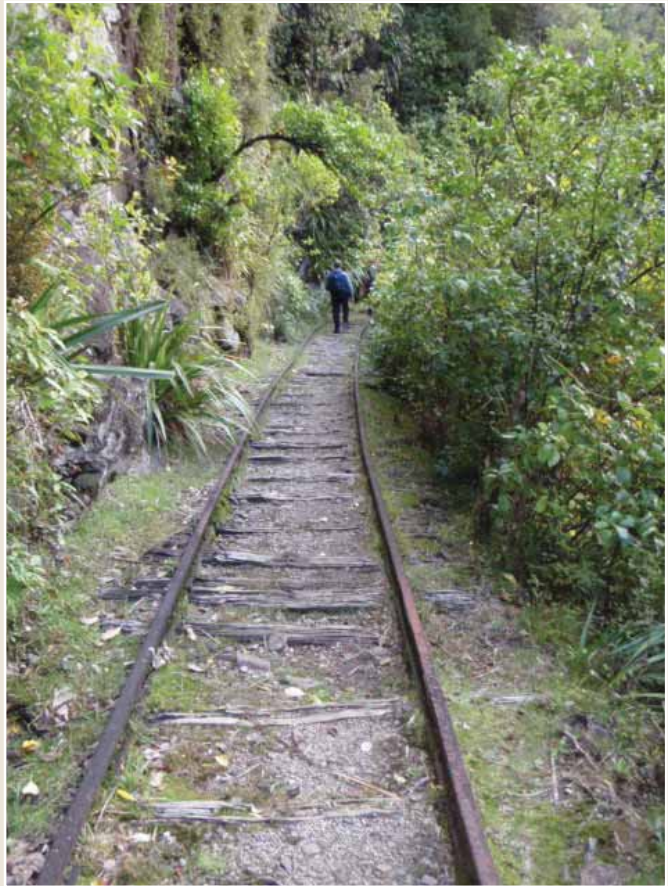
Photo 74: A good section of alignment, typical of the more intact parts of this section. N. COOKE 2008

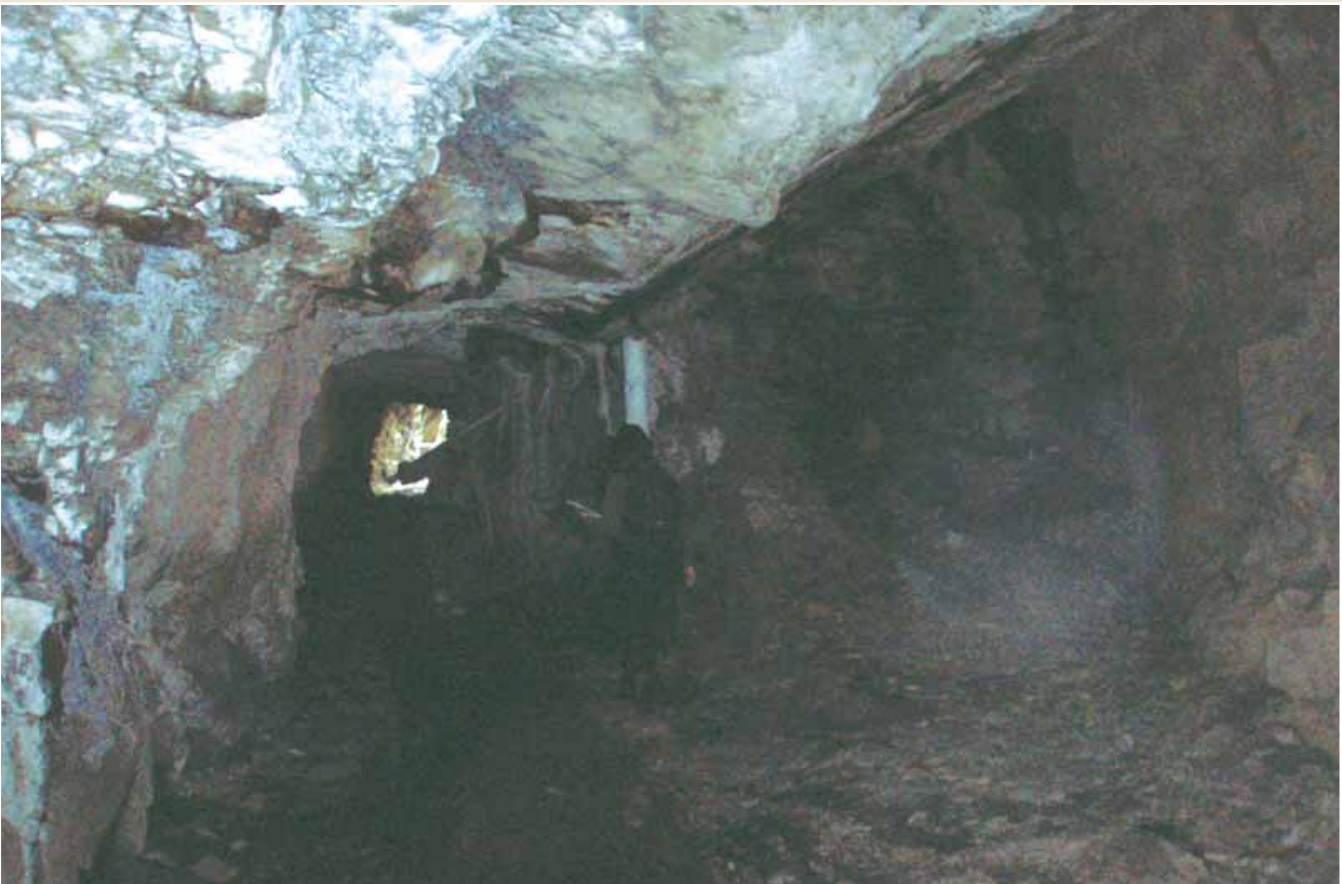
There is a single tunnel on this section. It is called Irishman's Tunnel and still appears to have rail and sleepers in-situ. This tunnel illustrates evidence of both the extensive earthworks undertaken on this tramway and of an alignment blunder that occurred during its construction (see photo 75). This tunnel was a 1930s upgrade of the tram, with the original line still present as a small bench formation around the rocky bluff.

Photo 75: Irishman's Tunnel. The large excavation on the right is an alignment mistake made during the creation of the tunnel.

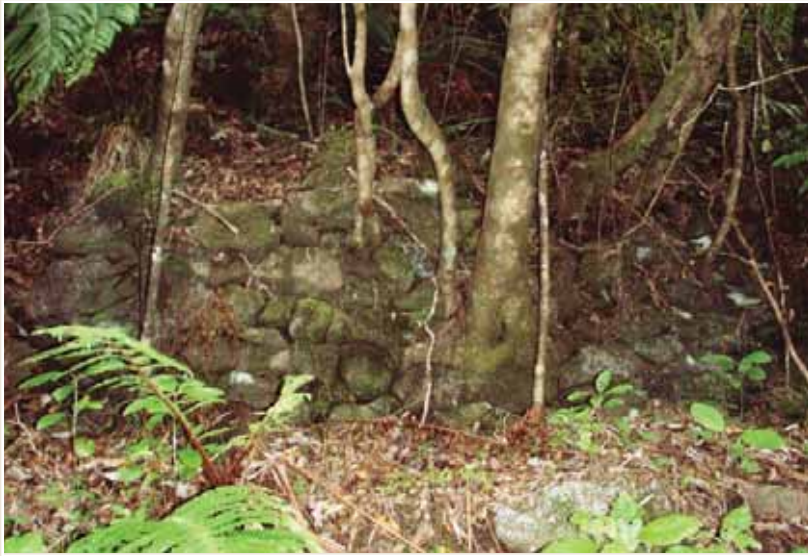
One of the more unusual features is a hand stacked rock wall, about 6m long, visible two metres from the track. This is the only example up to this point on the walkway (see photo 76). As this section is in an area prone to slips this feature would have been important for stabilising the bank above the tramline, part of an older tram alignment.

Photo 76: Hand stacked rock wall.

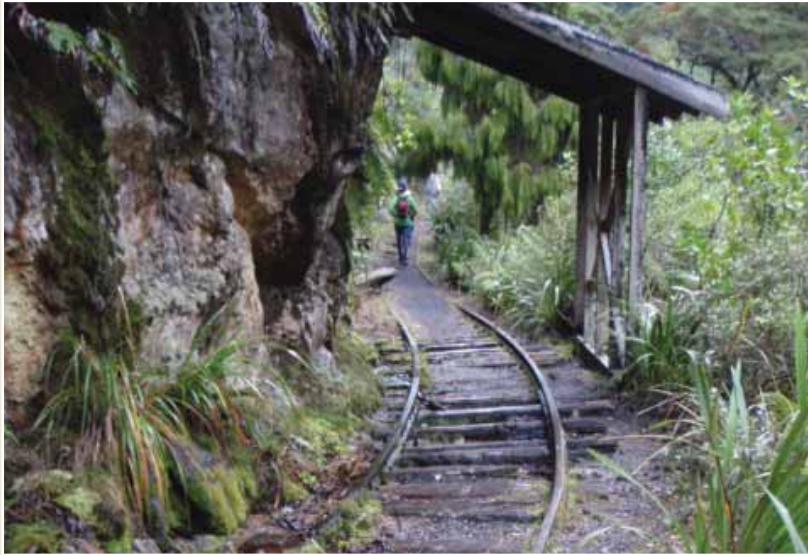
A modern water shelter (photo 77; GPS ID 228) on this section may be utilising historic tie downs.

Photo 77: Tramway going under the water shelter. N. COOKE 2008
