Charming Creek Walkway

Baseline Inspection Report

Jackie Breen and Amy Findlater West Coast *Tai Poutini* Conservancy

A report prepared for the Buller Kawatiri Area Office

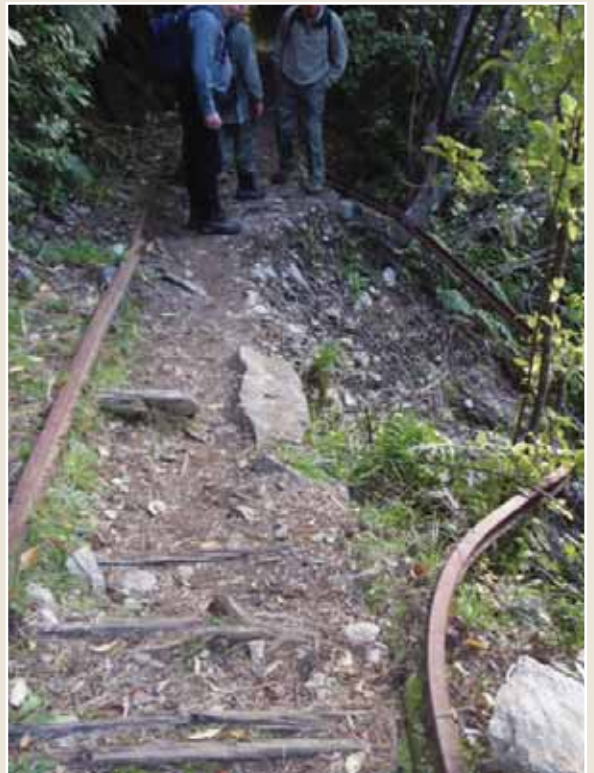
Photo 80: left: Roots growing over tramway formation.

but is really just a large modified leaning rock. At GPS ID 257 the walkway diverges from the tramway alignment for about 5m over a slipped section. There are also numerous parts of the tram where roots from the regenerating native vegetation are intruding onto the tram (see photo 80).

- 1) Slips need to be monitored for safety reasons as well as to mitigate damage to the historic features.
- 2) Monitor large vegetation growth, especially for roots that may become established and undermine the historic features. Maintain vegetation to retain the tramway profile.

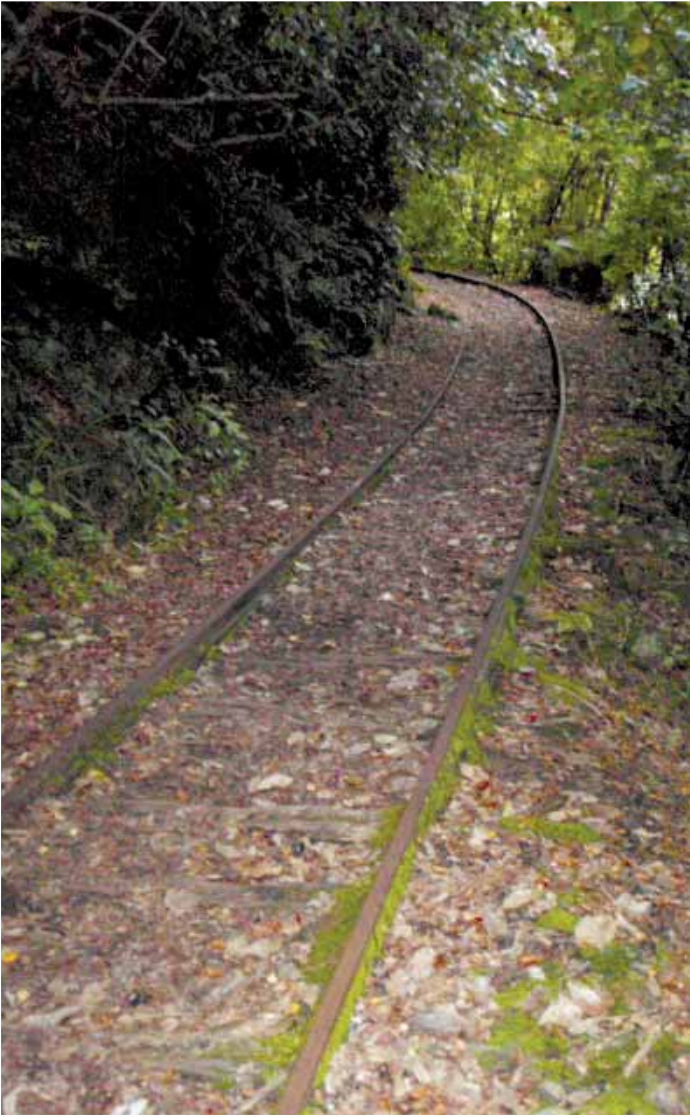
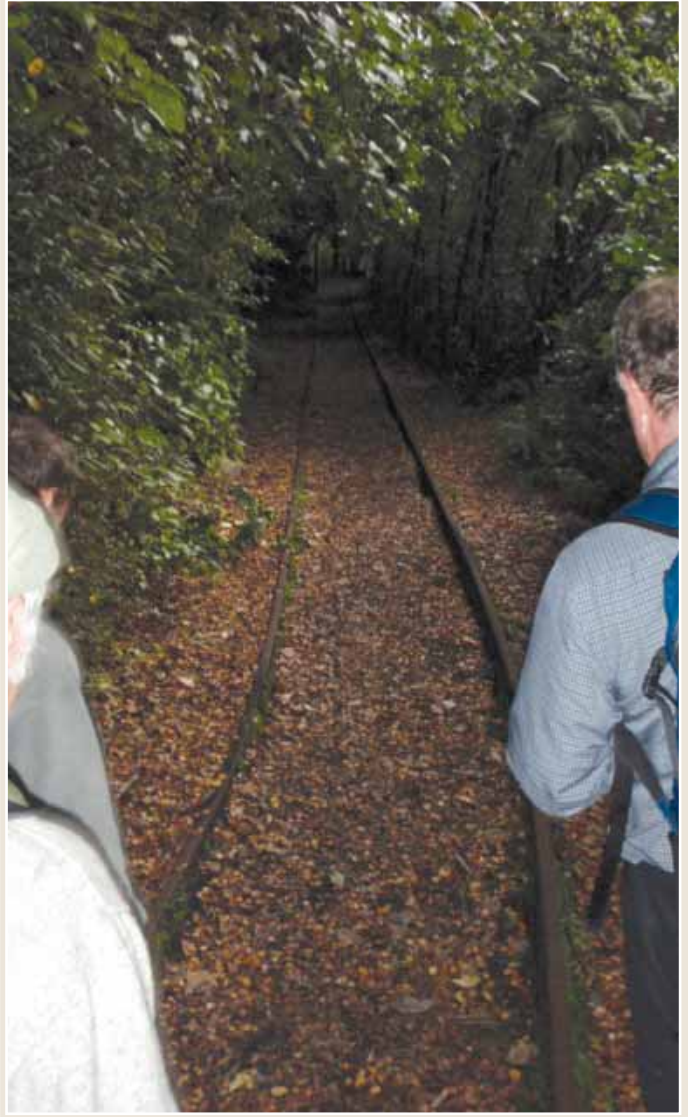
With this being said there are some very good sections of benched tram formation, with sleepers and rail intact (photos 81 and 82).

Photos 81 and 82: Examples of two sections tram in very good condition.

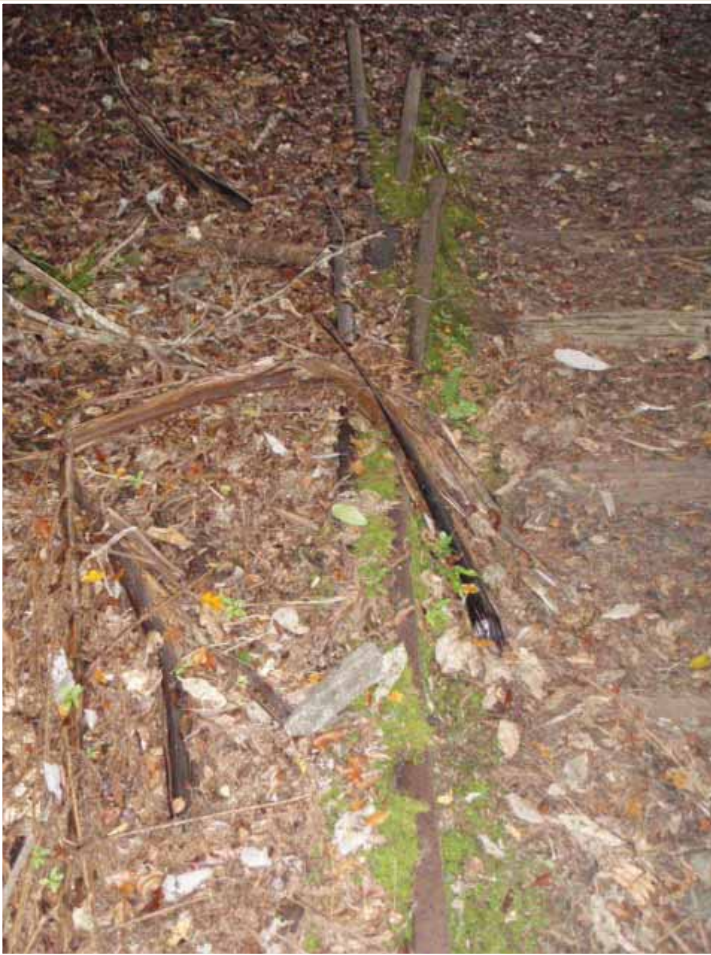
There are a number of other features along these lines, such as a set of points and a points lever (Photo 83 and 84).

Photo 83: A 'frog' at a set of points where rails for the coal and timber trams split to provide sidings access. N. COOKE 2008

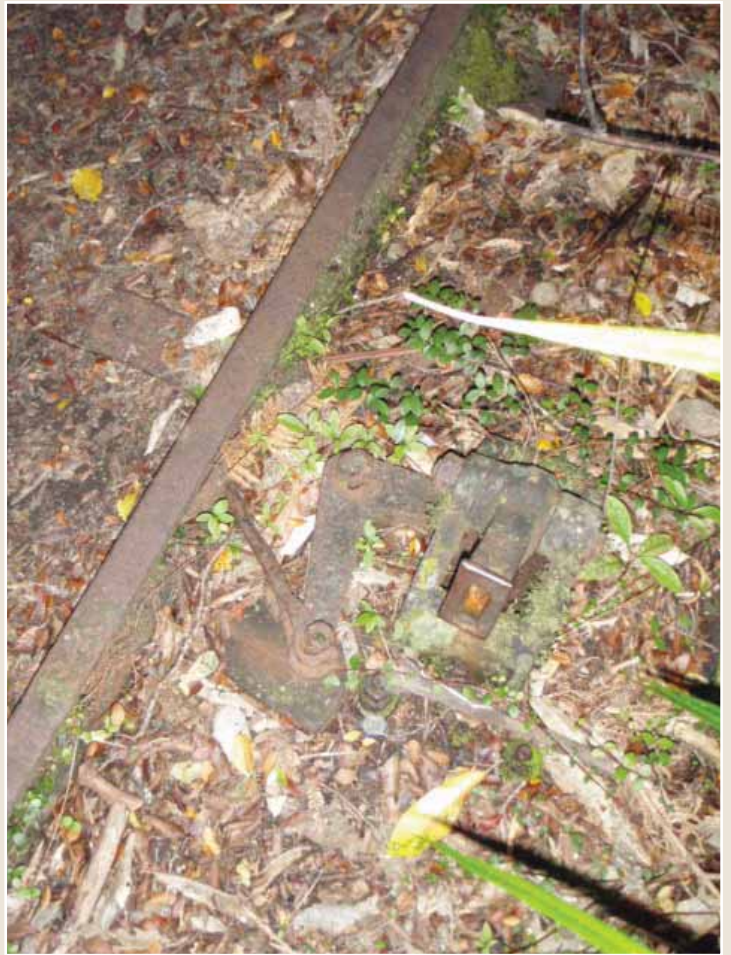
Photo 84: Part of a points lever mechanism. N. COOKE, 2008

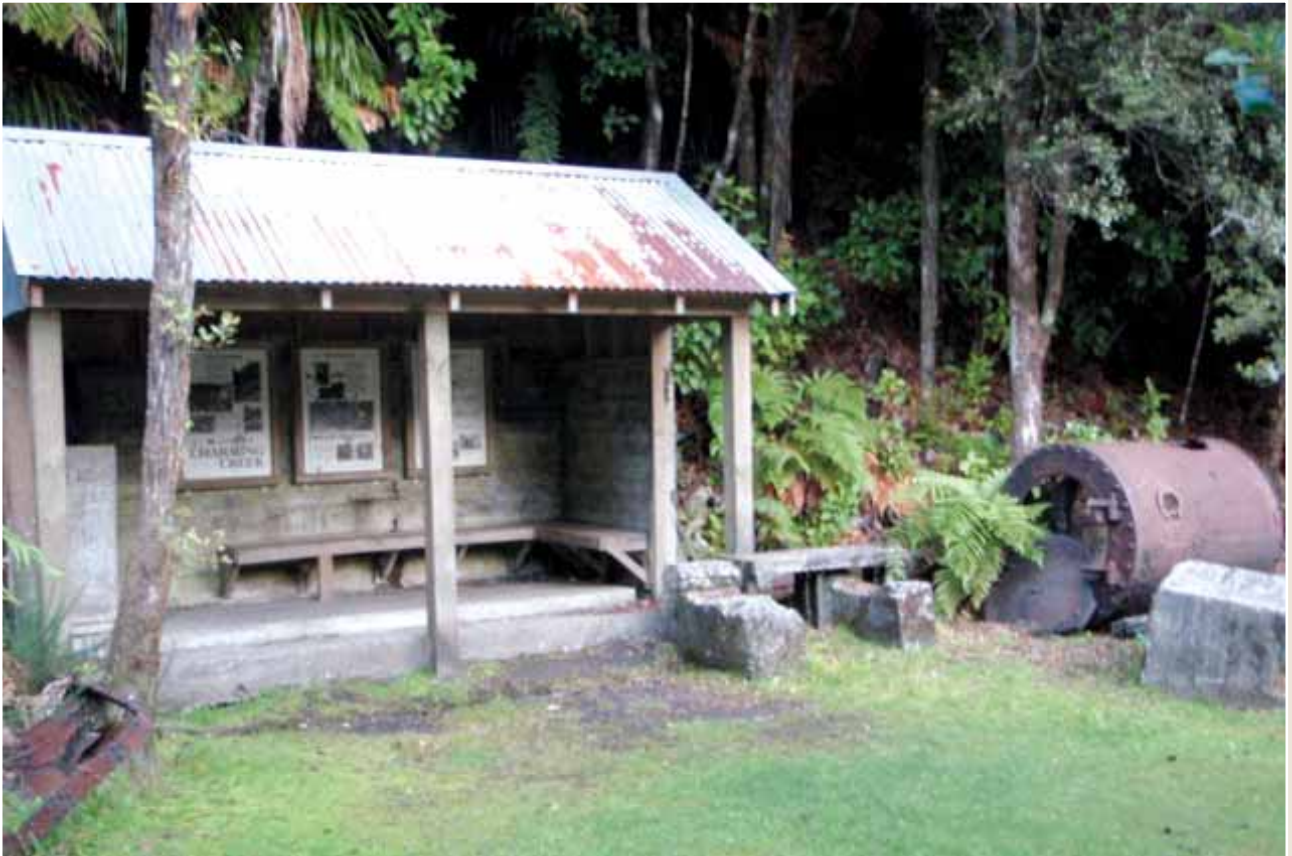
A modern foot track snakes down from the low level line to the timber tram line and the walkway, which is followed to the clearing at the bins site. At the bins clearing the tram is not apparent, with no rails or formation apparent. To the southeast of the clearing is an interpretation shelter which sits on the concrete pad of a shower unit. The line of a drain runs across the pad. Hot water was used from the steam plant that ran the bins screen. Other foundations adjacent to the shelter are associated with the steam engine plant. The boiler from this steam engine plant also lies near the shelter (see photo 86).²²

Photo 86: Interpretation shelter at the bins site, the steam boiler and foundations of the steam plant are to the right.
N. COOKE, 2008

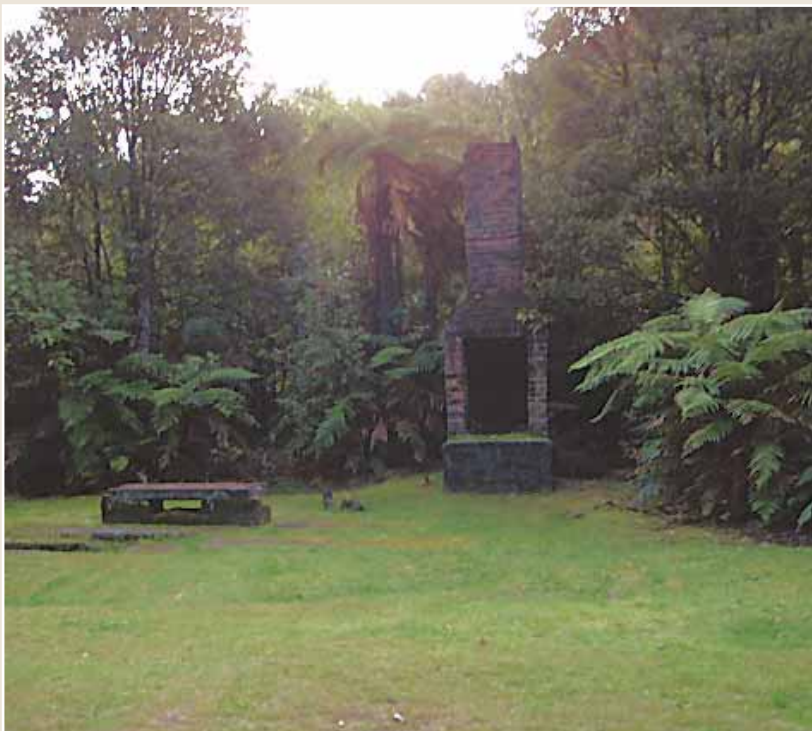
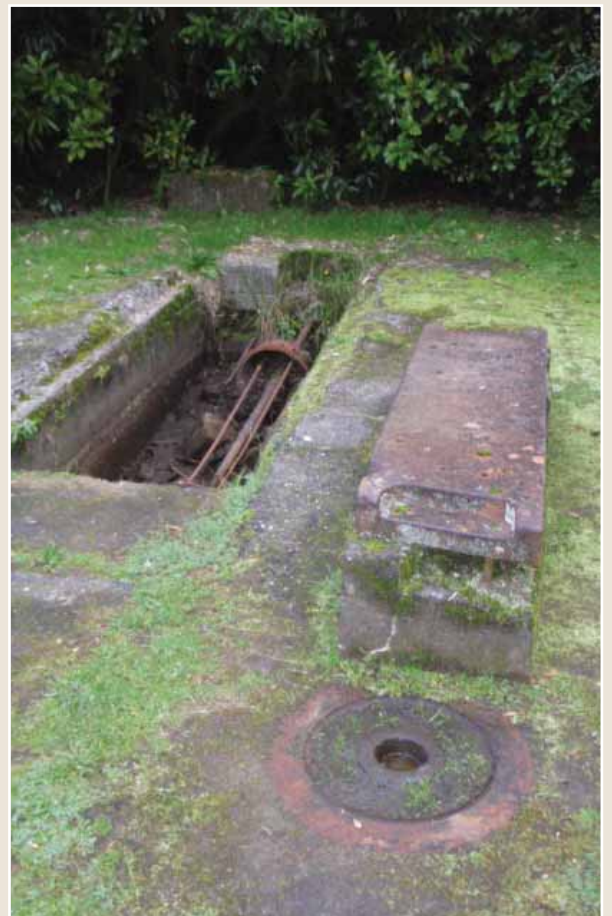
To the northwest of the clearing is the workshop site which is dominated by a brick chimney which was the forge. It has holes at the base that allow bellows to be inserted. Nearby is a pedestal for either a crane or drill press, other concrete foundations, an inspection pit and a lathe bed (see photos 87 and 88).

Photos 87 and 88: Above – view from the bins shelter to the workshop site; right – detail of the inspection pit and the lathe bed.
N. COOKE, 2008

- 7) Check the concrete and brick remains and produce a maintenance specification if required.
- 8) Start metal preservation work at the site. Write a maintenance specification and implement a maintenance regime, taking into consideration the maintenance requirements for the features listed in table 5. Carry this out with advice from TSO Historic.

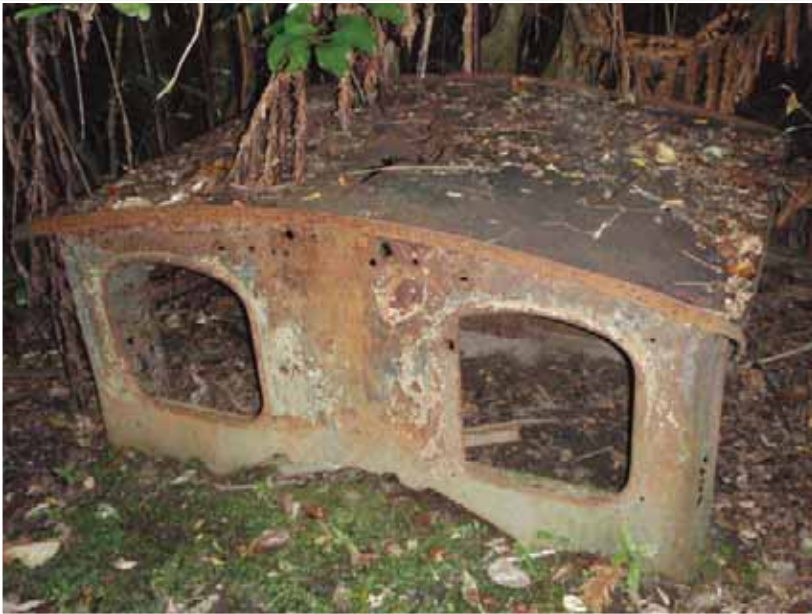
There are still many historic artefacts associated directly with the activities that occurred at the bins site in and around the area. For example a shaker plate is lying in the scrub behind the workshop was used in the bins to sort the coal, and along the track to the car park, the cab from an F-loco can be found (Photo 89).

Photo 89: An F-type locomotive cab, in the bush next to the track. N. COOKE, 2008

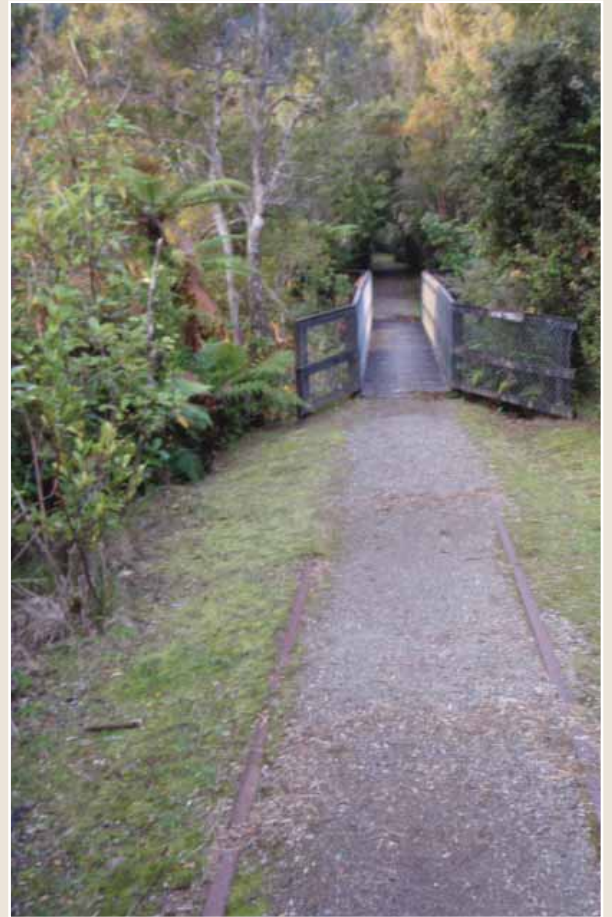
On leaving the bins clearing, the walkway follows the rail line out to the car park at Nagkawau. Not far from the clearing the track passes the site of a loco shed, with an inspection pit (see figure 22 at the top right hand side of the plan). The section of tramway formation west of the bins is a siding built to New Zealand Rail (NZR) standard gauge. NZR Q-wagons were used to transport coal from the bins to the main line. There are rails visible here in the track surface, and these lead up to the east side of the Mine Creek Bridge (see photo 90)

Photo 90: Mine Creek Bridge where the rail terminates either side of the bridge. N. COOKE 2008

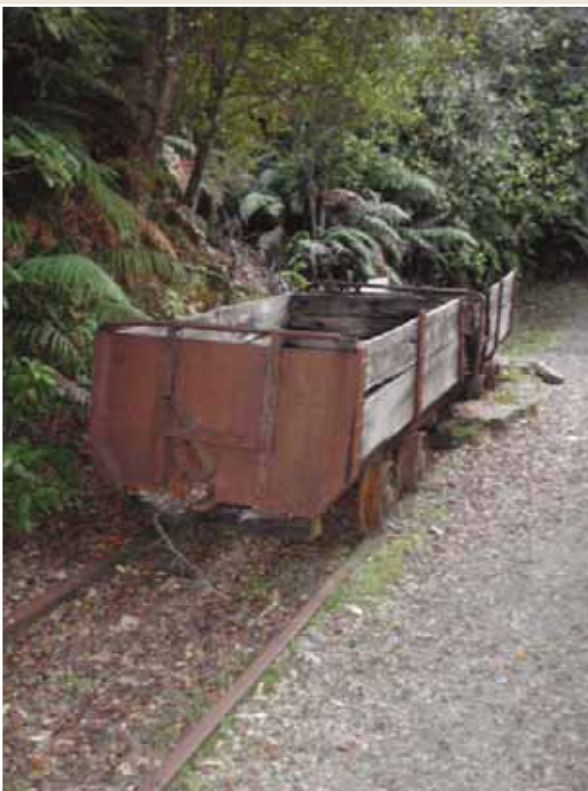
Photo 91: Set of coal tubs on the line from the bins to Ngakawau - this is not a historically accurate representation. N. COOKE 2008

- 5) Shift the coal tub display to the tram on the north-eastern side of the bins. Potential to set them up near the Ruston Lokey.
- 6) Vegetation should be monitored around any historic features at appropriate intervals.

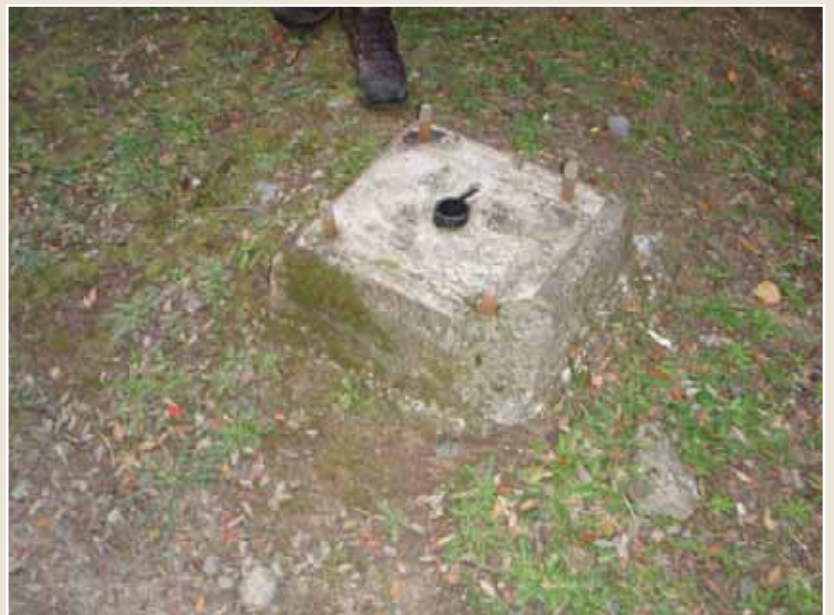
After this, the rails appear again in the walking track surface. This section is relatively modern, with rail screws being present to fix the rails to the sleepers. At GPS ID 306 the mounting for an electric rail signal light is present. The rail line disappears from this point, to re-emerge near the car park. It seems that this piece of the line is still being used as a back shunt by the coal trains from the Solid Energy Stockton Mine operations.

Photo 92: Mounting for the rail signal light. N. COOKE 2008
