# Riparian habitat enhancement in Hakarimata Streams

The Hakarimata Streams riparian habitat project was carried out by Genesis Energy as part of the resource consent conditions for the operation of Huntly Power Station. They were required to enhance and maintain fisheries habitats on at least two tributary streams of the Waikato River.

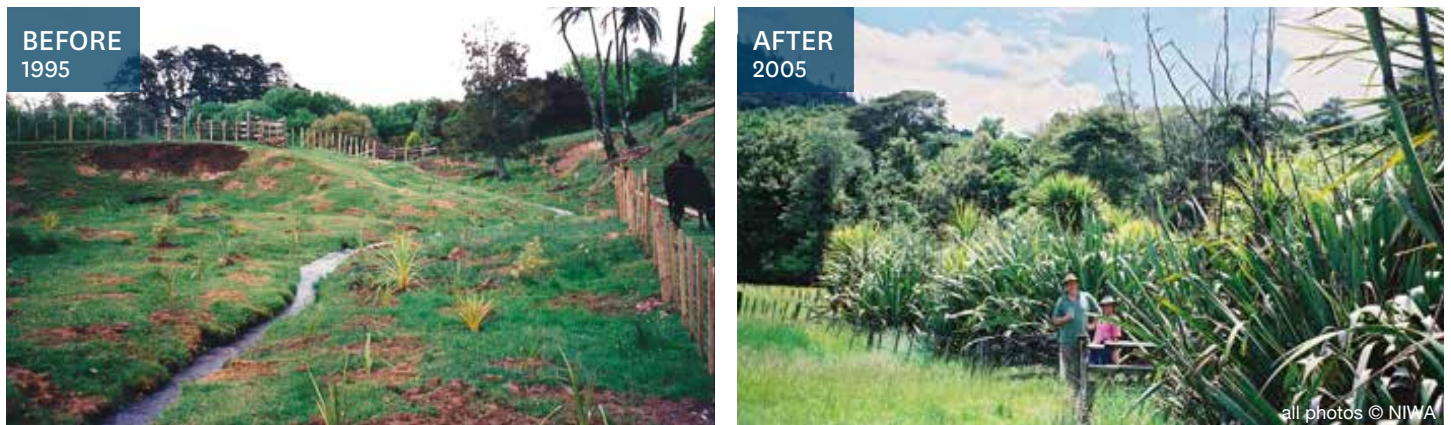
FIGURE 1: Martin Stream before and after the enhancement works

By 2005, the restoration efforts were deemed successful (Figure 1) with the total abundance of species associated with forested streams or streams containing good riparian cover (giant kōkopu (*Galaxias argenteus*), banded kōkopu (*Galaxias fasciatus*) and redfin bully (*Gobiomorphus huttoni*)) all having increased by 50% or more. In addition, lamprey (*Geotria australis*), a culturally important taonga species, had become established in two of the restored streams.

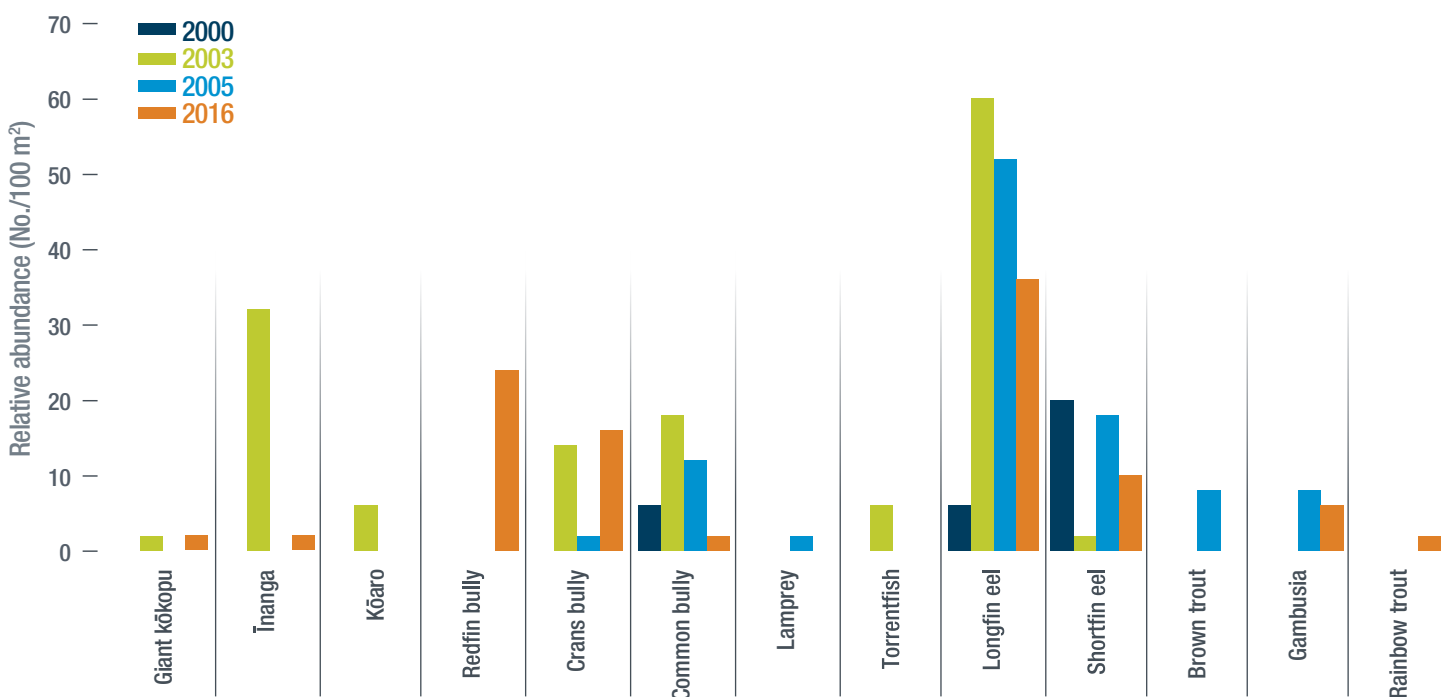
FIGURE 2A: Martin Stream – Abundance of fish species (2000–2016)

After 20 years (2016), the continued high abundances of banded kōkopu and redfin bullies indicated that the riparian restoration works have continued to provide good quality habitat in the lower sections of the streams (Figures 2A & 2B). Longfin eel (*Anguilla dieffenbachii*) abundances have also been maintained or increased compared to previous surveys, which provides further evidence that as the

In Martin Stream, the decline of īnanga (*Galaxias maculatus*), smelt (*Retropinna retropinna*) and common bully (*Gobiomorphus cotidianus*) in 2016 was thought to be the result of the perched culvert in the lower section of the stream (under Hakarimata Road) rather than a reduction or loss of suitable habitat. Erosion at the culvert outlet has created a barrier to migratory fish species (Figure 3), limiting access for swimming fish species unable to climb the wetted margins of obstacles.

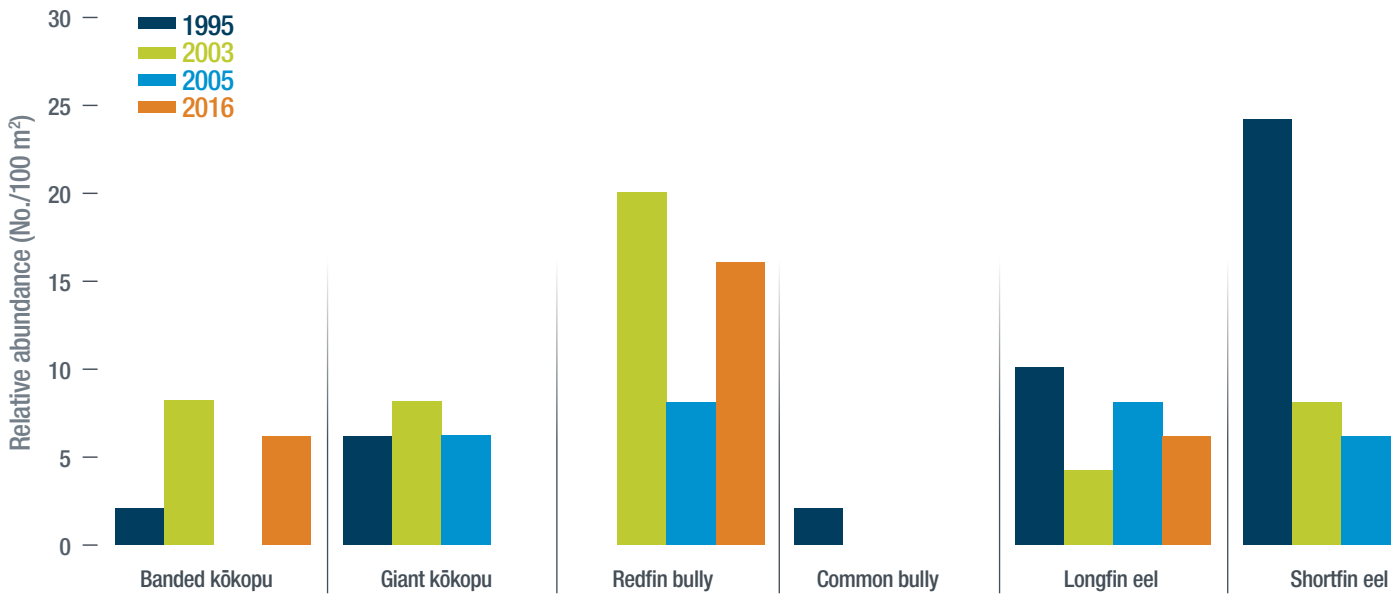
FIGURE 2B: Forested Stream – Abundance of fish species (1995–2016)

The absence of giant kōkopu in Forested Stream during 2016 is likely to be because fish had moved out of the survey reaches in search of more favourable habitat, as low summer flows had resulted in a decline of the deep pool habitat preferred by this species.

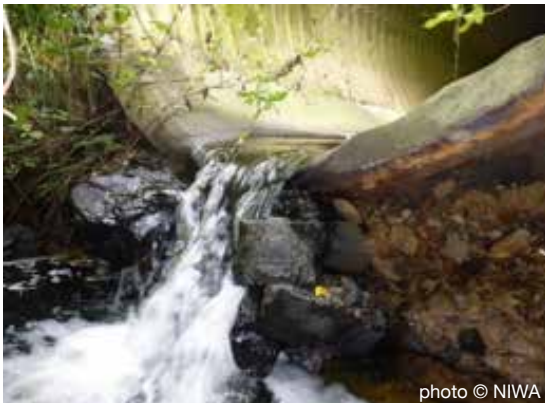
FIGURE 3: Perched culvert in the lower reaches of Martin Stream under Hakarimata Road

- In order to maintain diadromous fish populations, access to habitats is just as important as habitat provision itself. Although the council-owned culvert under Hakarimata Road (Figure 3) is downstream of the enhancement area, erosion at the outlet has decreased the abundance of swimming fish species (e.g., īnanga, smelt and common bullies) in the restored habitats. This highlights how other stressors in the wider catchment can impact on maintaining populations of migratory fish species after the development of self-sustaining riparian vegetation.
