## Built 1936 Bridge to Nowhere

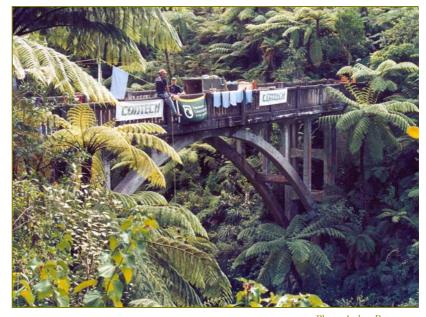
Concrete repairs in progress by Contech in February March 1996, total cost \$70,000. The concrete was spalling in some locations areas due to insufficient cover of the reinforcing steel.
